*Middle Waikato Bed Degradation  
Investigation Stages III & IV.*

*Contract number: AM2004/5-30*

**Proposed Middle Waikato River  
Bed Degradation Management  
Strategy - Appendices**

Mid-Waikato Bed Degradation Investigation Stages III and IV  
River Bank and Infrastructure Condition Photographs - May 2005

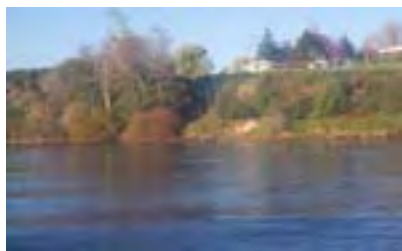
km 107.25L

| Distance from river mouth, km | Beca waypoint/<br>cross-section No. | Photo Filename | Bank | Feature | Bank Condition Comments |
|---|---|---|---|---|---|
| 107.25 | WP128 | km 107.25L.jpg | L | Wide road reserve. | Soil failure; shallow beach with high terrace behind. Benched slope. |

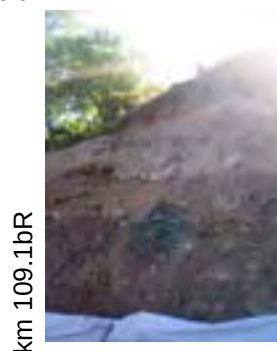
km 109.1bR

| Distance from river mouth, km | Beca waypoint/<br>cross-section No. | Photo Filename | Bank | Feature | Bank Condition Comments |
|---|---|---|---|---|---|
| 109.10 | WP145 | km 109.1bR.jpg,<br>km 109.1cR.jpg,<br>km 109.1dR.jpg | R | | Fallen trees. Recent cut prepared for walkway; bench too narrow to maintain stability if lower slope lengthened due to degradation. |

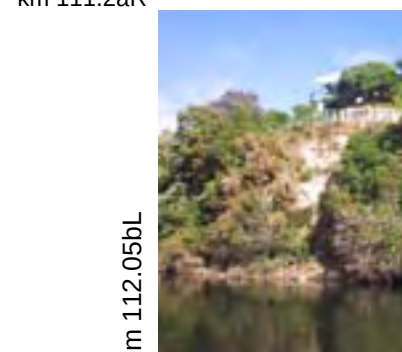
km 112.05bL

| Distance from river mouth, km | Beca waypoint/<br>cross-section No. | Photo Filename | Bank | Feature | Bank Condition Comments |
|---|---|---|---|---|---|
| 112.05 | CS59 | km 112.05aL.jpg,<br>km 112.05bL.jpg | L | | Hummocky slope failing next to sheet-piled outfall (3 sheetpiles at 2 m spacing and timber). Loss of material below; walkway above; houses beyond. Bare of vegetation. |

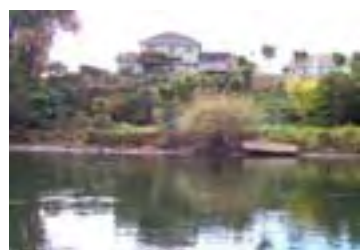
km 113.2R

| Distance from river mouth, km | Projected 100 years bed degradation, m | Beca waypoint/ cross-section No. | Photos | Bank | Feature | Land/ Property/ Infrastructure | Subjective risk assessment | Comments and Options to address bed degradation |
|---|---|---|---|---|---|---|---|---|
| 113.2 | 2.9 | WP187 | Yes | R | Failed timber jetty | Property | Moderate | Needs reconstruction |

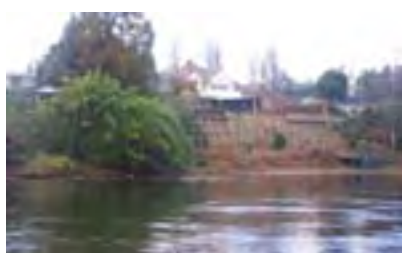
km 113.6R

| Distance from river mouth, km | Beca waypoint/<br>cross-section No. | Photo Filename | Bank | Feature | Bank Condition Comments |
|---|---|---|---|---|---|
| 113.60 | WP195 | km 113.6R.jpg | R | Jetty | Significant 5 tiered timber retaining wall. May become undermined with bed degradation. Active movement/ slide/ flow/ creep upstream. |

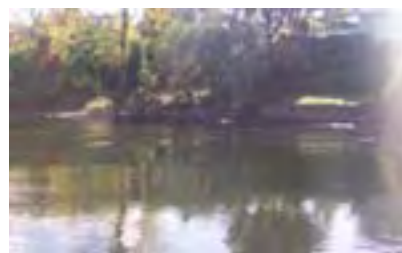
km 113.9cL

| Distance from river mouth, km | Beca waypoint/<br>cross-section No. | Photo Filename | Bank | Feature | Bank Condition Comments |
|---|---|---|---|---|---|
| 113.90 | CS62 | km 113.9cL.jpg | L | | Erratic use of riprap on bank; slope movement evident; curved trees; debris. Slope benched for walking track. Tree roots exposed. Likely to fail in response to bed degradation. |

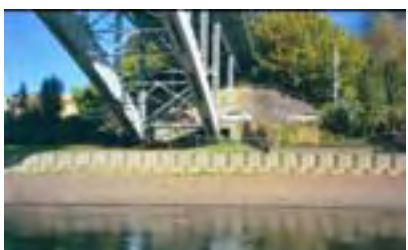
km 116.3bL

| Distance from river mouth, km | Beca waypoint/<br>cross-section No. | Photo Filename | Bank | Feature | Bank Condition Comments |
|---|---|---|---|---|---|
| 116.30 | CS65 | km 116.3bL.jpg | L | Bridge Street Bridge, outflow, rowing club. | Outflow tunnel with rock riprap in water. Fine gravel beach fronts rowing club. Concrete slab wall upslope, needs repair. |

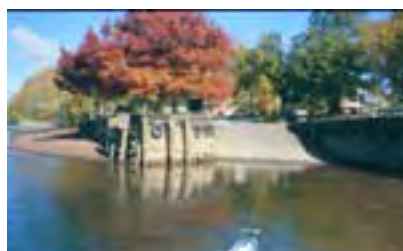
km 116.7L

| Distance from river mouth, km | Beca waypoint/<br>cross-section No. | Photo Filename | Bank | Feature | Bank Condition Comments |
|---|---|---|---|---|---|
| 116.70 | WP230 | km 116.7L.jpg | L | | Cemented rock wall retaining carpark. Will be redundant with bed degradation. |

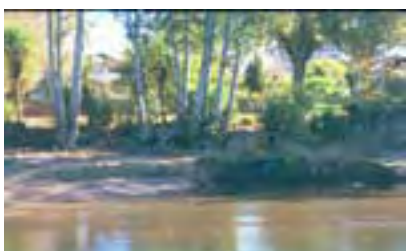
km 116.8L

| Distance from river mouth, km | Beca waypoint/<br>cross-section No. | Photo Filename | Bank | Feature | Bank Condition Comments |
|---|---|---|---|---|---|
| 116.80 | WP232 | km 116.8L.jpg | L | | Outfall onto flat sandy to gravelly beach; significant scour; will be high and dry with bed degradation. Slopes in behind are showing signs of movement. |

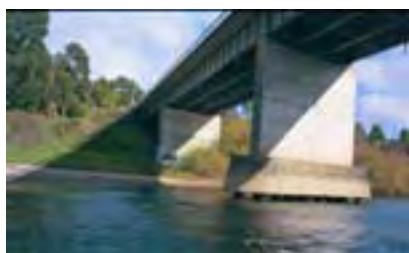
km 118.5L

| Distance from river mouth, km | Projected 100 years bed degradation, m | Beca waypoint/ cross-section No. | Photos | Bank | Feature | Land/ Property/ Infrastructure | Subjective risk assessment | Comments and Options to address bed degradation |
|---|---|---|---|---|---|---|---|---|
| 118.5 | 2.6 | CS68 | Yes | | Cobham Bridge | Infrastructure | Severe | Two piers in river, with pile caps just above water level. Review record drawings for impact of bed degradation |

| Distance from river mouth, km | Beca waypoint/<br>cross-section No. | Photo Filename | Bank | Feature | Bank Condition Comments |
|---|---|---|---|---|---|
| 118.50 | CS68 | km 118.5L.jpg | L | Cobham Bridge | Beach elevated. Protection may be required downstream of pile slab if bed degradation occurs. |

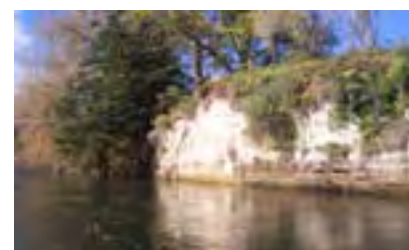
km 119.5L

| Distance from river mouth, km | Beca waypoint/<br>cross-section No. | Photo Filename | Bank | Feature | Bank Condition Comments |
|---|---|---|---|---|---|
| 119.50 | WP265 | km 119.5L.jpg | L | | Spalling and slabbing of subvertical cliff. |

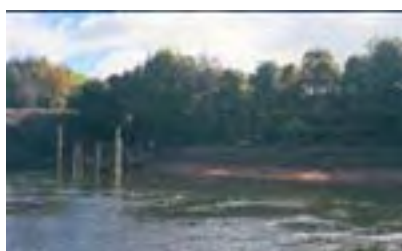
km 119.5R

| Distance from river mouth, km | Projected 100 years bed degradation, m | Beca waypoint/ cross-section No. | Photos | Bank | Feature | Land/ Property/ Infrastructure | Subjective risk assessment | Comments and Options to address bed degradation |
|---|---|---|---|---|---|---|---|---|
| 119.5 | 2.5 | WP265 | Yes | R | 50-m long gabion wall and timber landing | Property | Moderate | Timber steps will need extending. Gabions are set back from river edge, so unlikely to be affected by bed degradation |

| Distance from river mouth, km | Beca waypoint/<br>cross-section No. | Photo Filename | Bank | Feature | Bank Condition Comments |
|---|---|---|---|---|---|
| 119.50 | WP265 | km 119.5R.jpg | R | Cemetery | Gabion protection below road. Beach developed. Slope steepens and lengthens; well vegetated but susceptible to spalling/ slabbing/ oversteepening. Terraced next to cemetery/ walking track. |

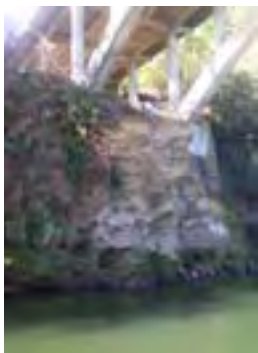
km 126.4bR

| Distance from river mouth, km | Beca waypoint/<br>cross-section No. | Photo Filename | Bank | Feature | Bank Condition Comments |
|---|---|---|---|---|---|
| 126.40 | CS74 | km 126.4bR.jpg, km 126.4cR.jpg | R | Narrows Bridge | Abutment piles extend to edge of top of slope; may require mitigation irrespective of bed degradation. Erosion upstream may lead to loss of bank. |
