Estuarine vegetation survey : Whangapoua Harbour

Estuarine Vegetation Survey Whangapoua Harbour

Estuarine Vegetation Survey – Whangapoua Harbour, June 2010

Natural Solutions Contract Report 10/095

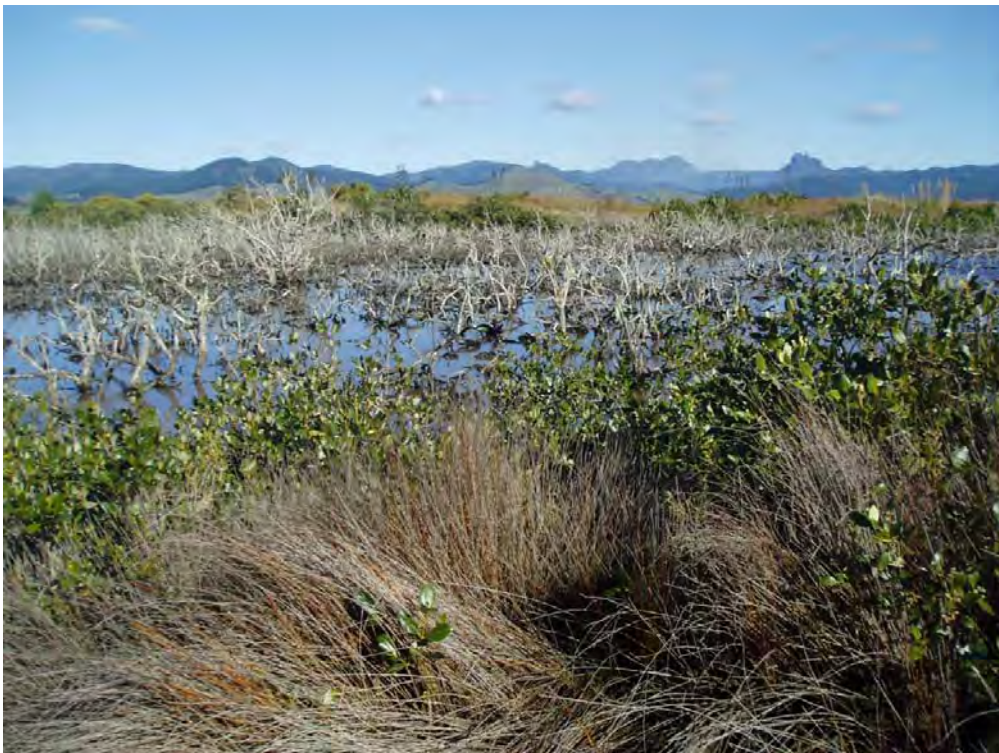
Figure 3: A dead mangrove zone behind the main chenier at Matarangi. The mangroves stand in deep sulphur-smelling mud and brown algae is common on the surface.

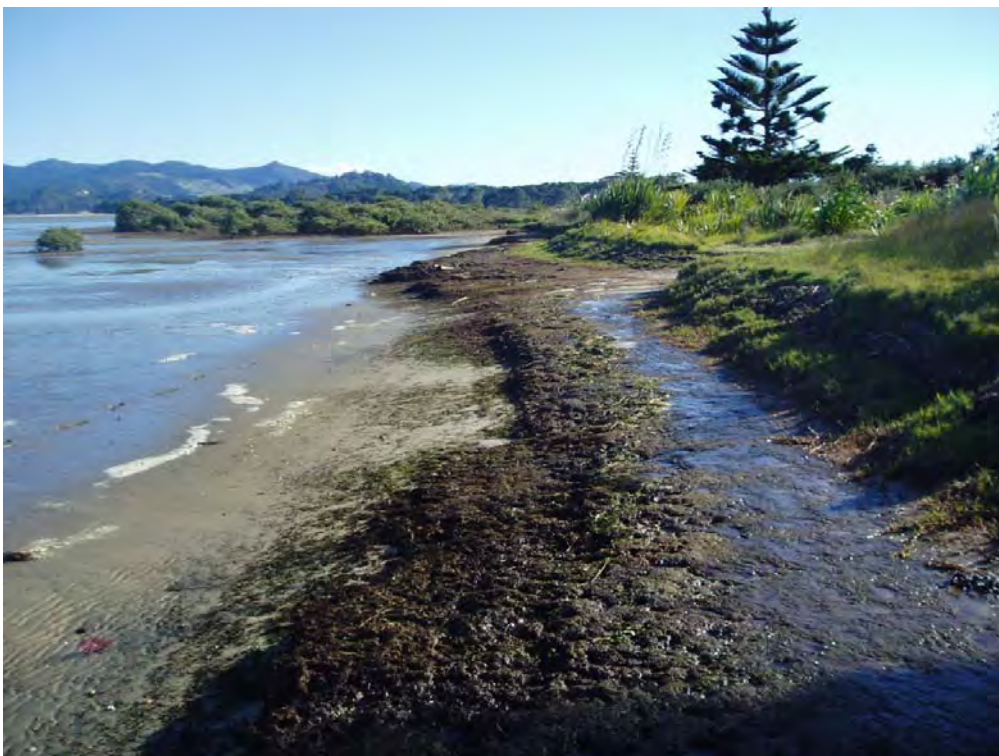
Figure 7: The eroding shoreline north west of the Matarangi boat ramp.

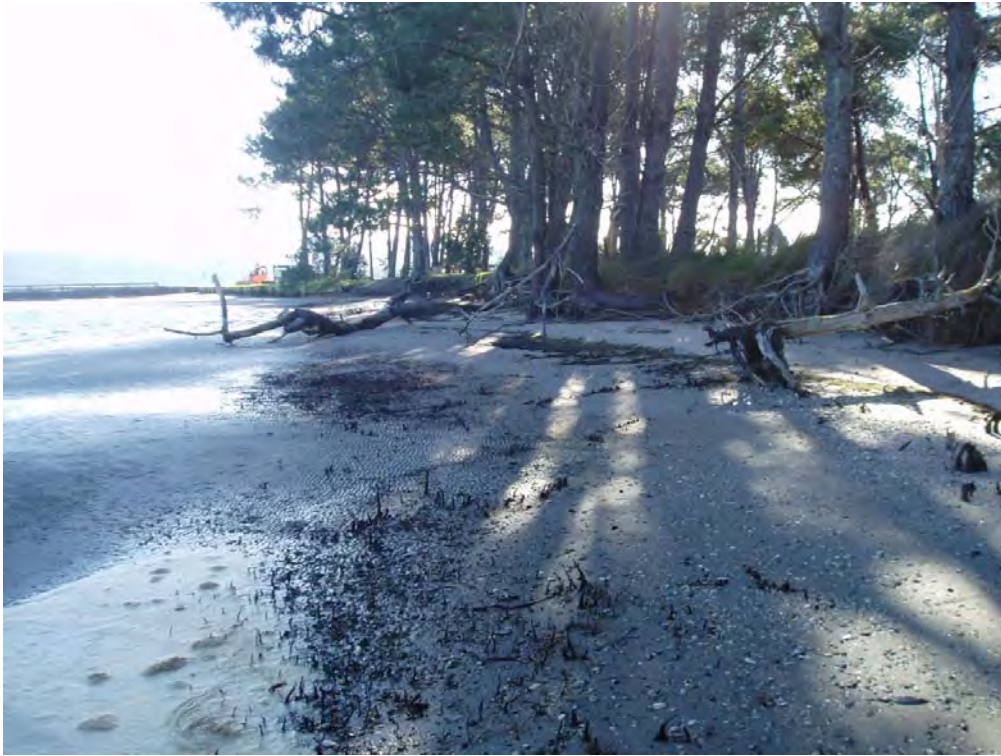
Figure 8: The eroding shoreline south east of the Matarangi boat ramp.

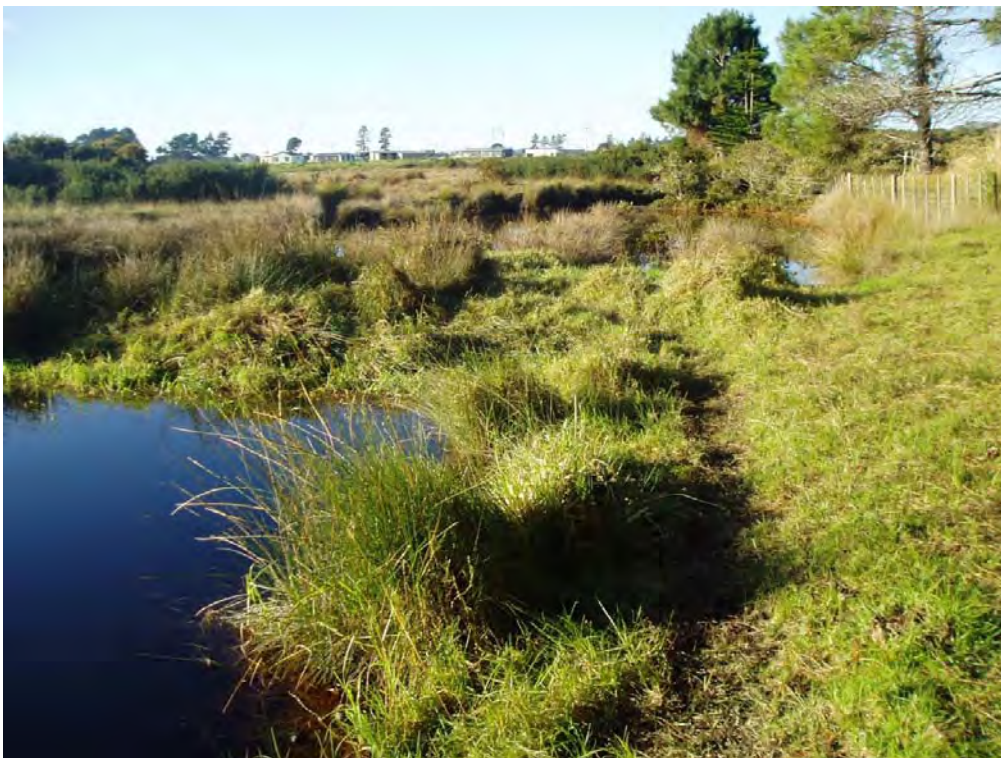
Figure 9: This small embayment of the harbour has been bunded and drained resulting in markedly different water levels in the ponding areas either side of the bund.

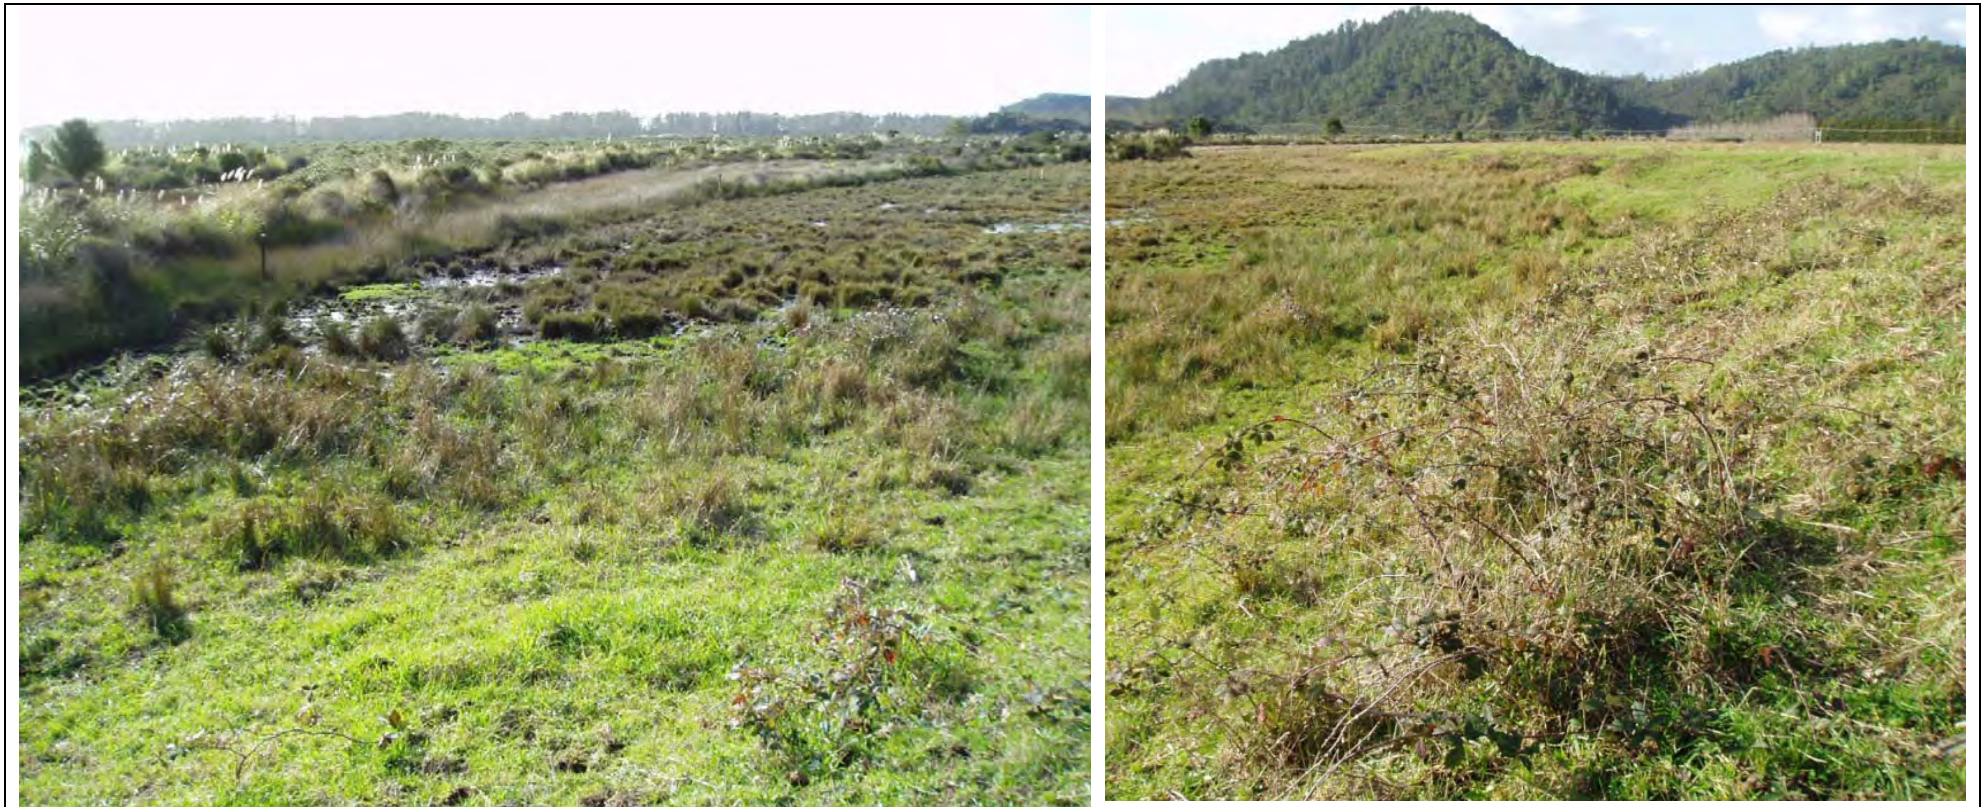
Figure 17: A grazed and stop-banked edge of the harbour. Matarangi Road causeway is in the right-hand background.

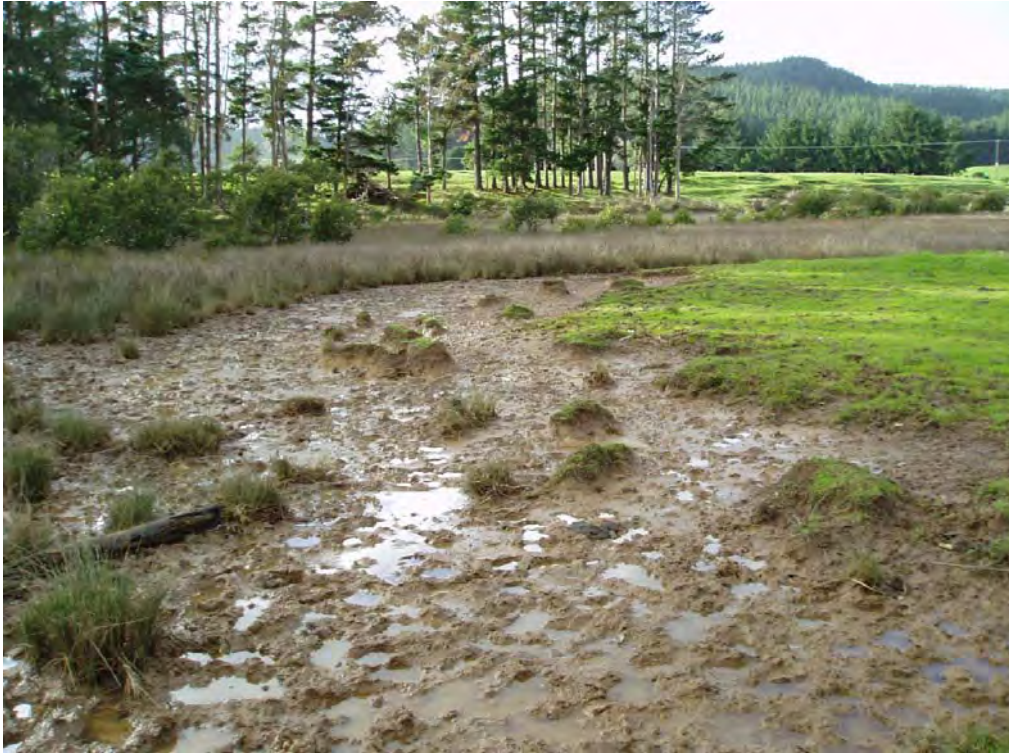
Figure 22: An unfenced edge of the TRB Otanguru River showing stock damage to sea meadow and sea rush. The mangroves line a drain edge.

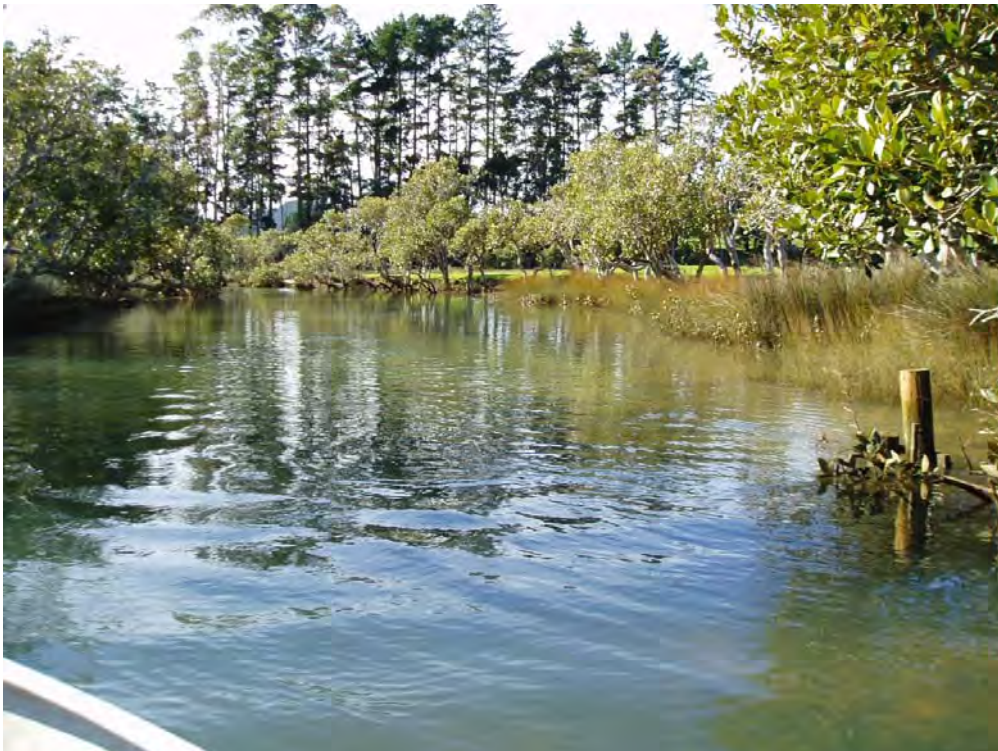
Figure 23: Another view of unprotected banks of the Otanguru Stream (TRB).

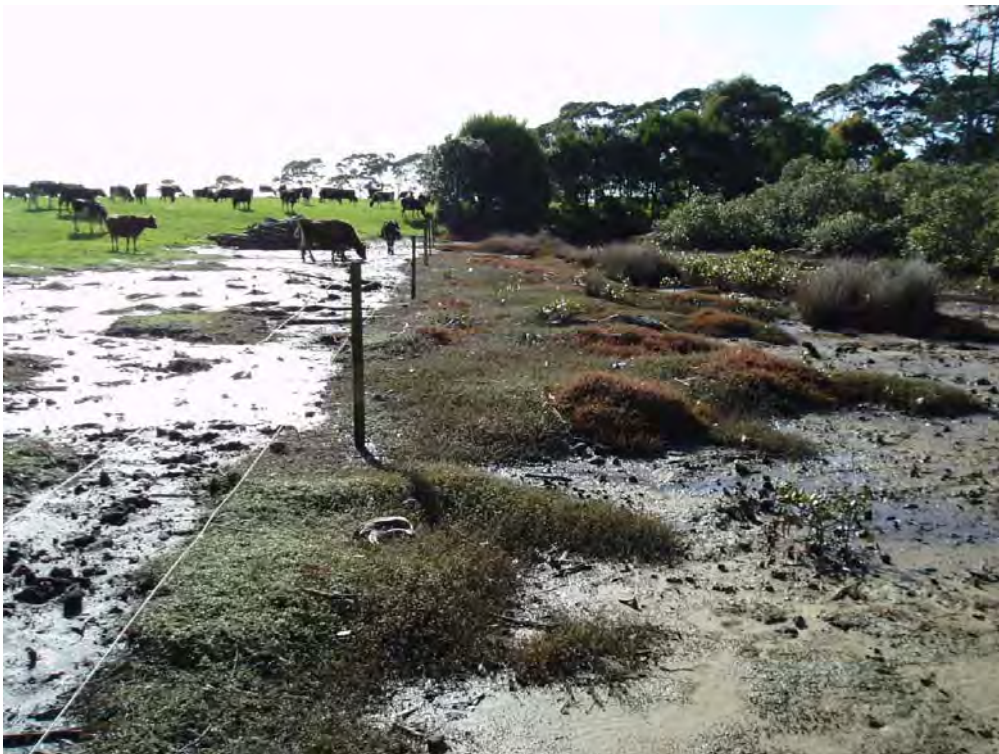
Figure 27: An area of partially fenced sea meadow clearly showing the negative effect of stock grazing and pugging.

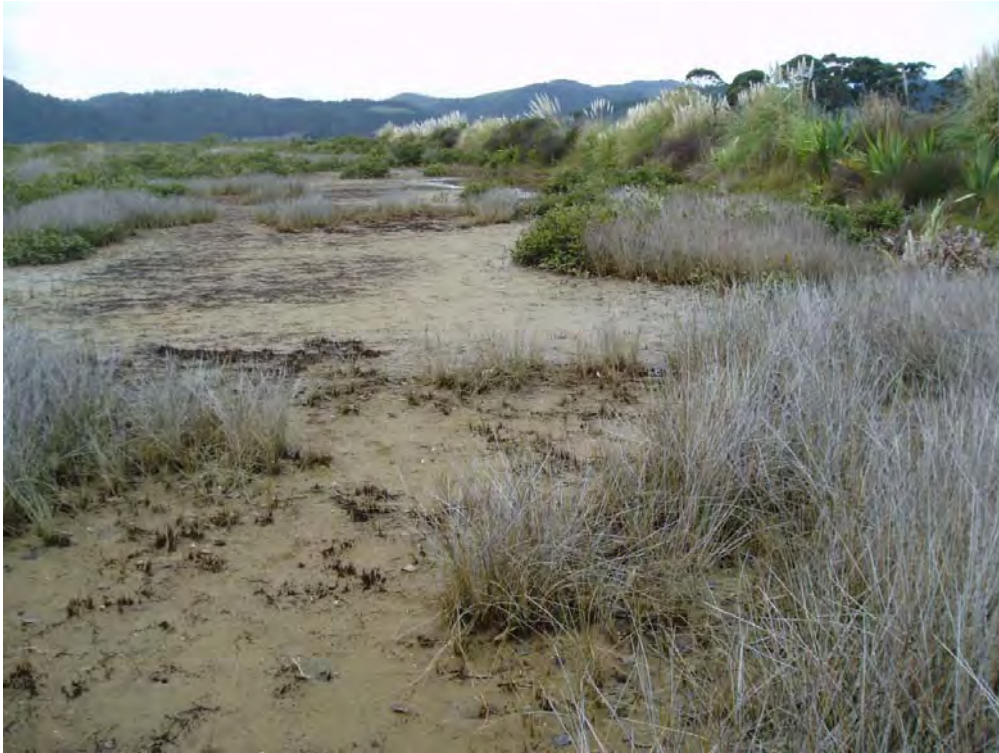
few areas where the dead root mass of sea rush is found immediately seaward of the stopbank (Figure 28), but it was not clear what was causing the die-back. Banded rail footprints were found in the area. There is saltwater *Paspalum* along the seaward edge of the headland, often associated with stopbank drainage works (Figure 29). The rush/sedgeland and mangrove zone thins and disappears at the most northern and exposed tip of the headland. Saltwater *Paspalum* dominates along the stopbank foreshore with scattered knobby rush and pampas. Areas of exposed organic bed pan are common, making an unsuitable base for mangroves to establish in (Figure 30). There were loose clumps of oysters along the seaward edge of the exposed bed pan.

Figure 28: An area of dead sea rush immediately seaward of a stopbank. It is unclear why the sea rush has died and the reason for these open areas.

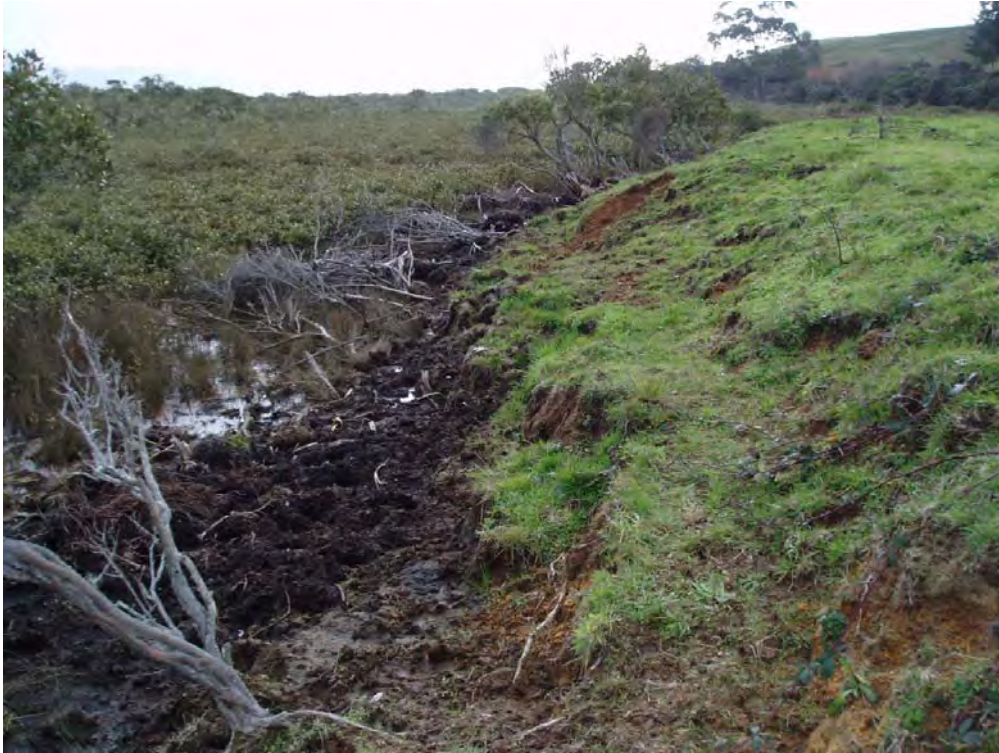
Figure 36: Stock access into the CMA here has resulted in bank erosion and loss of riparian shrubs, as well as grazed and pugged rush/sedgeland and mangroves out to the orange tape 'fence'.

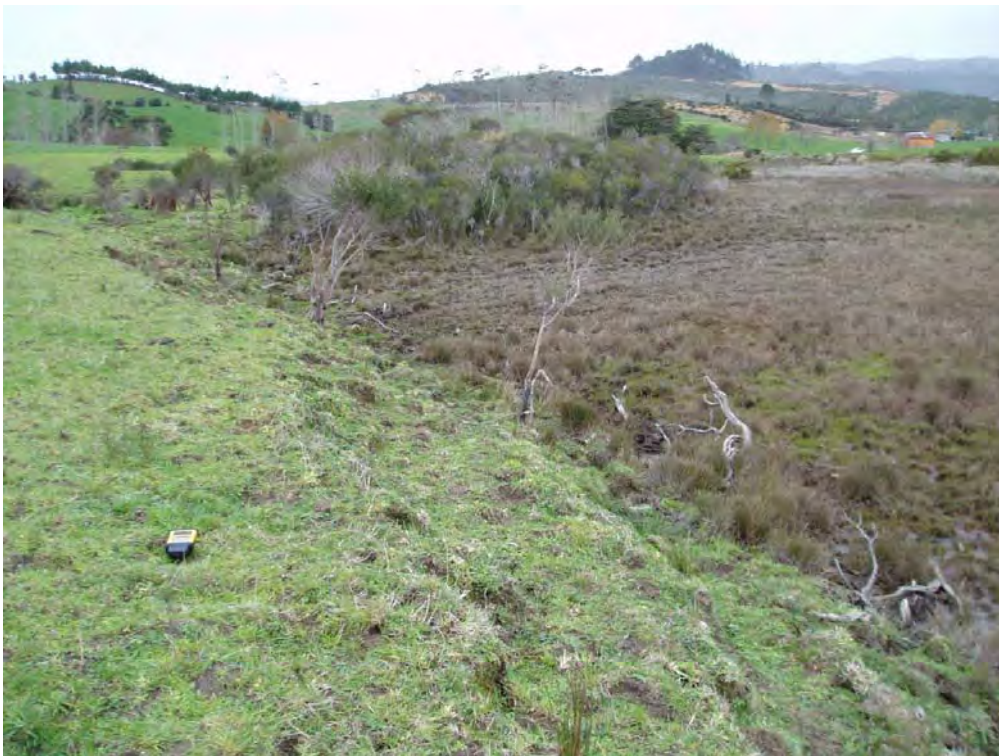
Figure 37: More unfenced coastal edge with obvious tracking through the rush/sedgeland and degraded riparian vegetation and freshwater seepage.

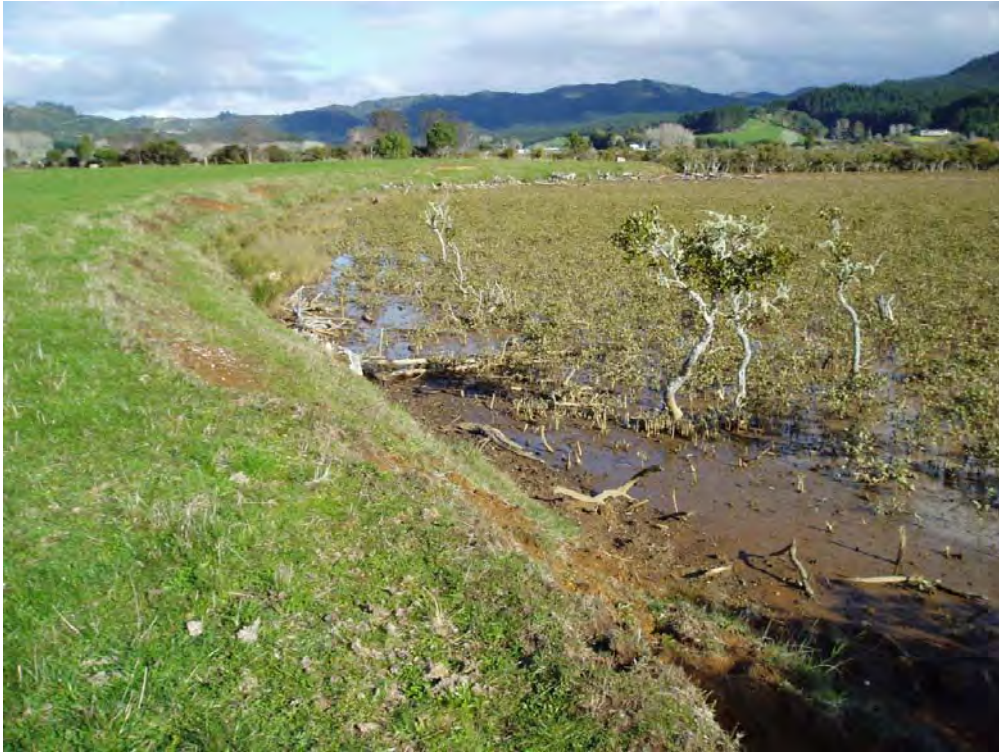
Figure 38: More unfenced harbour margin with heavily grazed mangroves, eroded banks and loss of riparian vegetation.

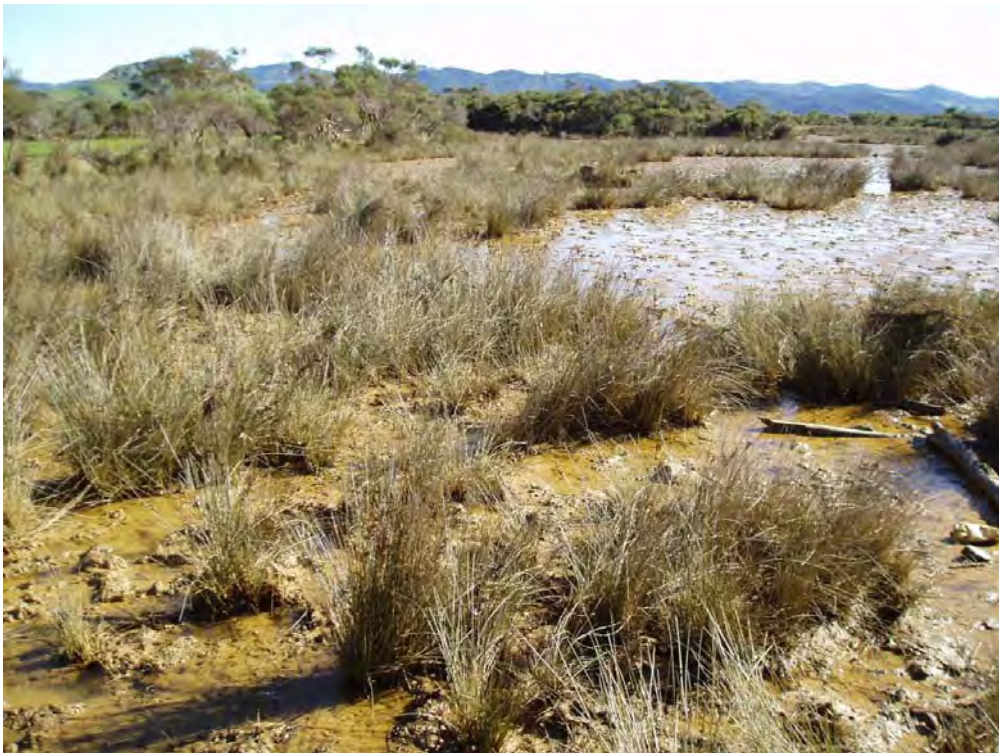
Figure 39: Badly pugged and grazed sea rush/saltmarsh ribbonwood/manuka/*Baumea juncea* wetland.

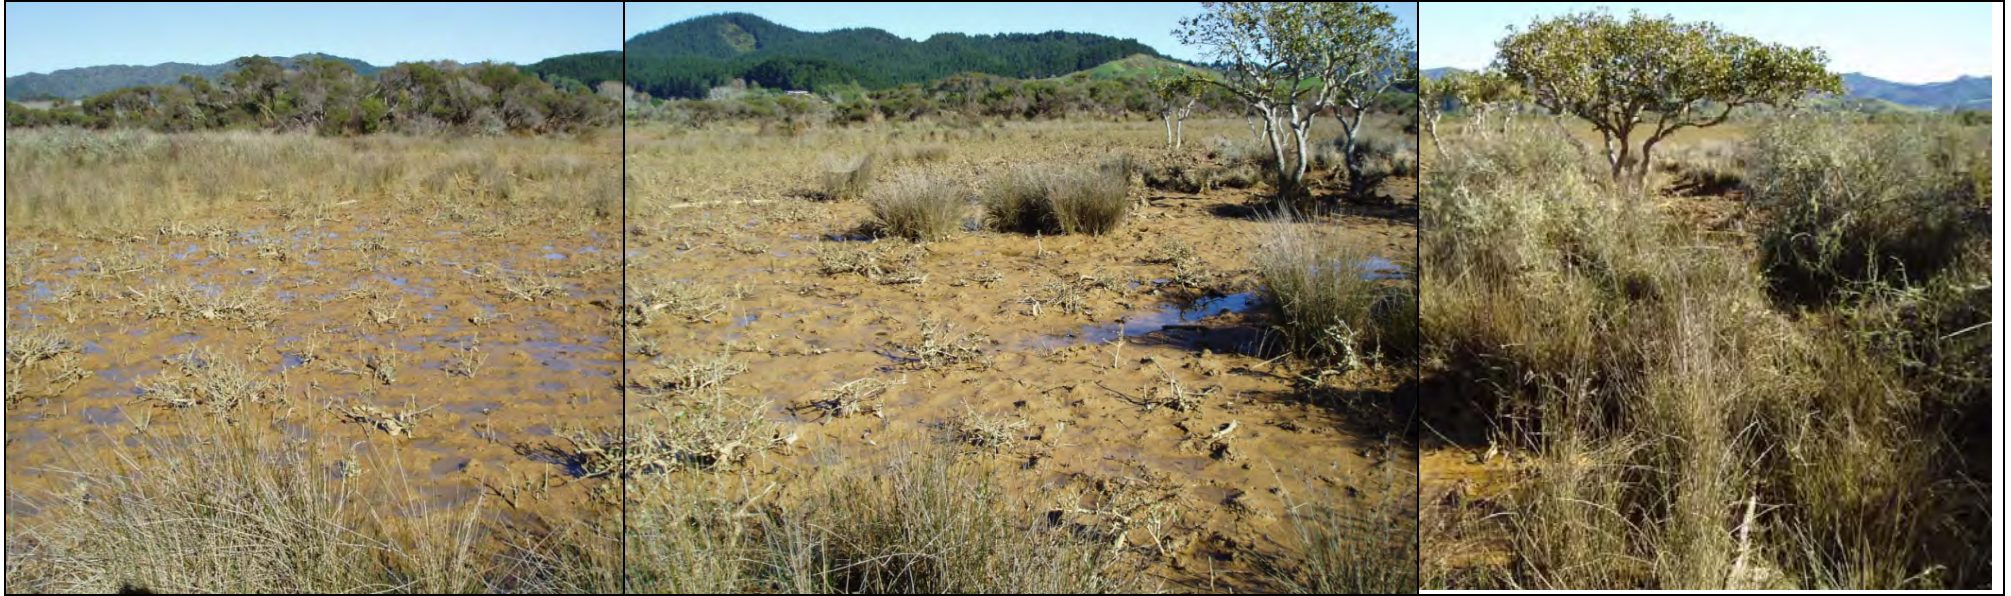
Figure 40: Mangroves have been completely grazed from this wetland except where they are out of stock reach. The rest of the sea rush and saltmarsh ribbonwood wetland is also badly pugged, tracked and occasionally grazed.

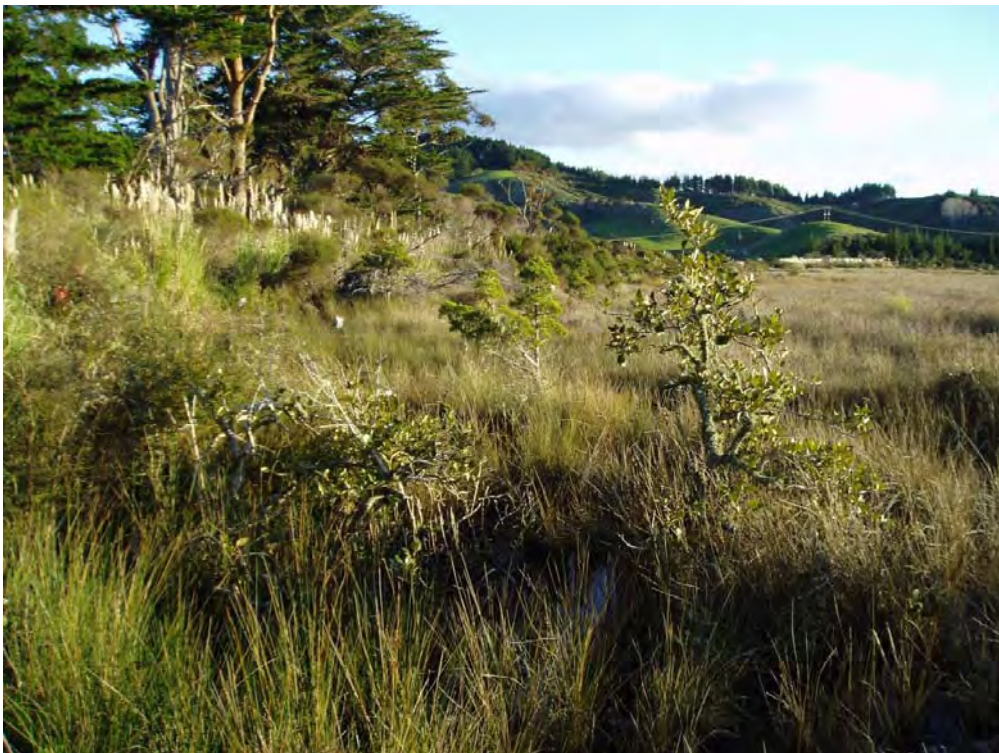
Further west in the next embayment the coastal edge is mostly fenced and planted, however stock must have access at some point as a dead cow was found in the rushes. Figure 43 shows *Cypruss* planted along the coastal edge with seedlings found in the rush/sedgeland. A gum seedling was also present. Bulldozer tracks occur through rush/sedgeland where a channel had been dug through the rushes to extend the drainage out into the CMA. Fernbird were heard along the saltmarsh ribbonwood margin. The south-western corner of the embayment is bordered by pines along the State Highway, and has a good example of a natural sequence of mangroves – sea rush and oioi – manuka/*Baumea*/flax/raupo freshwater wetland (Figure 44). The only unnatural feature in this sequence is the willow invading the freshwater wetland.

Figure 43: Large *Cypruss* planted along the coastal edge are seeding into the rush/sedgeland. Three *Cypruss* seedlings are visible in the middle of the photo.

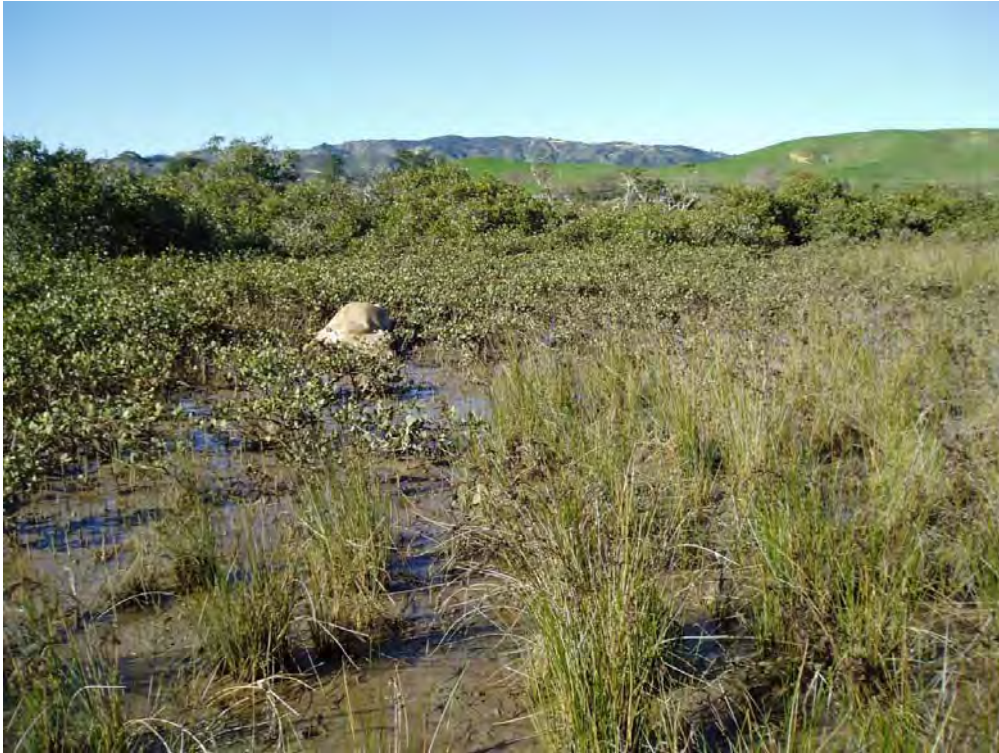
Figure 45: Heavy tracking and pugging of the estuary and a dead cow amongst mangroves.

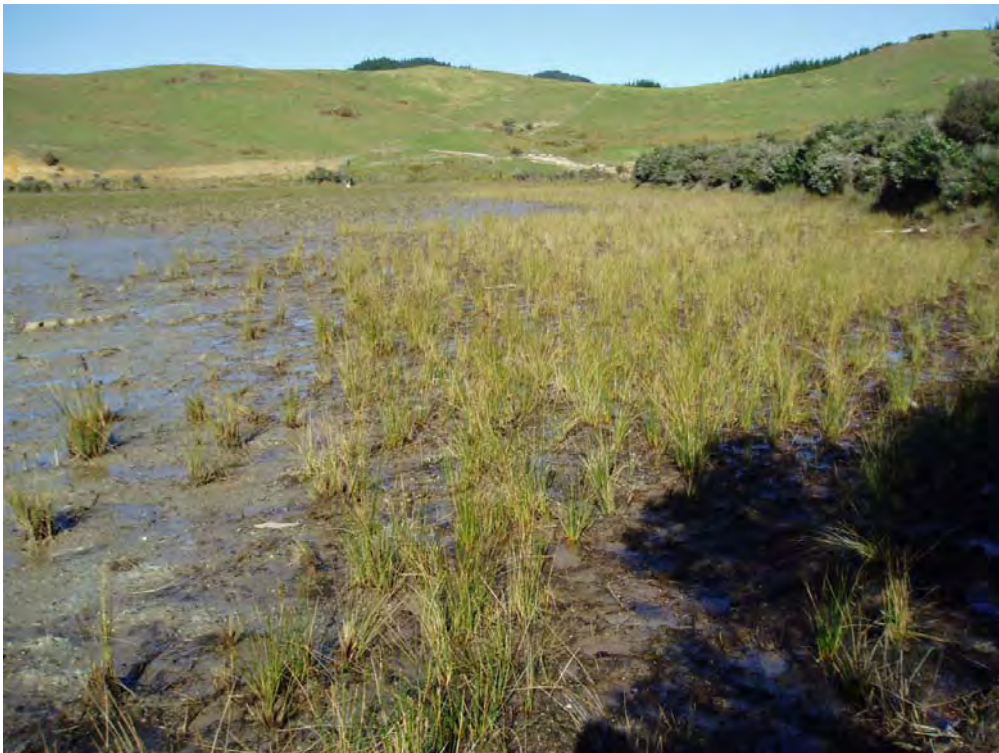
Figure 46: This stretch of harbour edge is badly pugged, grazed and polluted (dung). The riparian vegetation survives but is heavily tracked and grazed underneath.

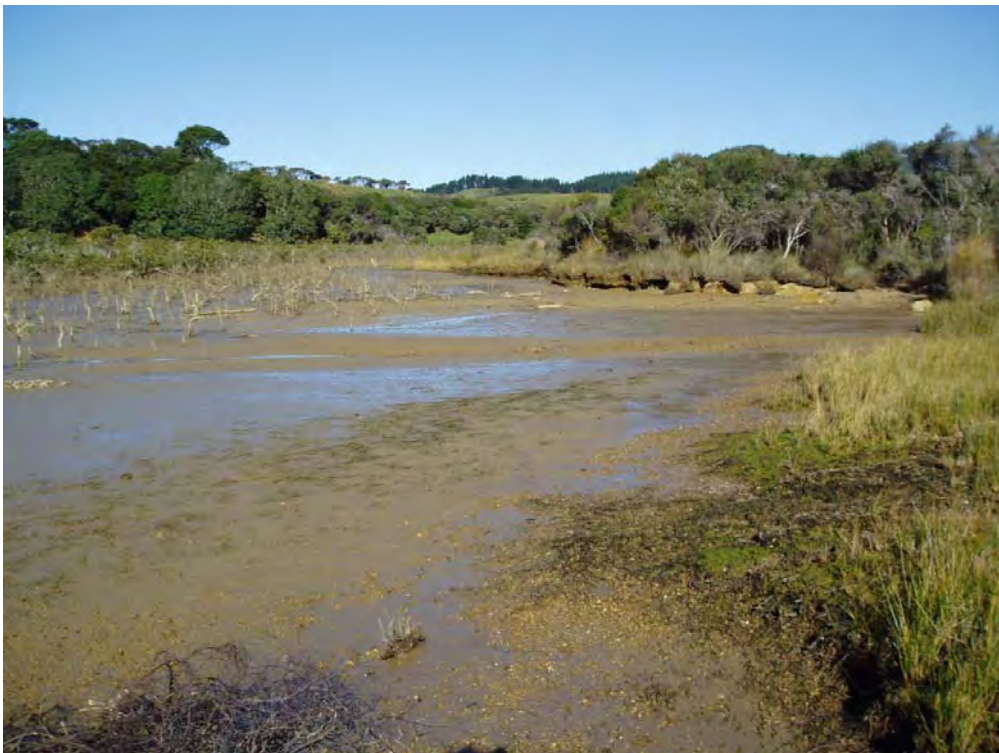
Figure 50: The land edge becomes eroded where mangroves are absent (or grazed) and the sediment firmer to walk on.

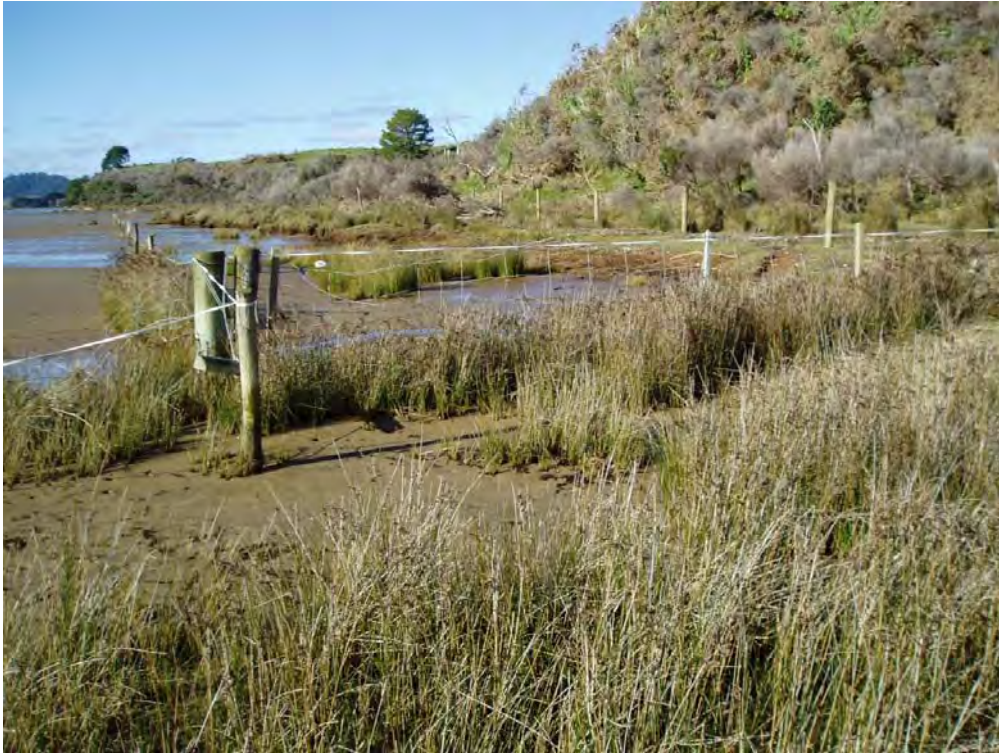
Figure 53: The exposed coast line west of Oweria Head (distant left headland) is also eroded where the fringing vegetation is damaged and removed by stock.

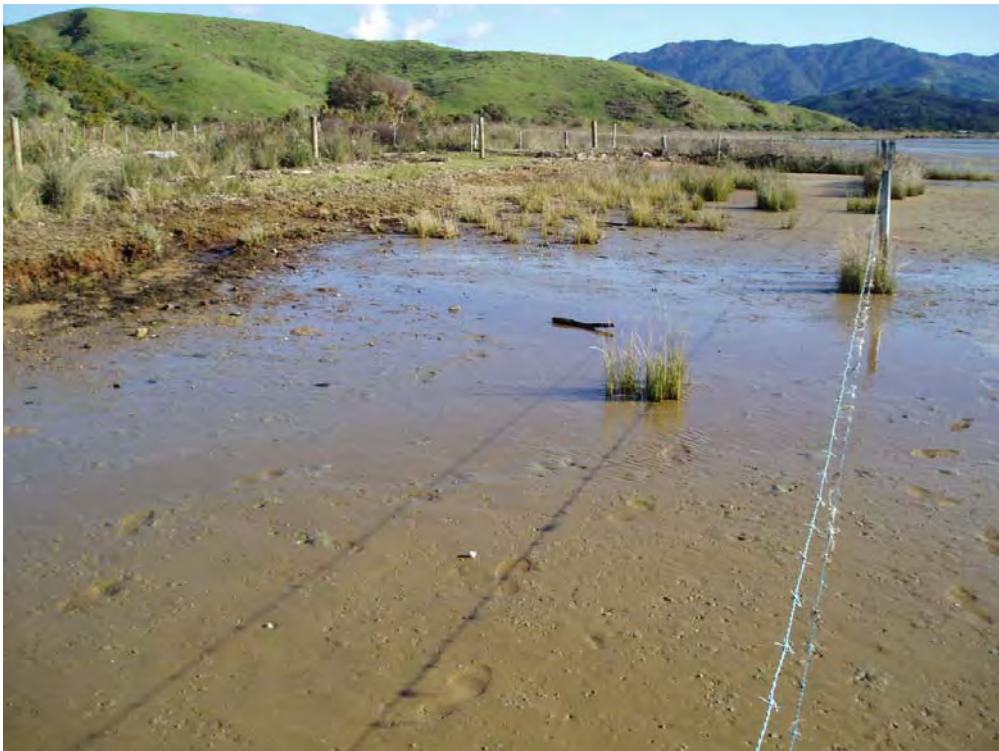
Figure 54: Stock fencing protects the coastal edge vegetation in the distance while the coastal edge vegetation in the forefront is unprotected. A new fence is being built along the immediate land edge of the badly eroded section.

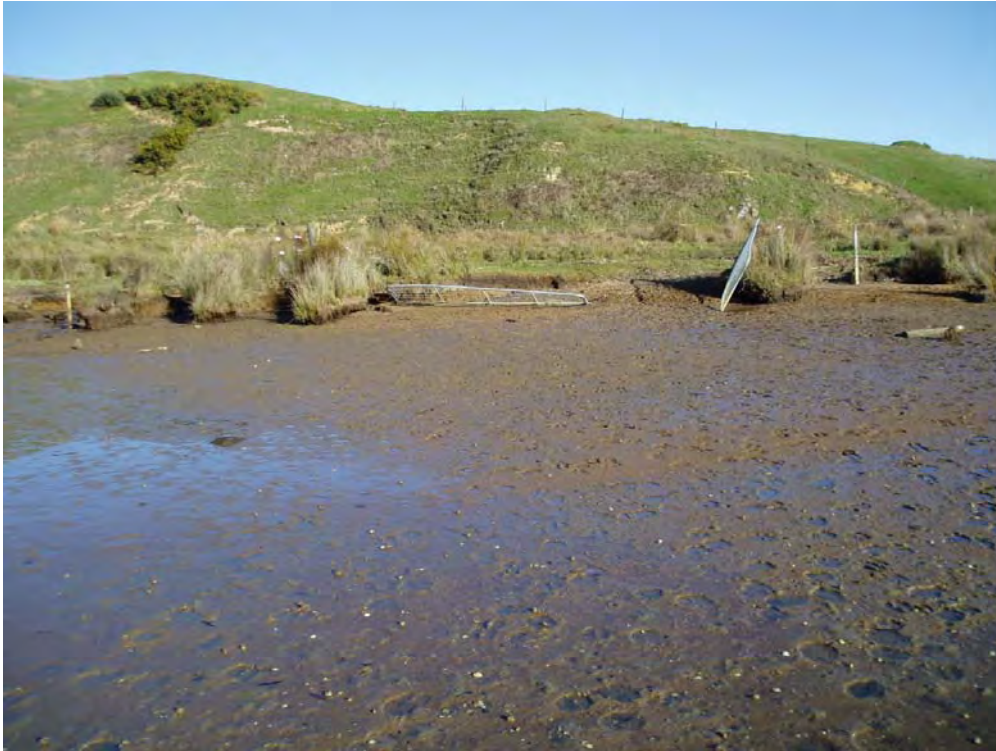
Figure 55: This gate forms part of the poorly fenced harbour edge and allows stock to access the harbour causing extensive damage to harbour vegetation and contributing sediment and faecal pollution.

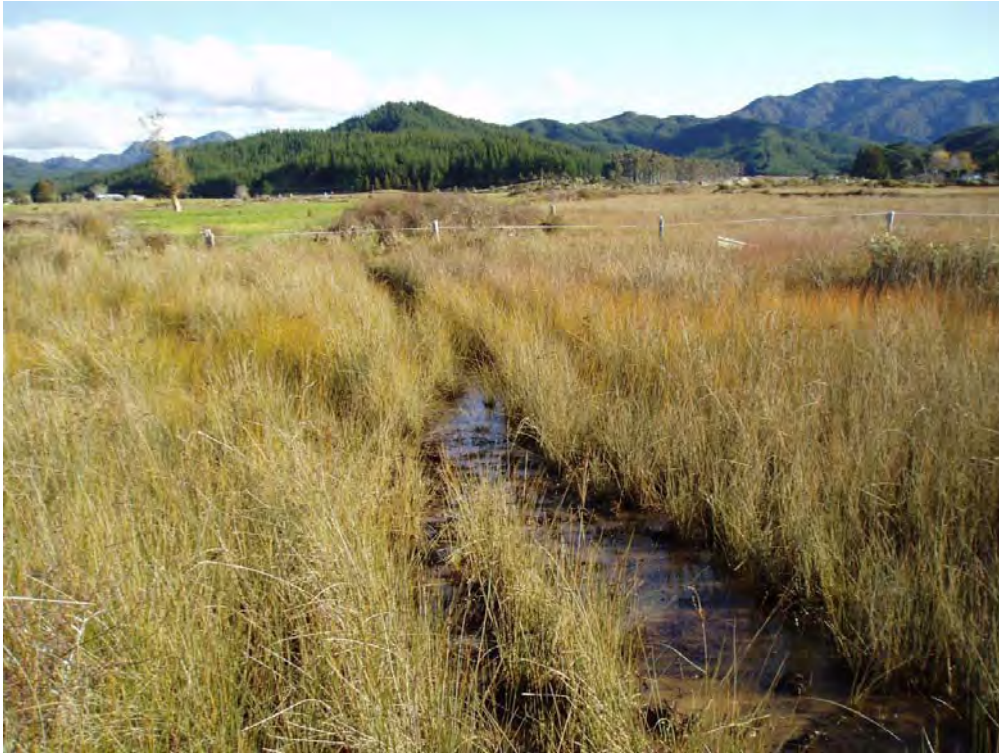
The TRB of the **Waingaro Stream** is either poorly fenced or unfenced (Figure 61), with very little riparian vegetation remaining above the estuarine zone. A large area of saltwater paspalum was found invading the rush/sedgeland (Figure 62). Drainage and pasture development has removed most of the original vegetation along the TRB bank of the Waingaro Stream; however there are some notable remnant estuarine (Figure 63) and freshwater (Figure 64) areas. Willow and pampas are weeds here. Saltwater paspalum is common around this coastal edge where stock have access from a number of points. Mangroves are generally 75cm high except for the odd tall one (3-4m) alongside channels.

Figure 61: The expanse of rush/sedgeland and saltmarsh ribbonwood in the foreground is poorly fenced and the more distant rush/sedgeland further up the TRB of the Waingaro stream is unfenced.

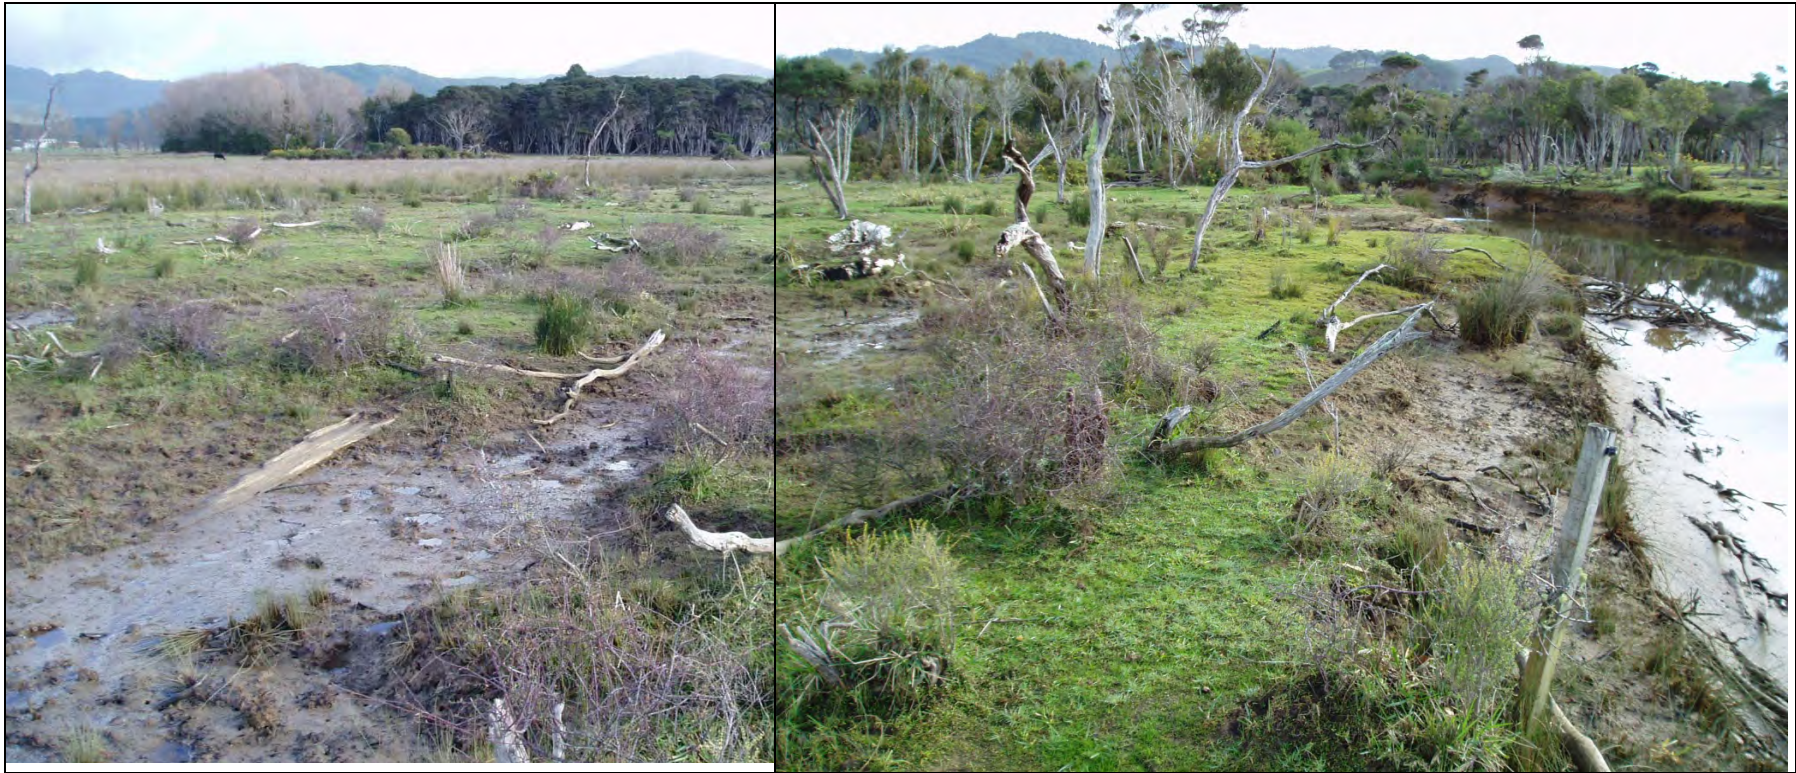
Figure 66: A view upstream along the TRB of the lower Waitekuri River over grazed and pugged saltmarsh ribbonwood, sea meadow and rush/sedgeland. The significant mature remnant stand of tarairi, puriri and kanuka floodplain forest can be seen in background.

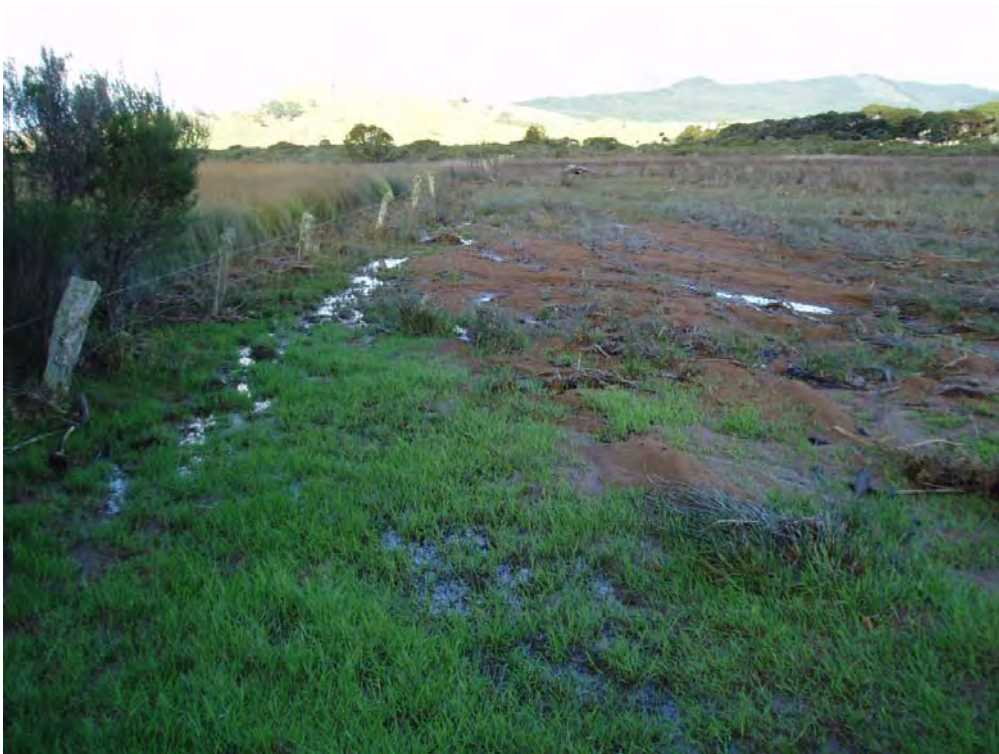
Figure 68: A view along a boundary fence showing the effect of grazing on rush/sedgeland. Also note the outwash debris from the Horongaherehere Stream over the 'paddock'.

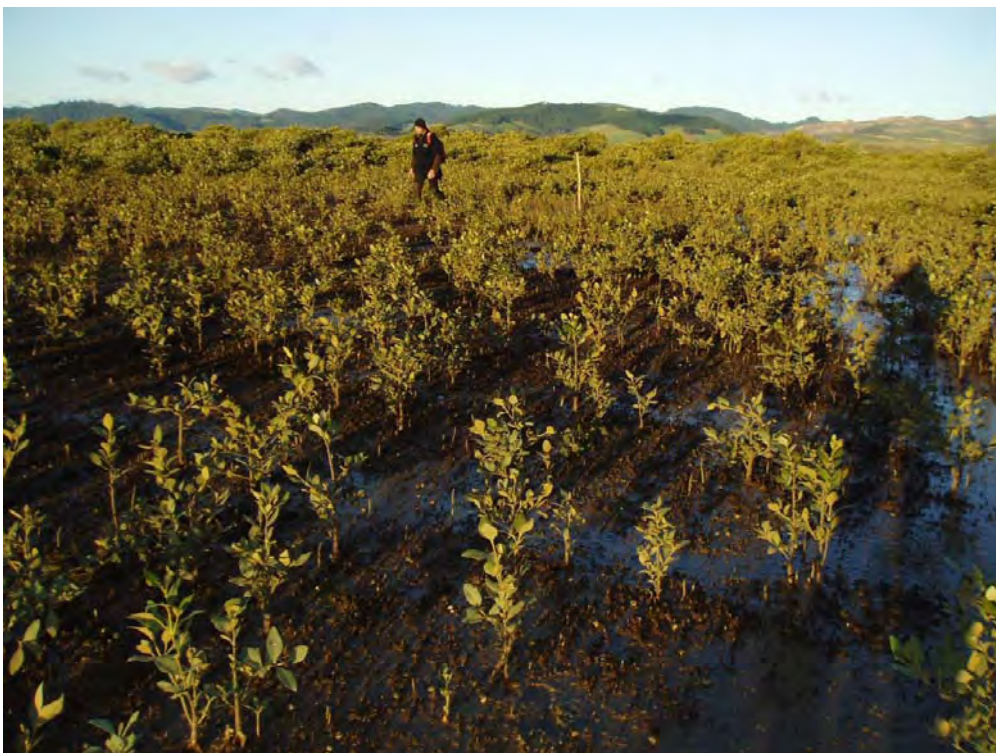
Figure 72: A large patch of sprayed spartina has left behind a decaying root base and encouraged the settlement of mangroves. A patch of live spartina is marked with a stick.

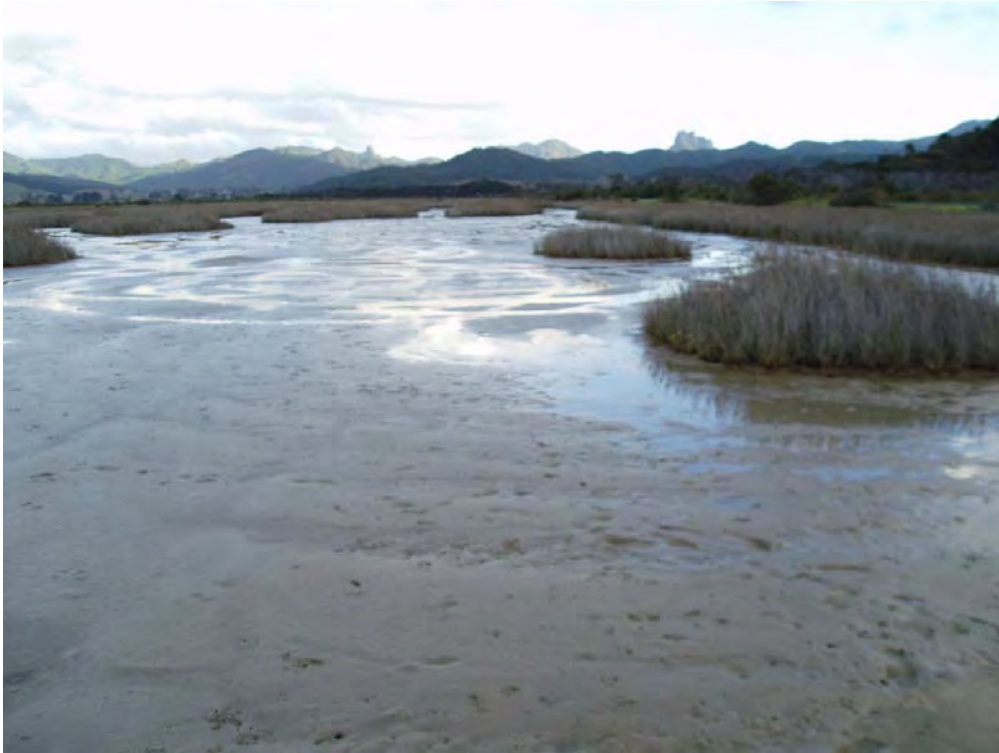
Figure 75: Vehicle tracks on the open mudflats between sea rush patches alongside Whangapoua Road.
