Estuarine vegetation survey : Whangapoua Harbour

Estuarine Vegetation Survey Whangapoua Harbour

Estuarine Vegetation Survey – Whangapoua Harbour, June 2010

Natural Solutions Contract Report 10/095

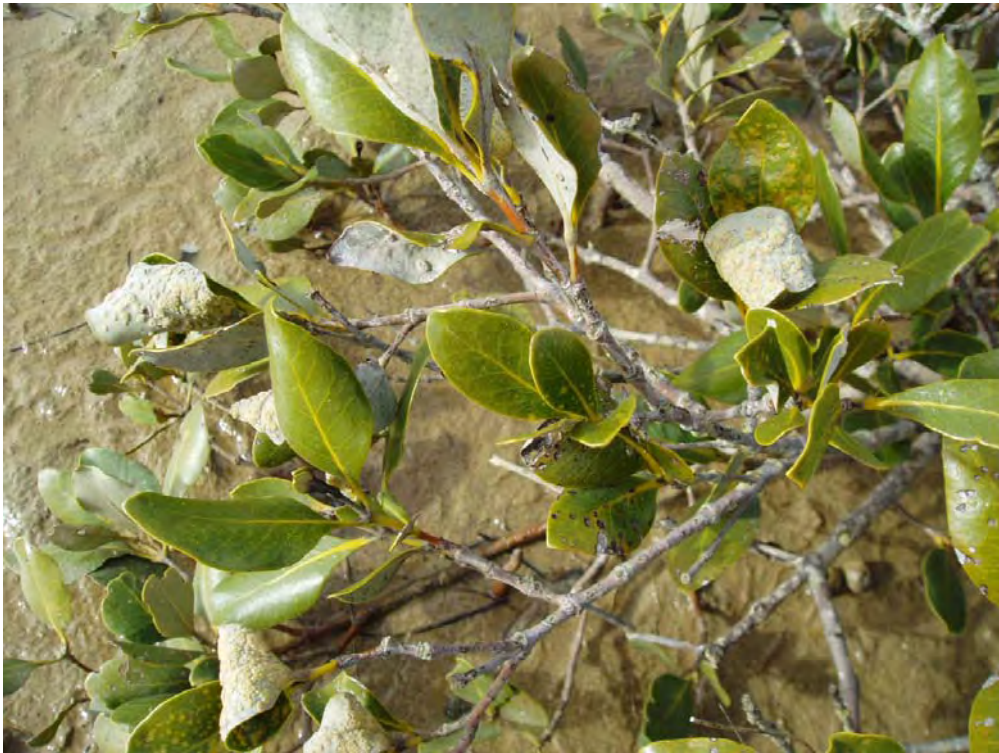
Figure 78: A mangrove with yellow lesions on its leaves.

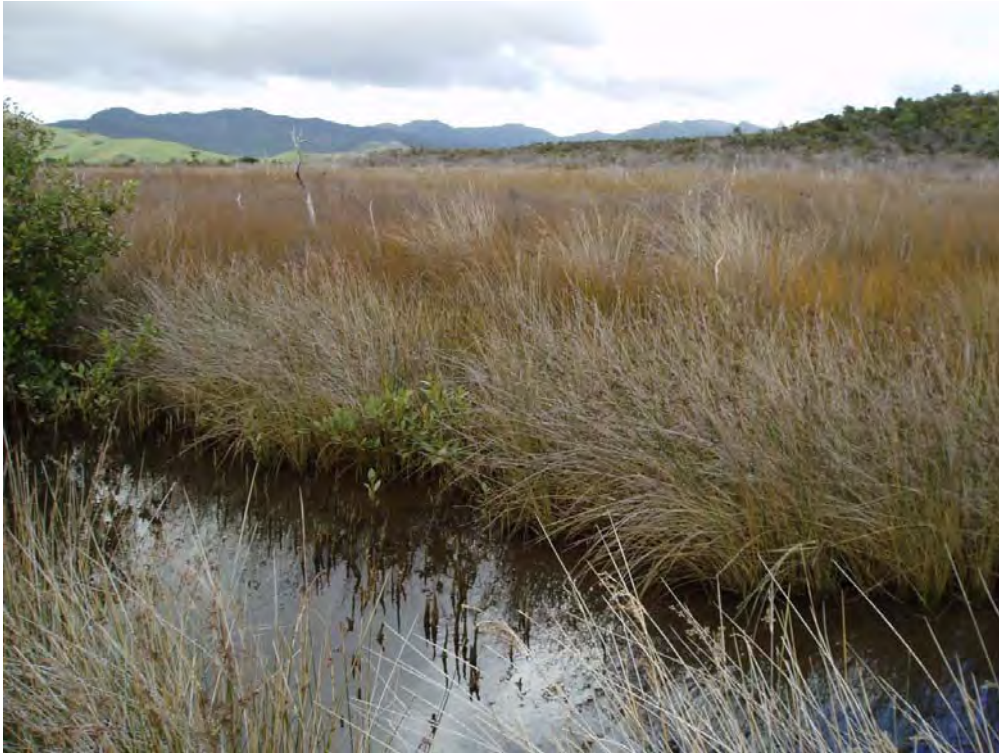
Figure 79: Rush/sedgeland behind the breached stopbank with mangroves and seagrass in the drain. Note the zone of dead manuka as a result of breaching the stopbank.

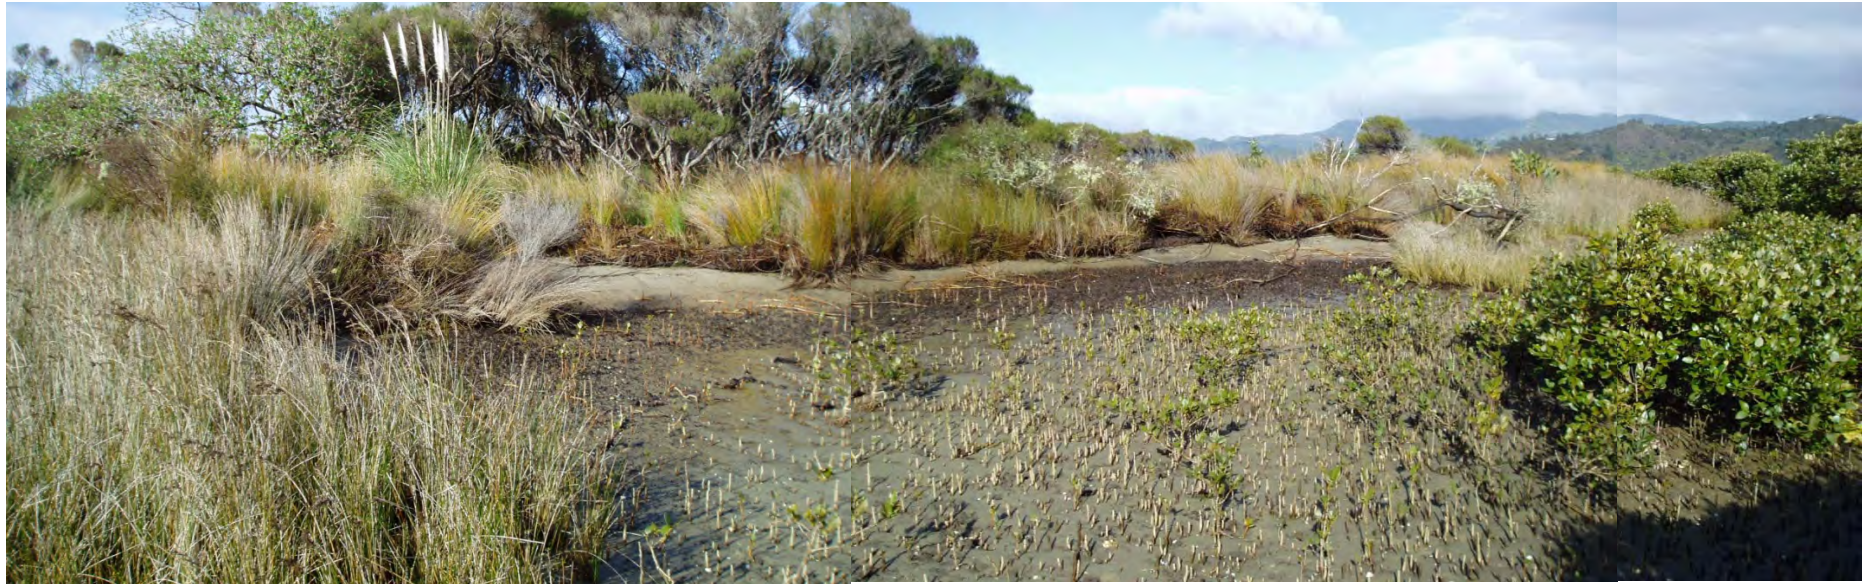
Figure 90: An eroding frontal edge of a vegetated chenier ridge. Old mangrove stumps and rush root mass are present in the dark exposed bank.

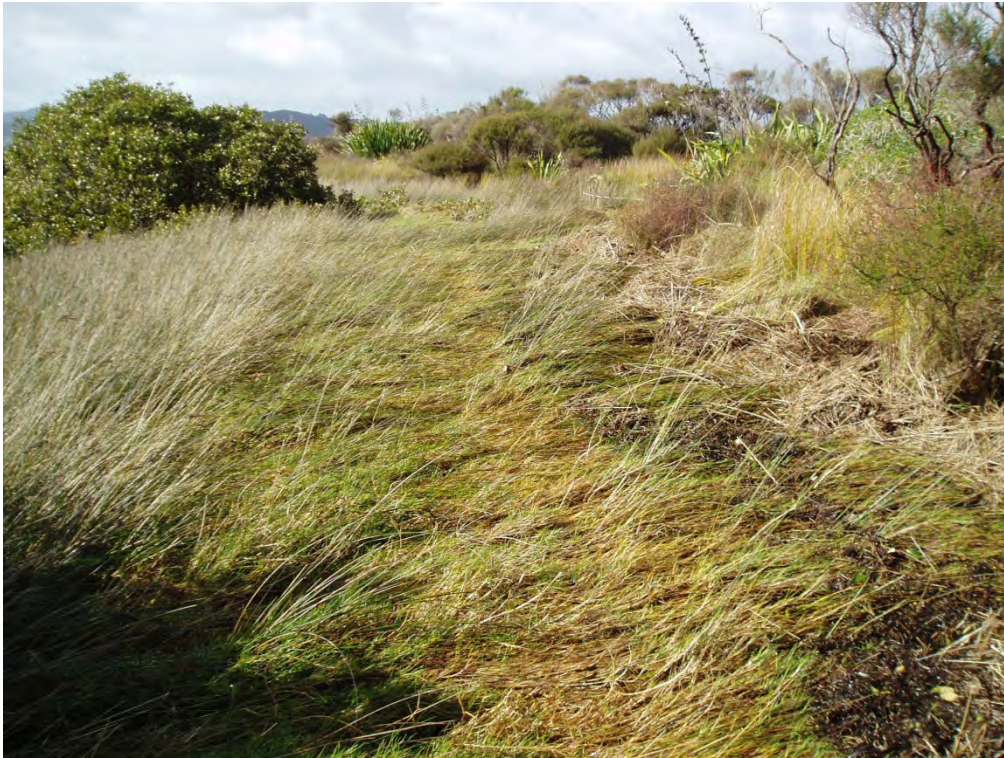
Figure 91: Here saltwater paspalum is invading the sea rush band and extending into the saltmarsh ribbonwood and knobby rush zone.
