# **Analysis of Degradation**

## **Waikato River**

## **Karapiro to Ngaruawahia**

Prepared by Graeme Smart

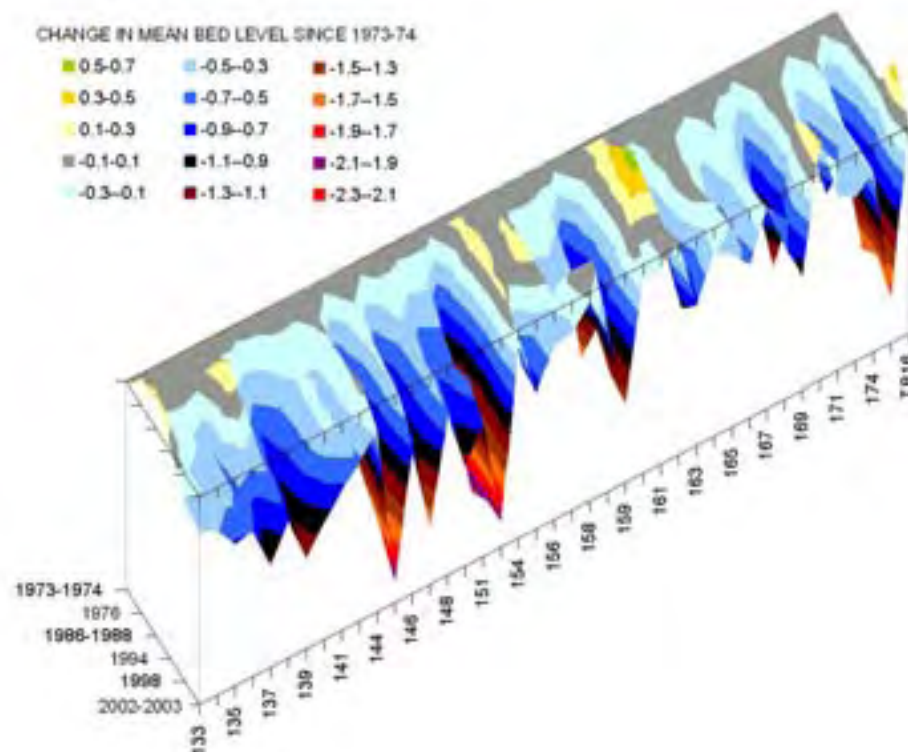
**Figure 1** Changes in mean bed level since 1973, shown in metres, from Section 133 (near Ngaruawahia) to Section TB16 (near Karapiro Dam).

An indication of the problem is given in Figure 1 which shows changes in mean bed level at a series of cross sections monitored by Environment Waikato. Areas shown in grey have not changed in level since 1973.

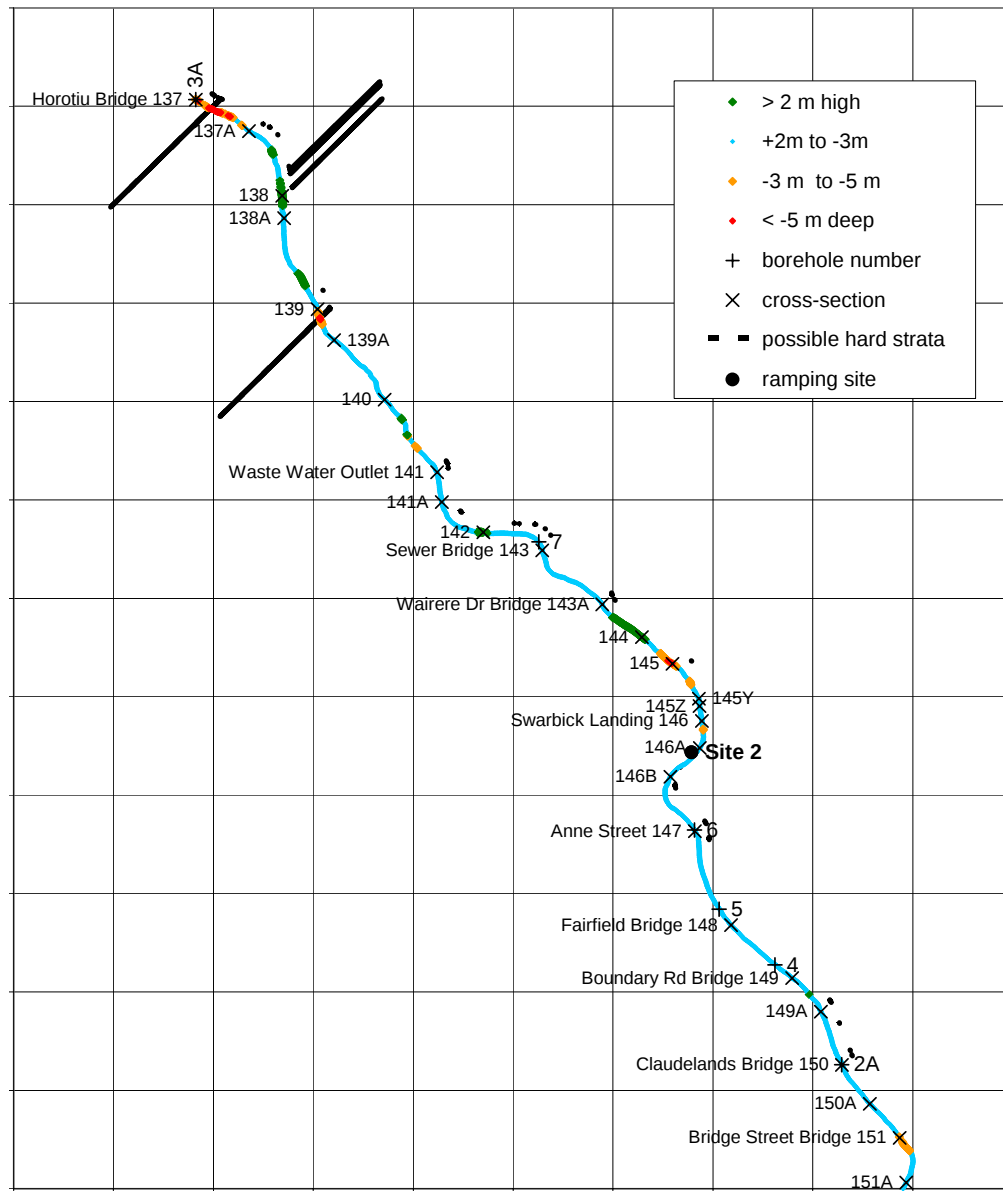
**Figure 2 Bed levels of Northern Hamilton reaches, indicated by deviation of the thalweg elevation from its linear trend line. Possible hard strata, cross-sections and borehole measurement locations are shown. Grid size is 1km.**

A graphic picture of variations in bed level is indicated by deviations of the thalweg from its linear trend line as shown on Fig. 2 and Fig. 3.

In these figures, dark green points show where the thalweg lies over 2 metres above the trend line. Such high points are potential hard sills in the bed. Black dots alongside the river right bank show where the seismic survey indicated

potential hard strata in the bed. Although underlying the river channel, for clarity the potential hard strata points are offset in a NW direction on the figures.

Four locations where high points correspond to potential hard strata are marked on the figures by diagonal lines rising to the right of the river. These are located 1.25 km and 1.43 km upstream of Horotiu Bridge on Fig. 2 and between 0.45 km and 2.53 km downstream of the Narrows Bridge on Fig.3. There are three high areas (shown in green) in the central Hamilton region. These are located halfway between sections 153A and 153Z on Fig. 3, and on Fig. 2 between Boundary Rd Bridge and section 149A and from section 144 downstream. None of these correspond to locations of hard strata indicated by the seismic survey. In Hamilton the thalweg is quite flat from just below Bridge St to the golf course just upstream of Swarbick Landing on Fig. 2. The flat bed could indicate an alluvial substrate with no hard sills.

Low points in the thalweg are shown on Fig. 2 and Fig. 3 in orange and very low points are shown in red. Four locations where very low points correspond with indications of potential hard strata are shown by diagonal lines to the left

of the river. These are at 180 m upstream of Horotiu Bridge (where the bed is only 0.39 m above sea level datum), 2.77 km upstream of Horotiu Bridge (bed level is 1.01 m above datum), 30 m downstream of Cobham Bridge (bed level is 1.08 m above datum) and around half way between cross sections 157 and 157A north of the city (bed level is 2.52 m above datum). There is a notable low section downstream of the golf course, near section 145 where the bed level falls to 1.43 m above datum and no hard strata were indicated. Low points in a thalweg are typically found on the outside of river bends (see orange and red reaches on Figs 2 and 3). While this explains many of the low points between the Narrows and the Golf Course, downstream of Swarbick Landing there are deep sections in straight reaches.

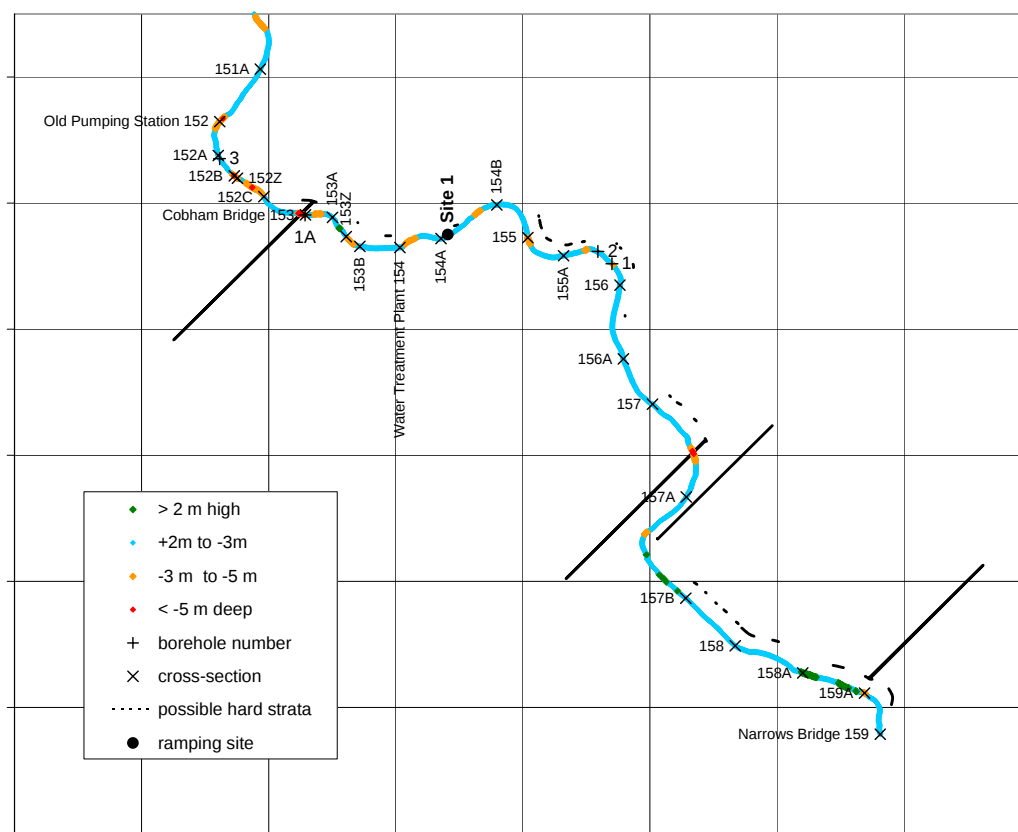
**Figure 3 Bed levels of Southern Hamilton reaches, indicated by deviation of the thalweg elevation from its linear trend line. Possible hard strata, cross-sections and borehole measurement locations are shown. Grid size is 1km.**

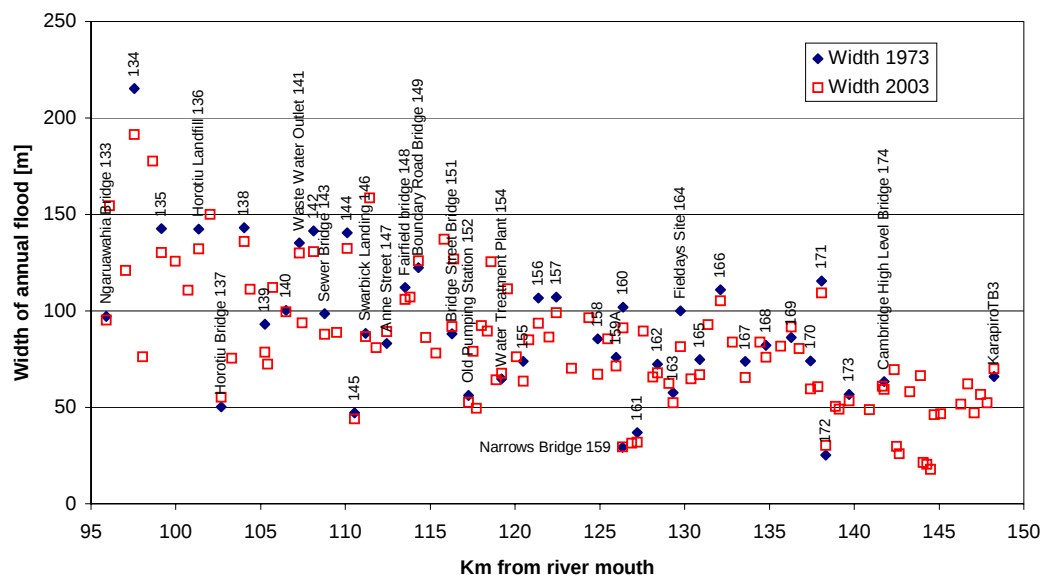
**Figure 4 Profile of flood widths from Ngaruawahia to Karapiro in 1973 and 2003.**

For this type of investigation it is necessary to have a reference level at which surface widths are compared. The width at the level of the average annual flood was selected as this is generally considered to be the “channel forming discharge”. A width investigation was commissioned by EW using the Mike 11 hydraulic model and the four sets of measured river cross-sections. The annual average flood was taken as 490 m<sup>3</sup>/s input from Karapiro and 350 m<sup>3</sup>/s from Whatawhata. The calibrated Manning’s coefficients did not need to be changed for the different time periods indicating that channel roughness can be considered relatively stable over the years. Locations of Hamilton cross-sections where width was calculated are the same as those shown on Fig. 2 and Fig. 3. The widths of the reference flood along the channel are shown in Fig. 4 for the 1973 and 2003 cross-section sets.

The flood widths narrow from over 150m near Ngaruawahia to less than 50m near Karapiro. At most sections, the width of the mean annual flood has narrowed over a 30 year period (blue diamonds lie above the red squares on Fig. 4). Summary statistics on annual flood width in the Hamilton region are given in Table 1. The apparent increase in mean width between 1991 and 1998 is mainly because the average width of an additional 25 cross-sections included in the 1998 and 2003 surveys was greater than the average width of the earlier sections.

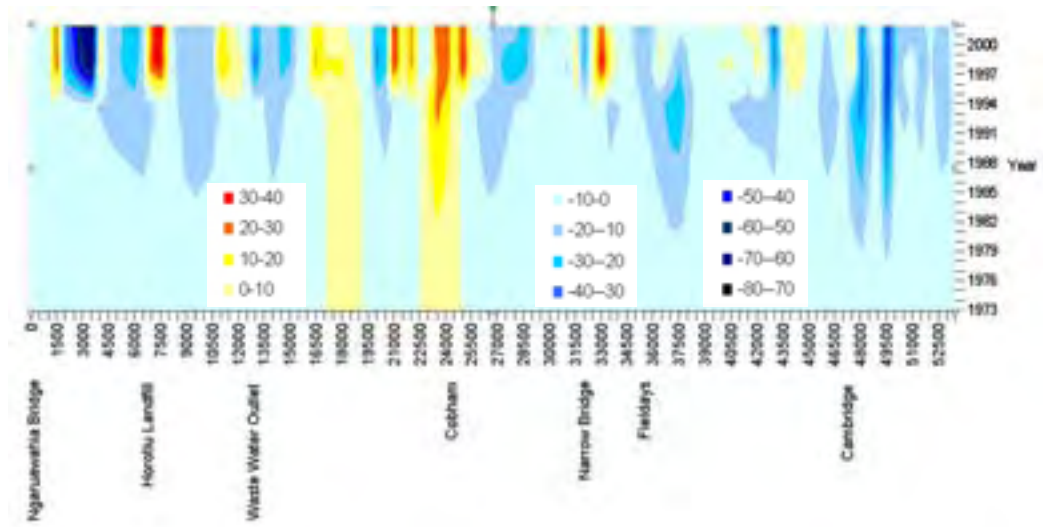
**Figure 5. Changes in width of an average annual flood from Ngaruawahia Bridge to Karapiro between 1973 and 2003 (yellow, orange and red indicate widening up to 40 m, darker blue regions show narrowing of up to 80m). Ref. EWDOCS-#923799.**

The spatial and temporal distributions of changes in river width during the last 30 years, according to the modelling, are shown in Fig. 5.

The greatest increases in width occur just upstream of Horotiu Landfill and close to the city centre (from the Water Treatment Plant to Anne Street).

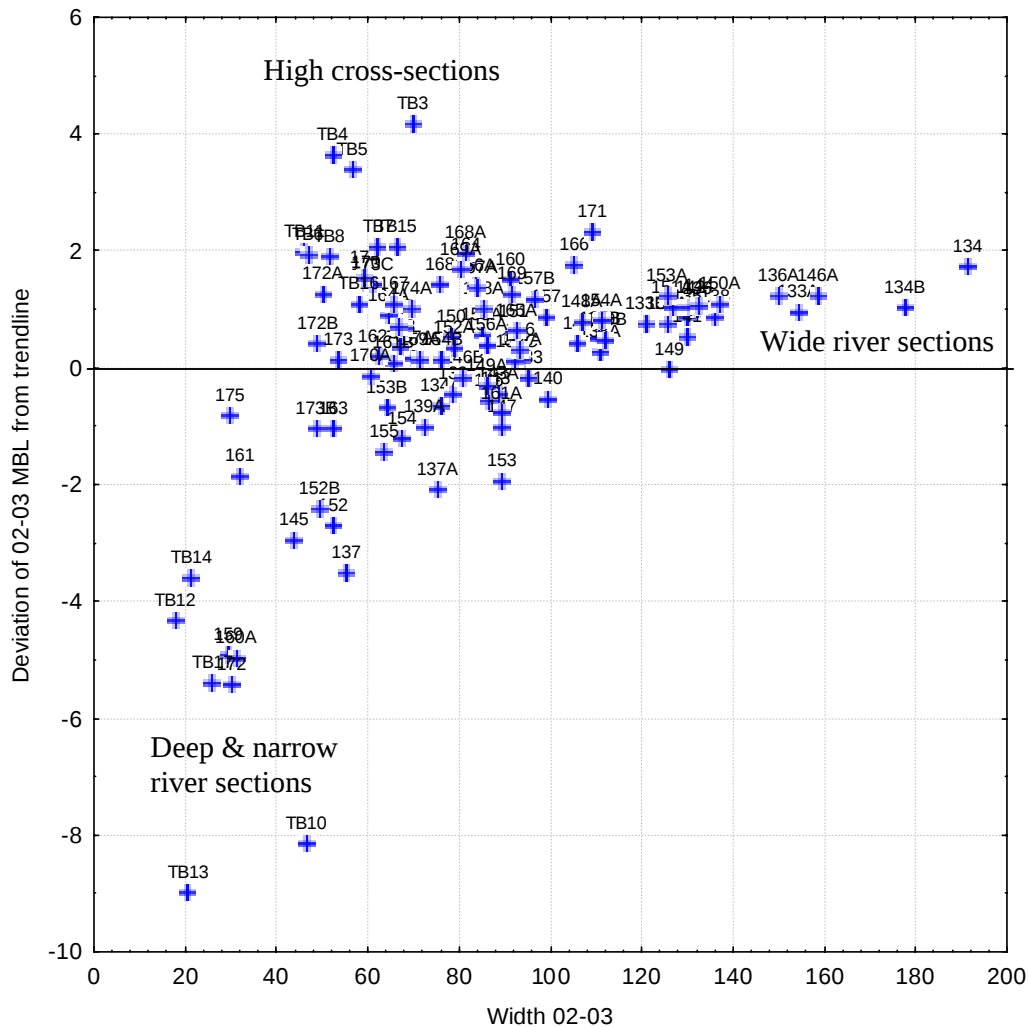
**Figure 6 Deviation of Mean Bed Level from its trendline and flood width for the 2003 survey data, Ngaruawahia to Karapiro.**

Fig 6 shows deviation of the MBL from its trend line and the annual flood reference widths for the 2003 survey. This figure demonstrates that wider cross sections deviate very little from the trend line (reaches of 80 m width or greater are generally within 2m of the trend line). The two widest sections lie downstream of Horotiu.

The deepest reaches (relative to the trend line) are also narrow and lie close to Karapiro Dam (TB section numbers on Fig. 6). The highest reaches (relative to the trend line) have moderate widths and also lie close to Karapiro Dam. It is understood that these very high reaches are situated on bedrock. When these reaches are excluded a clearer pattern is evident as shown in Fig. 7 which shows the same data for reaches between Horotiu Landfill and Narrows Bridge.

For the Hamilton region, narrower reaches are relatively deeper, and wider reaches are relatively higher than the uniform bed plane. No wide reaches have suffered serious degradation. Narrow reaches correspond to locations where degradation has been most severe. The two deepest measured sections lie at Horotiu Bridge and Narrows Bridge. The thalweg survey (section 3 and Fig. 9) shows that there are other very deep points in the river between these sections.

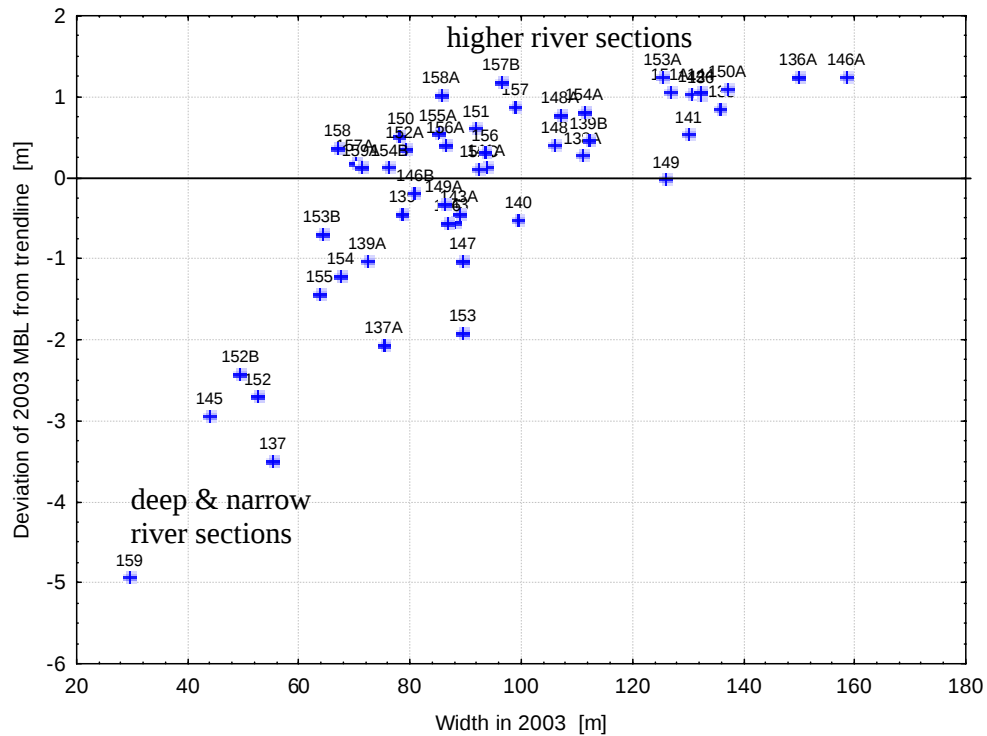
**Figure 7** Deviation of mean bed level from its trend line and flood width for the 2003 survey data, Horotiu Landfill to Narrows Bridge cross sections.

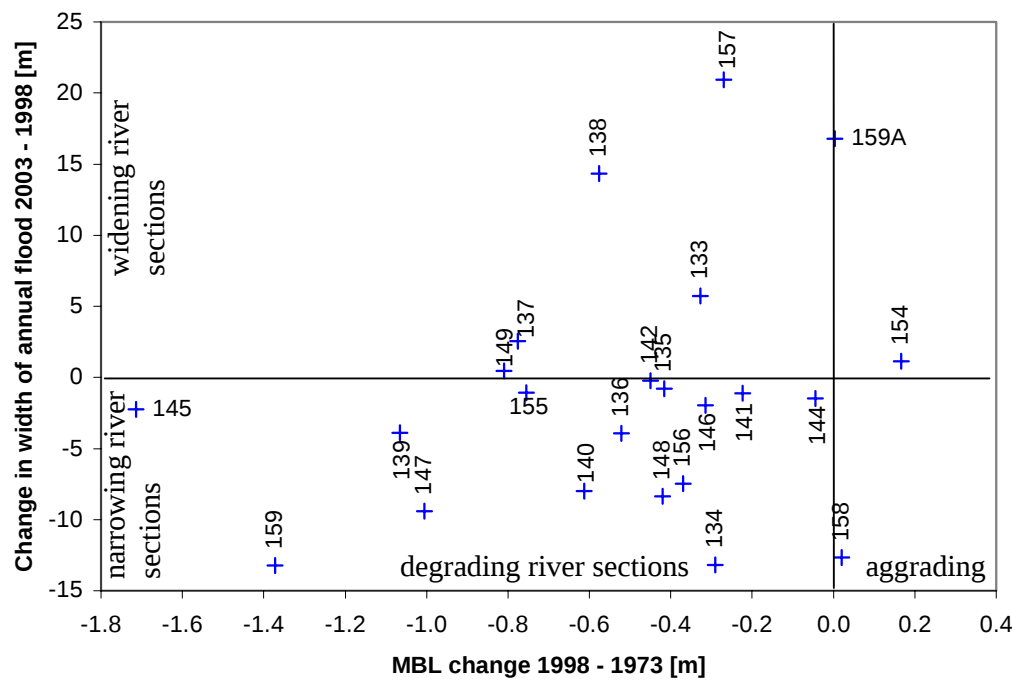
**Figure 8** Changes in mean bed level between 1973 and 1998 and changes in annual flood width between 1998 and 2003 for sections between Ngarauwahia and the Narrows.

To investigate evidence of degradation heralding bank erosion, changes in MBL between 1973 and 1998 were compared with changes in flood width between 1998 and 2003. This is shown in Fig. 8 but no trend is evident which could indicate that sections which degraded prior to 1998 then widened post 1998. It is therefore concluded that the modelling reveals no evidence that a general switch from deepening to widening has occurred.

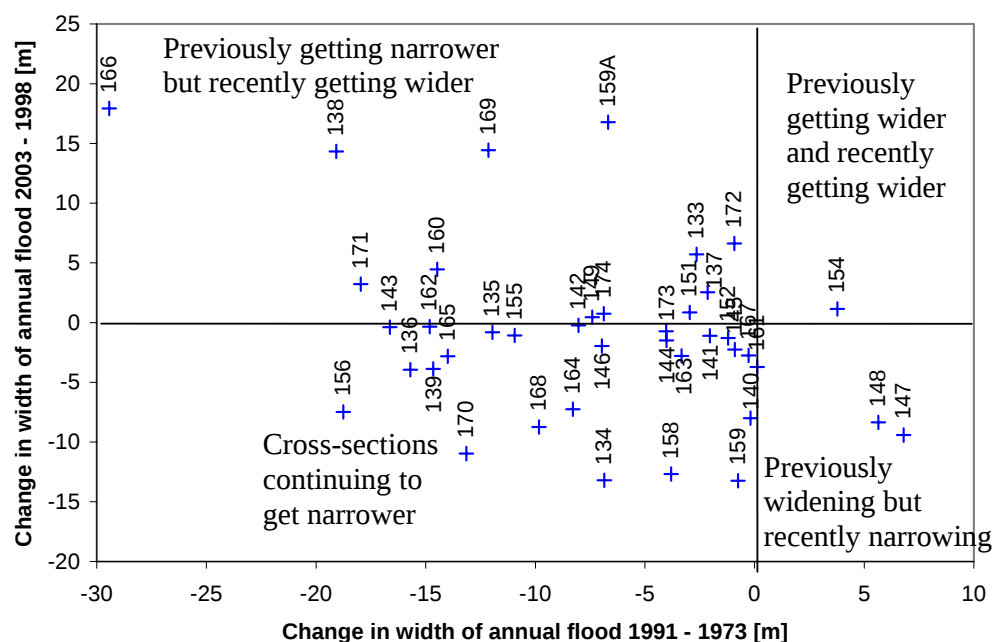
**Figure 9 Comparison of recent width changes with past width changes.**

Fig. 9 shows the changes in width between the 1998 and 2003 surveys compared with the changes in width between the 1973 and 1991 surveys. Negative changes indicate that the channel is narrowing with time.

This figure clearly indicates the dynamic nature of the degradation process with channels that were narrowing now widening and channels that were widening now narrowing. Within a 1m tolerance, there are no channels which were getting wider in the period prior to 1991 that are continuing to get wider post the 1998 survey.

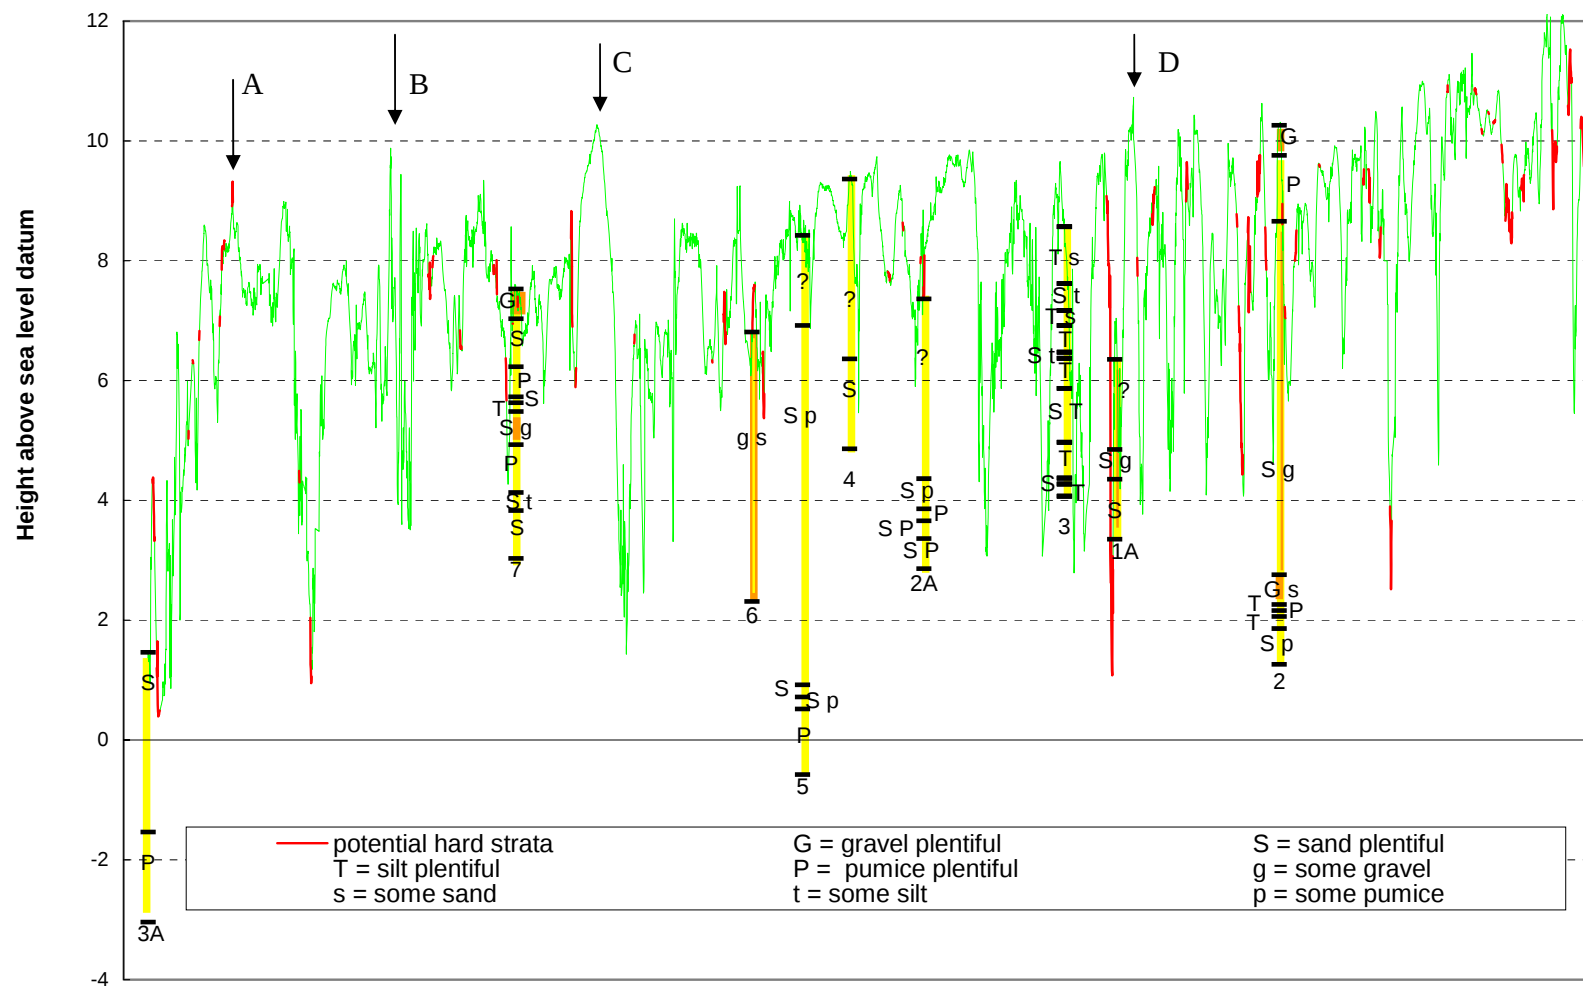
**Figure 10** Thalweg (green) between Horotiu and the Narrows showing initial borehole logs relative to potential hard strata (red). Borehole numbers are below the holes. Yellow strata are easily erodable, orange contain gravel. High sills are indicated by arrows.

Sills which presently appear to be controlling water levels are marked by arrows A – D on Fig. 10. It is suggested that further boreholes be drilled at these sites to investigate whether hard sills exist. Information from these bores will be invaluable if it becomes necessary to construct bed stabilisation sills at some stage in the future. It is also suggested that a further borehole be drilled at the location of ramping measurement site 2 as discussed in section 6. The recommended locations for supplementary boreholes are given in table 2.
