Tauranga Taupo - service level review report

Prepared by:
Tonkin+Taylor

February 2018

Service Level Review report

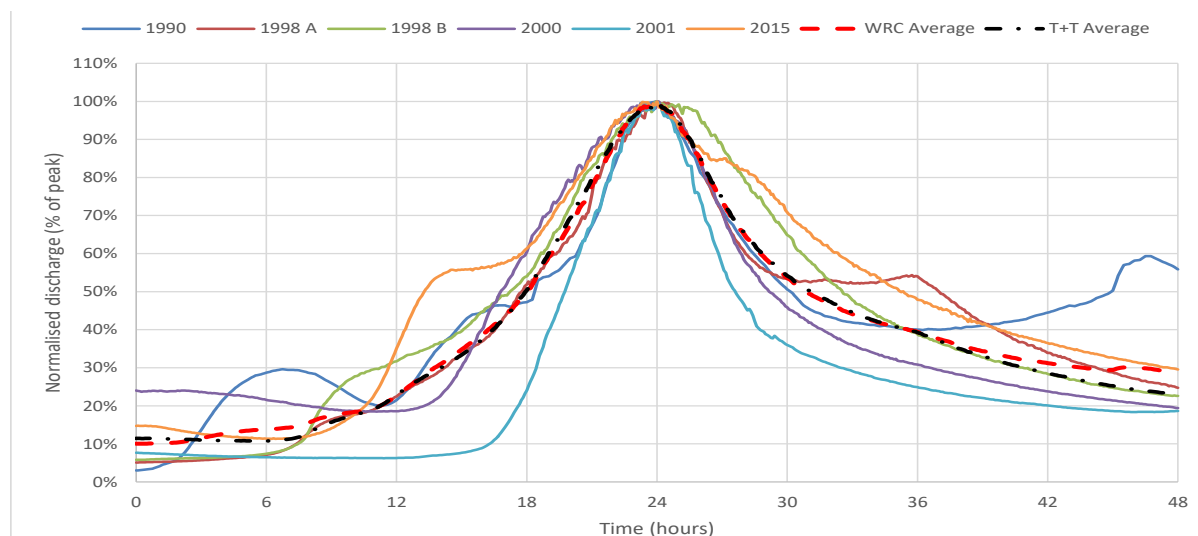
To estimate the design hydrographs, the observed hydrographs were normalised, by dividing flows by the hydrograph peak and then averaging the normalised hydrographs. Following further inspection (Figure 2-2), it is apparent that the 1990 hydrograph is not a typical single event hydrograph and could be excluded from calculation of the design hydrograph. Normalised hydrographs for the six events (analysis taken by Waikato Regional Council (WRC)) as well as the Tonkin & Taylor Ltd (T+T) average (which excludes the 1990 event) are shown in Figure 2-2.

Figure 2-2: Tauranga Taupo River at Te Kono: Normalised hydrographs

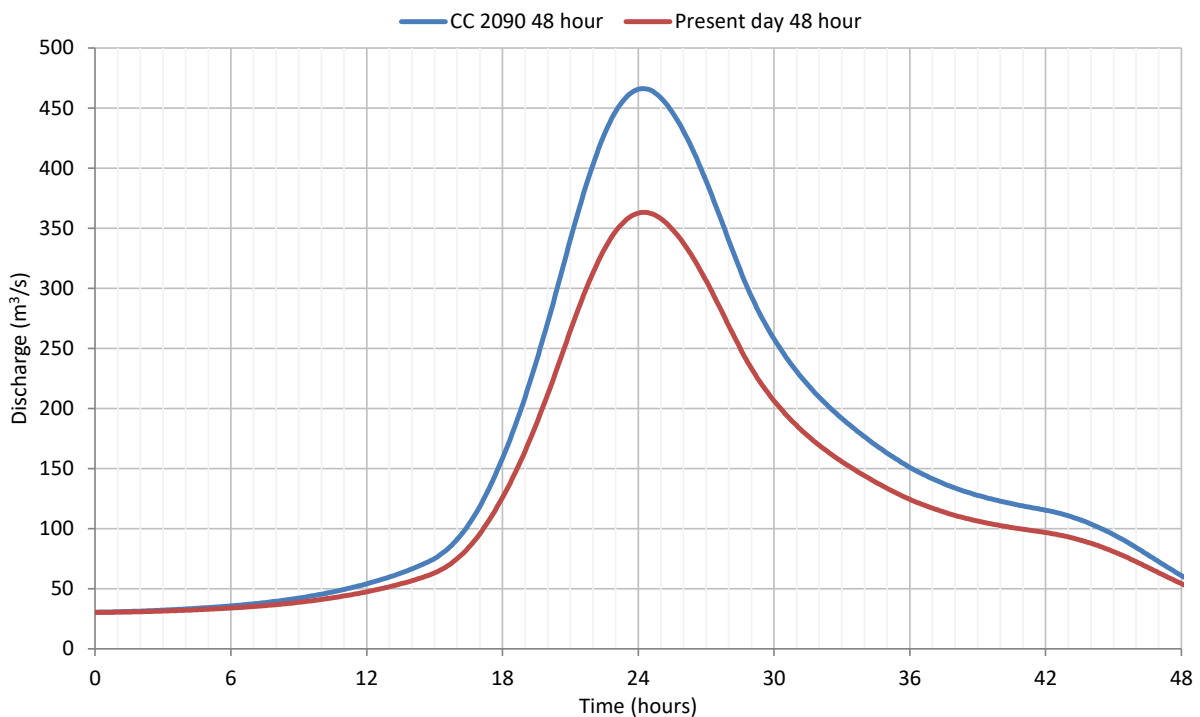
The calibrated model was used to generate the 1% AEP hydrographs for the full catchment for present and projected 2090 storm rainfall. These hydrographs are shown in Figure 2-3.

Figure 2-3: Tauranga Taupo Catchment: 48 hour design hydrographs (peak for entire catchment)

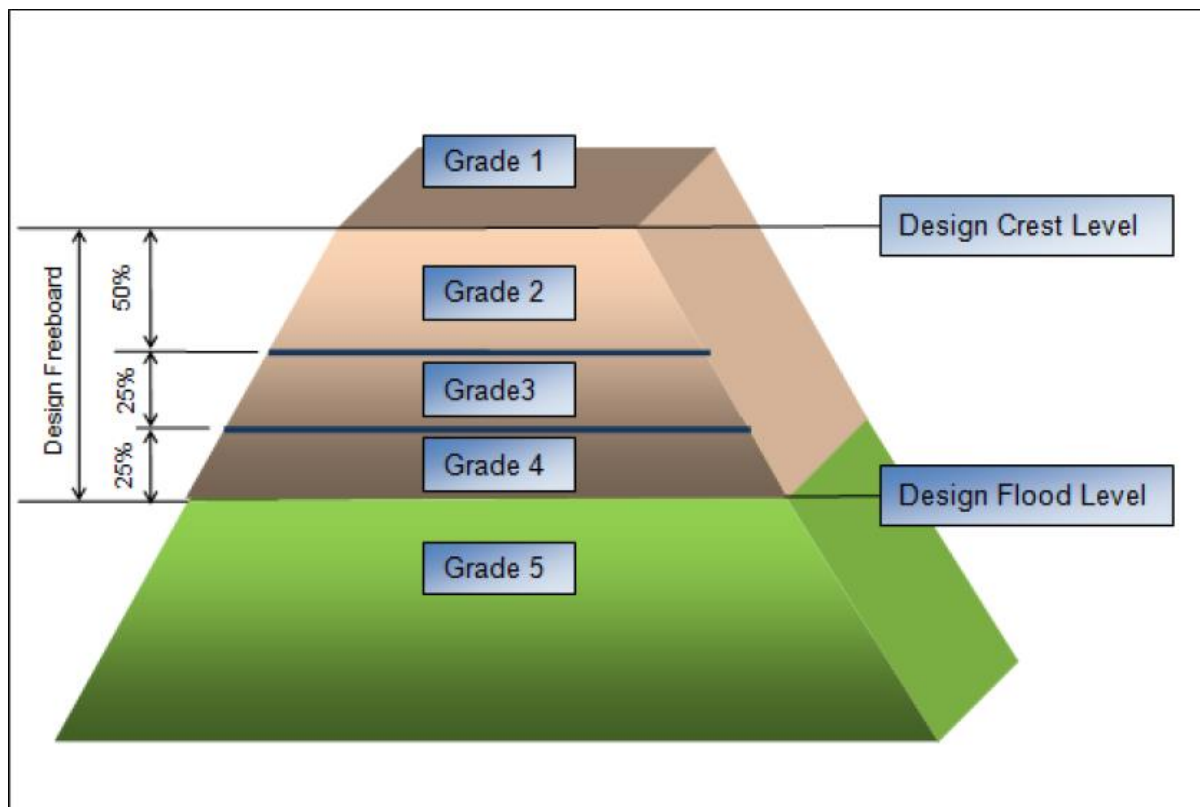
Performance Grade	Stopbanks	Spillways
	$P = (\text{Actual Freeboard} / \text{Design Freeboard}) \times 100\%$	$A^{*1} = \text{Actual Freeboard}$
1	$P \geq 100\%$	$ A \leq 0.025 \text{ m}$
2	$100\% > P \geq 50\%$	$0.025 < A \leq 0.05$
3	$50\% > P \geq 25\%$	$0.050 < A \leq 0.075$
4	$25\% > P \geq 0\%$	$0.075 < A \leq 0.1$
5	$P < 0\%$	$0.1 < A $

*1 Actual freeboard is the difference between the stopbank or spillway level and the design event level. For stopbanks the freeboard should be 0.4 m and for spillways the freeboard should be 0.

Figure 3-1: WRC Diagrammatic representation of stopbank performance grades

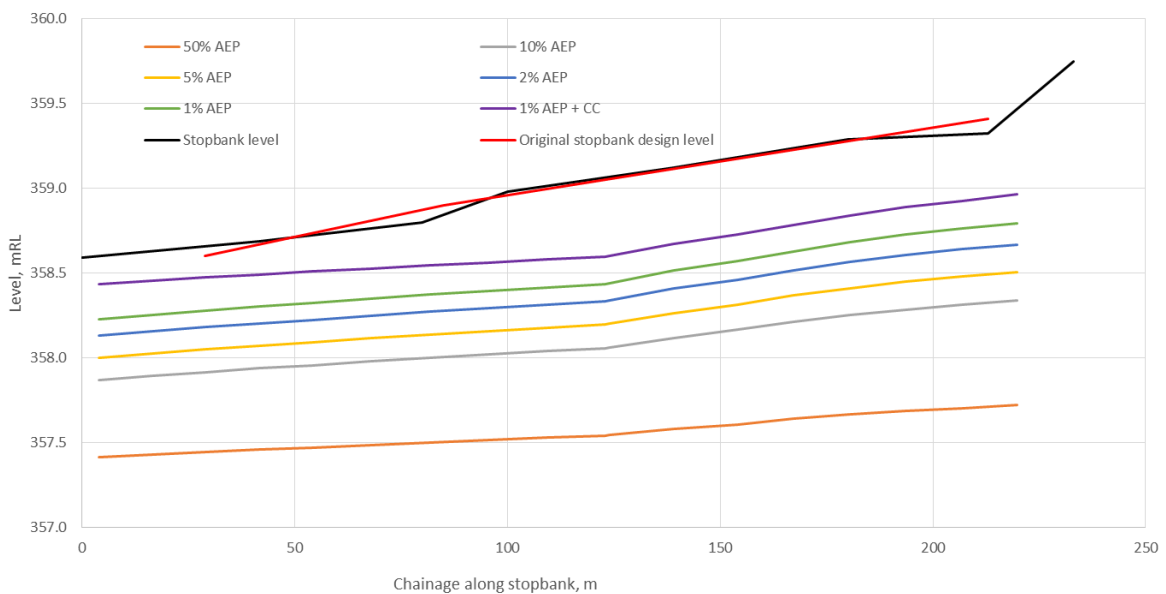
Figure 3-3: Heuheu Parade Stopbank system performance based on a range of events

The stopbank is designed for the 2% AEP event with 400 mm freeboard. The table below shows that the freeboard is maintained throughout the stopbank and the performance grade for the entire stopbank is 1.

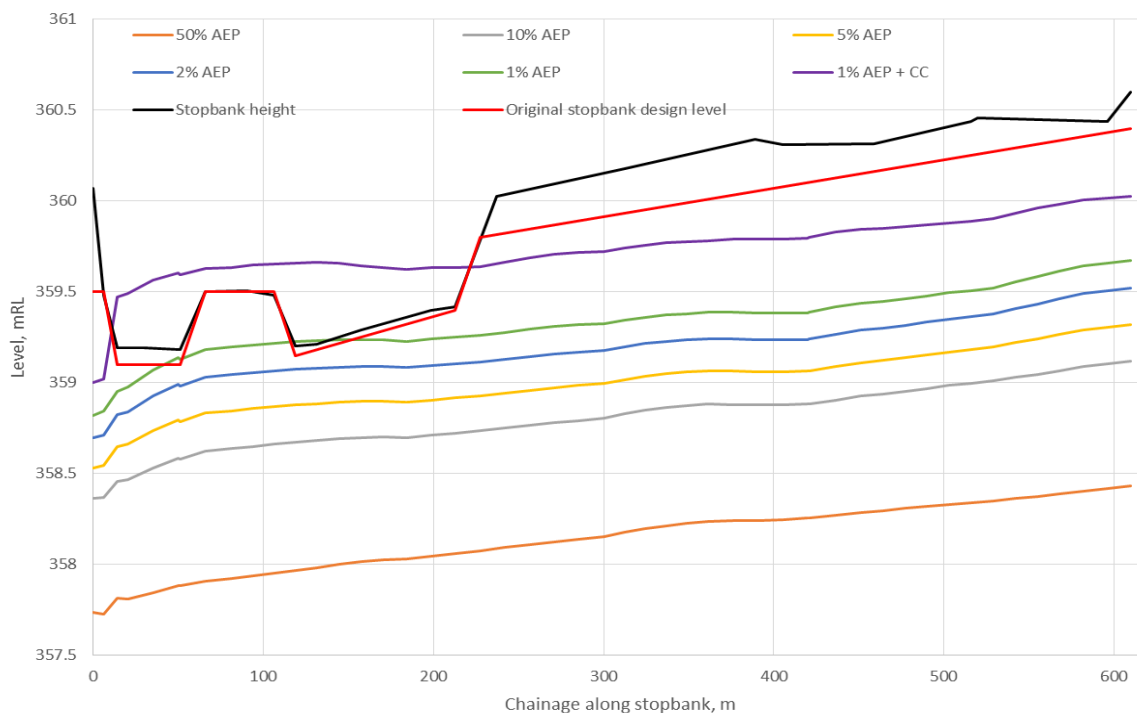
Figure 3-6: Eastern Stopbank system performance based on a range of events

The Eastern Stopbank spillway is set at the bridge soffit level of 359.1 mRL and is designed to provide safe conveyance for the over design event, as well as when there is significant blockage at the bridge. The stopbank is designed for the 2% AEP event with 400 mm freeboard. Table 3.3 below shows performance grade for the stopbank. The majority of the stopbank is performance grade 1, however as the water level in the design event is less than 100 mm below the spillway crest level, the spillway grade is 5 (it is not operating as designed in the design event).

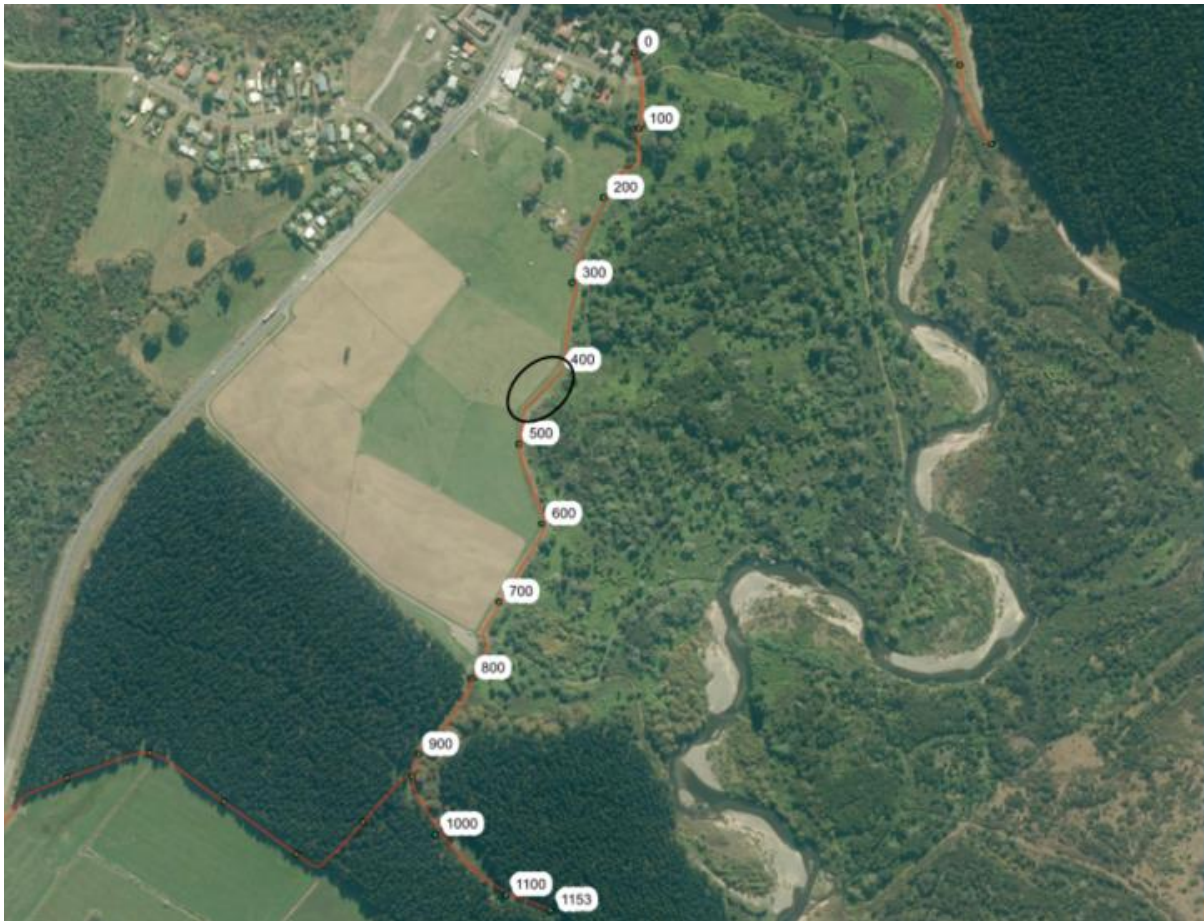
Figure 3-7: Western Stopbank location map

The Western Stopbank is an earth embankment, and the longest stopbank of the scheme at approximately 1150 m. The stopbank provides flood control to the properties to the western side of the river and SH1 as well as to Oruatua. Figure 3-7 shows the location of the stopbank while Figure 3-8 shows a long section along the stopbank with the different AEP flood events.

The model shows overtopping of the stopbank near Chainage 400 (marked by the black circle on Figure 3-7 above). Table 3.4 below shows the flow and volume associated with this overtopping.

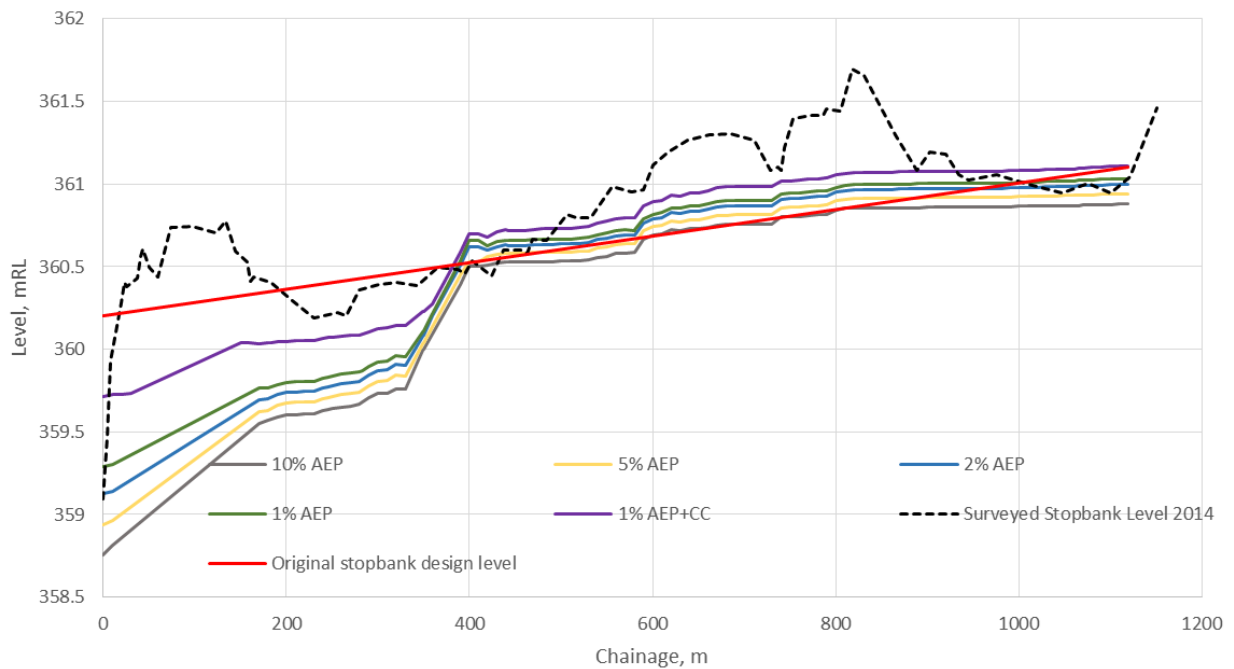
Figure 3-8: Western Stopbank system performance based on a range of events

The model results show a step between chainages 300 and 400. The results presented in Figure 3-8 are based on the 2D model results (taken from the area immediately adjacent to the stopbank). The

terrain was examined in this area and no clear anomalies were observed, however, the LiDAR shows some high ground in the area, refer to Appendix I for terrain near the Western Stopbank based on LiDAR. Additional ground survey is recommended (refer to Section 7 of this report) to confirm the ground levels in this area particularly given the heavy vegetation, this is discussed further below.

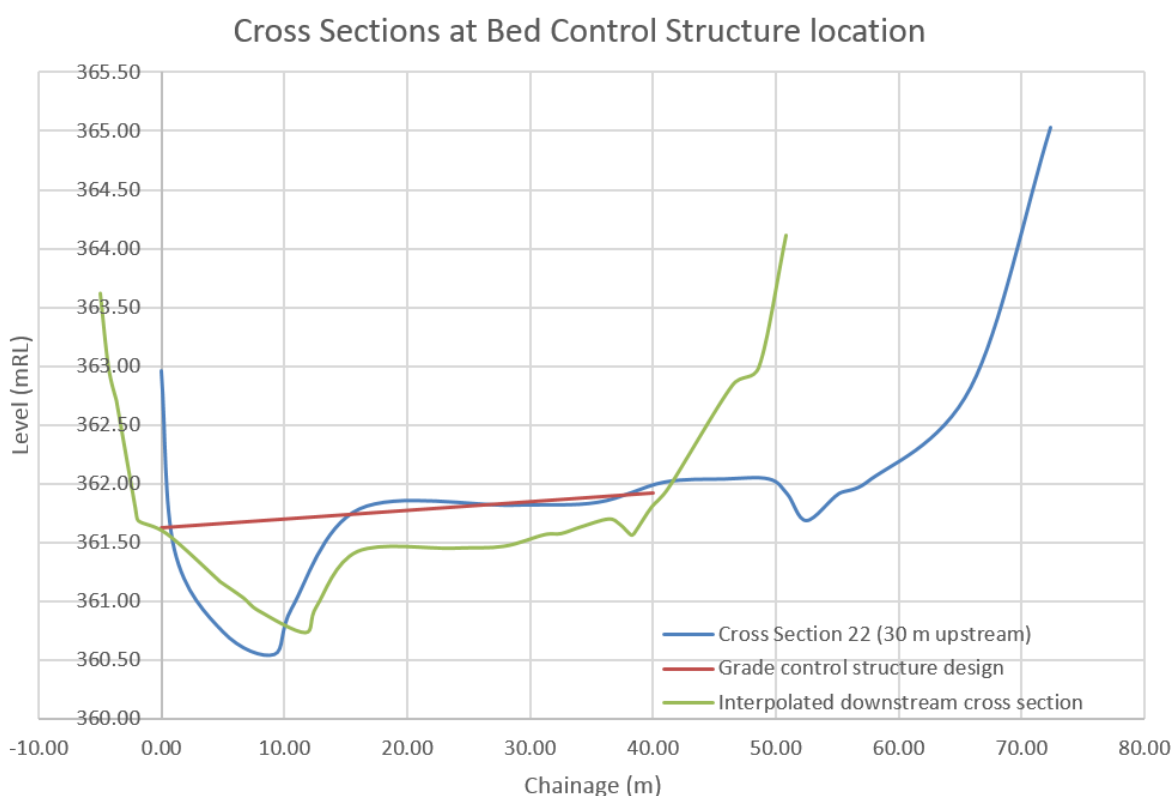
- Cross section 22, located approximately 30 m upstream of the Bed Control Structure has been surveyed. Figure 3-9 shows a comparison between this cross section and the Bed Control Structure design as well as the downstream interpolated cross section
- The survey at cross section 22 shows levels similar to the Bed Control Structure (although wider at 65 m). Also, there is an area with a lower bed level on the left side of the channel (refer to below to show cross sections relevant in the area and Appendix E for cross section survey locations).
- An interpolated cross section 70 m downstream (halfway between cross sections 21 and 22) shows a lower bed level and is approximately 45 m wide.

Figure 3-9: Cross section 22 and Bed Control Structure design comparison

The Bed Control Structure should be surveyed. It may then be compared to its design parameters to confirm whether the left bank revetment and end of the Bed Control Structure has failed. If so, reconstruction back to design levels will be required, and the model should be adjusted to the design levels/width to gain a more accurate representation of how the system will perform in this location when the structure is restored to design levels.

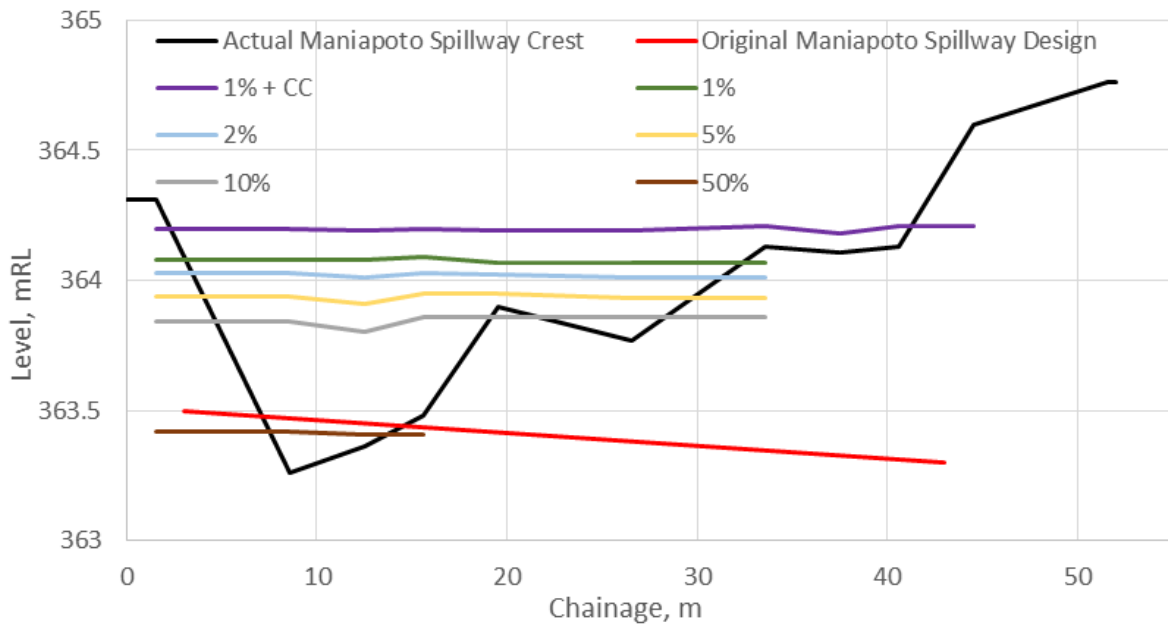
Figure 3-12 below shows the modelled events overtopping the Maniapoto Spillway entrance. However, the volume of water overtopping the entrance is not enough to overtop the downstream Kiko Spillway. This can be seen in the flood extent map for the 50% AEP in Appendix D.

Figure 3-12: Cross section across Maniapoto Spillway entrance performance based on a range of events – looking at the spillway from the river, section drawn with Chainage zero at upstream end

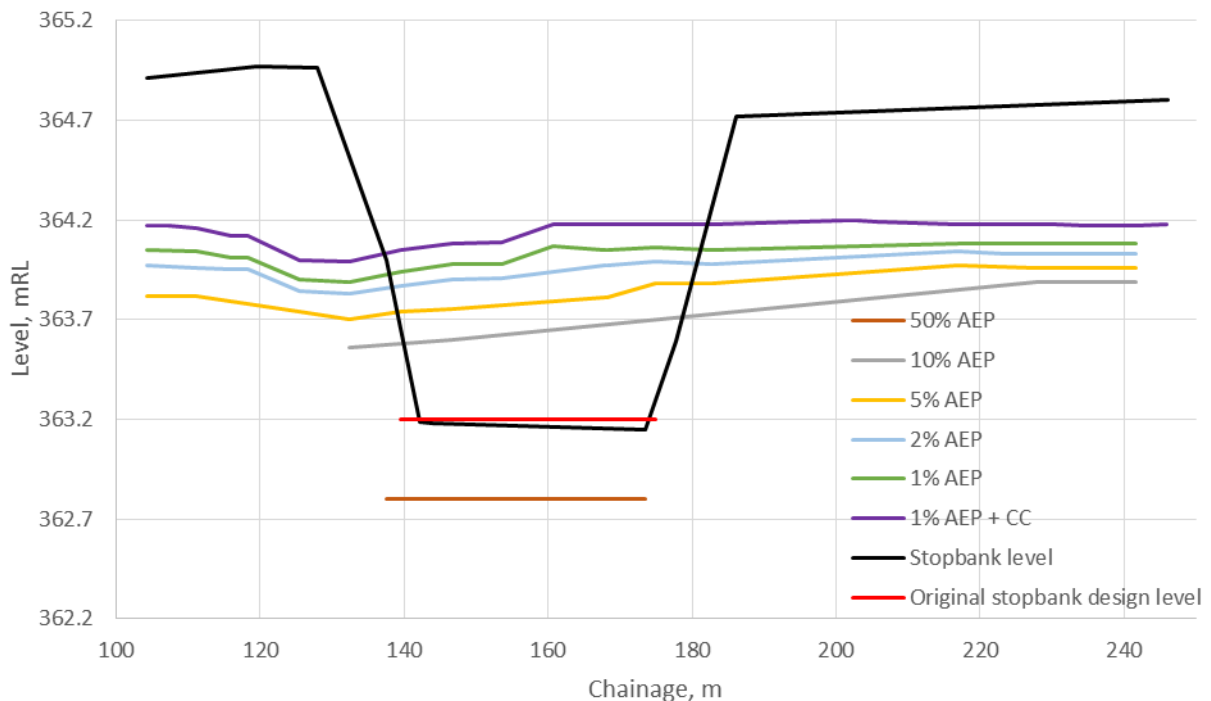
Figure 3-13 shows the model results for the different flood levels at downstream Kiko Spillway weir (over marked blue cross section in Figure 3-10, entrance to the Kiko Swale) during different events. It is noted that the spillway does not operate in the model as frequently as designed, this is discussed below.

Figure 3-13: Downstream Kiko Spillway weir performance based on a range of events – downstream to upstream (true right bank to true left bank)

The results of the model in this area show that the 50% AEP would overtop the downstream Kiko Spillway weir if enough volume could overtop the Maniapoto Spillway entrance. Similarly with other

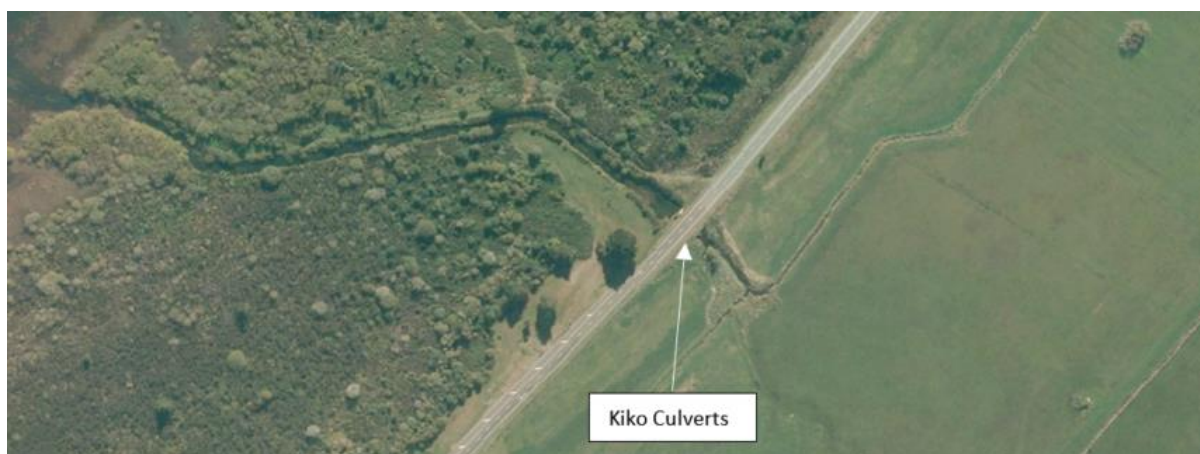
The Kiko Culverts are located under SH1. The performance measure of these culverts is the duration which the SH1 road and the paddock upstream of the culvert remain under water. The design requirement is that water drains from the area upstream of the culvert within approximately 1 day during the 2% AEP. The discharge over the road is summarised in Table 3.7. The duration of ponding over the area upstream of the culverts is estimated by the model at approximately 27 hours during the 2% AEP.

Figure 3-14: Kiko Culverts

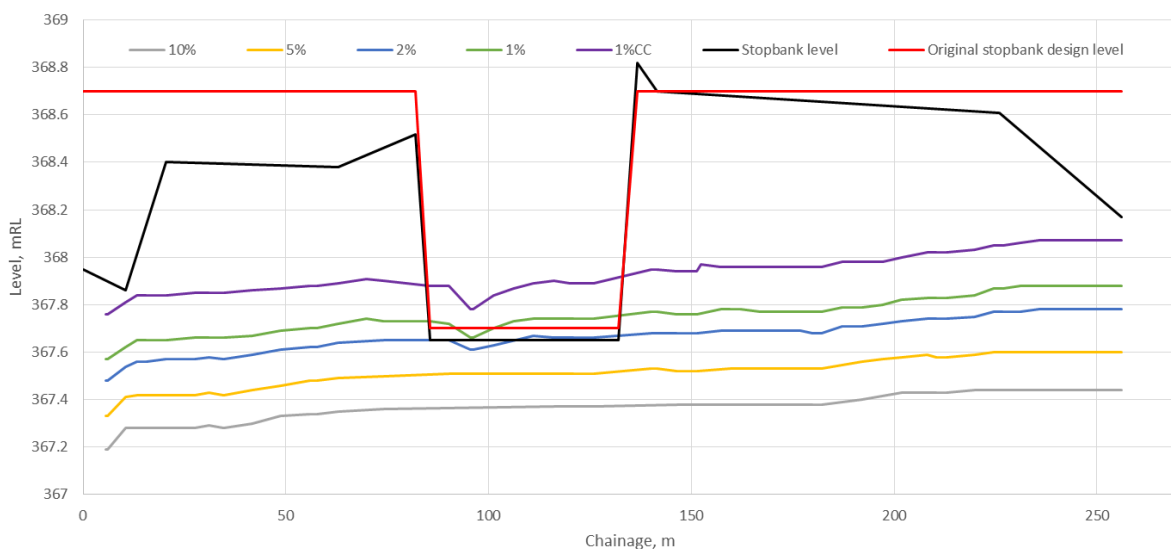
Table 3.8 below shows that the freeboard is reduced in both the upstream and downstream sections of the stopbank and the performance grade of the stopbank ranges from grade 1 to grade 2. In addition, the water is more than 100 mm below spillway crest height during the design overtopping event (10% AEP) so the spillway performance is grade 5 due to it not operating during its design event. The model shows that the spillway only starts to operate in the 2% AEP with only 1 m³/s (this is discussed further in Section 3.3 of this report).

Figure 3-16: Quarry Closure stopbank system performance based on a range of events

It should again be noted that there is high uncertainty in the model in this area. As discussed in Section 2.4, this is due to the dense vegetation on the floodplain, potentially causing ground levels to be recorded by LiDAR at a level higher (or lower if data is interpolated between two low points with no data available in densely vegetated areas) than they are in reality, thereby affecting the

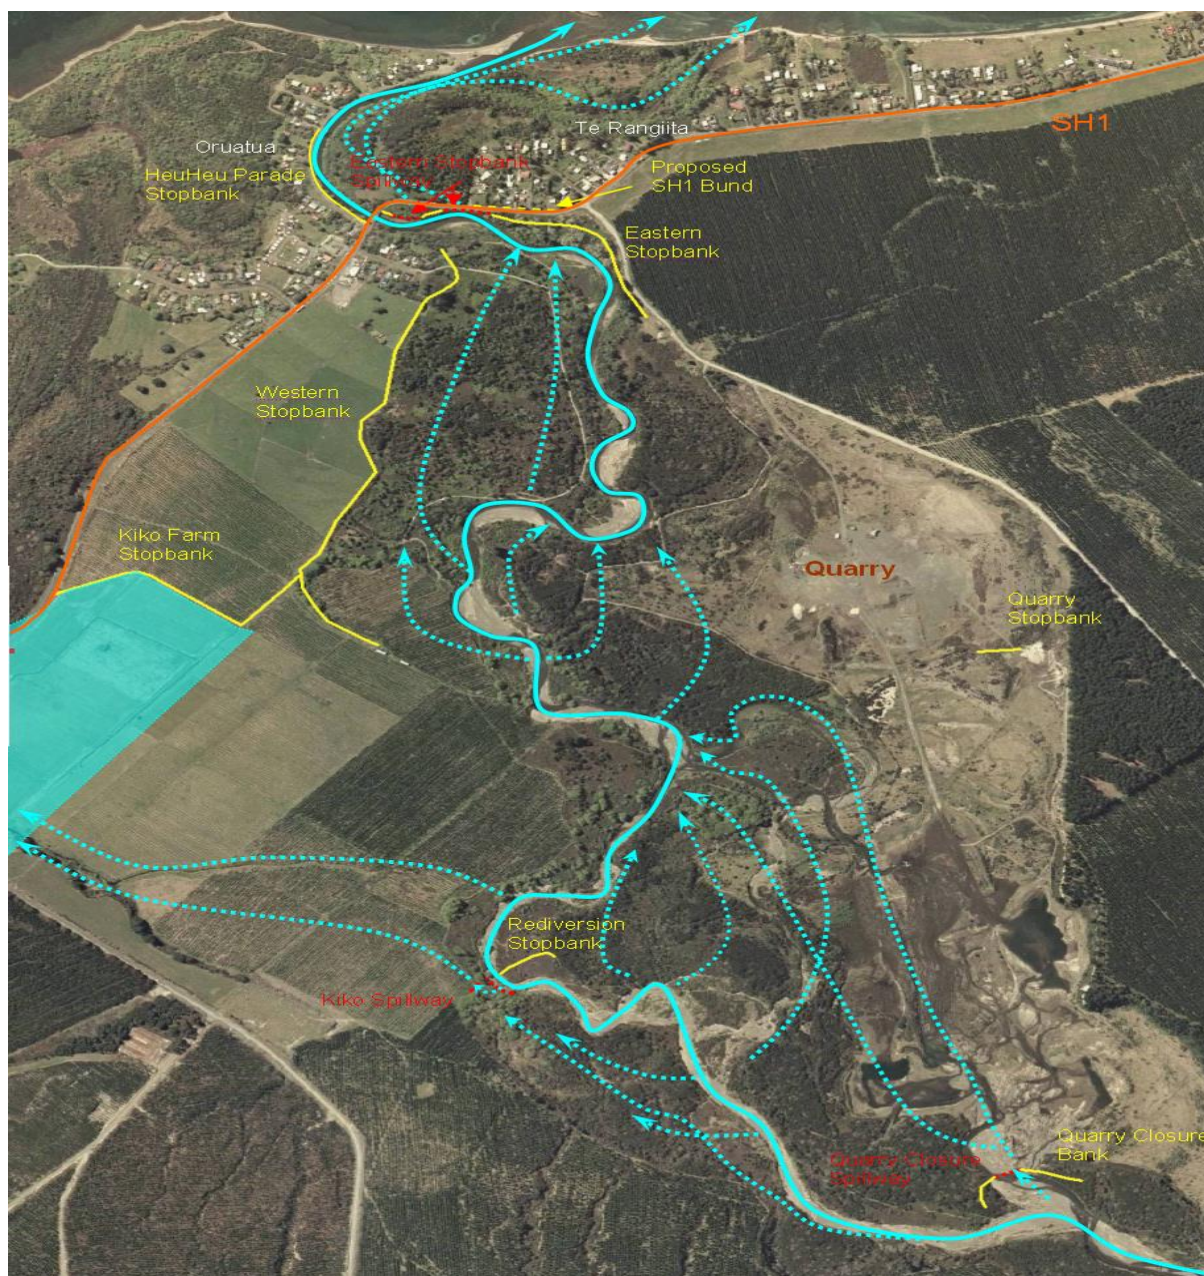
Figure 3-17: Scheme design plan

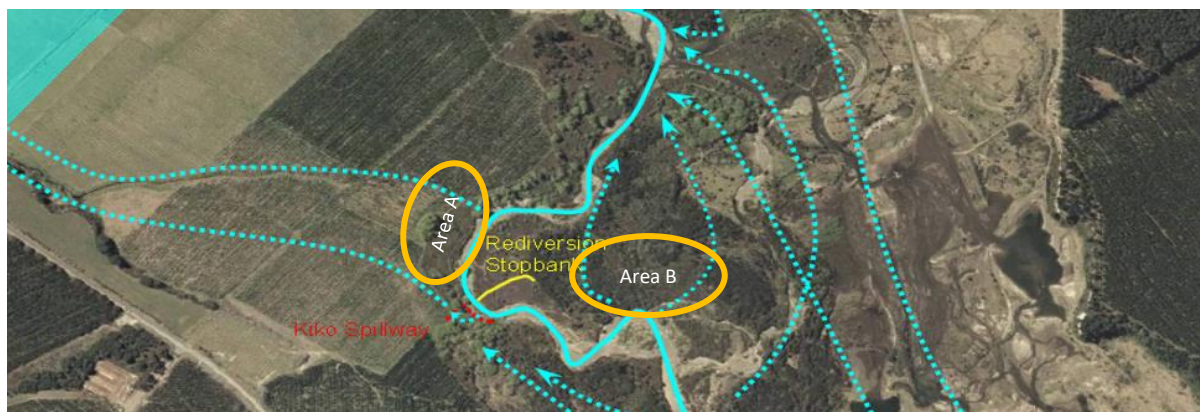
Velocity in the vicinity of Maniapoto's Bend is important as it is an indicator for areas that are likely to experience high erosion and therefore most likely to be where the river breaks out. Figure 3-18 shows the areas on the right bank and left bank where velocities were taken from the model (for maps showing velocity values refer to Appendix B). These are summarised in Table 3.10.

Figure 3-18: Maniapoto's Bend overflow area of interest for velocity
