Estuarine Vegetation Survey - Kawhia Harbour

Prepared by:
Meg Graeme M.Sc,
Natural Solutions – Marine and Terrestrial Ecologists Ltd

For:
Environment Waikato
PO Box 4010
HAMILTON EAST

29 June 2005

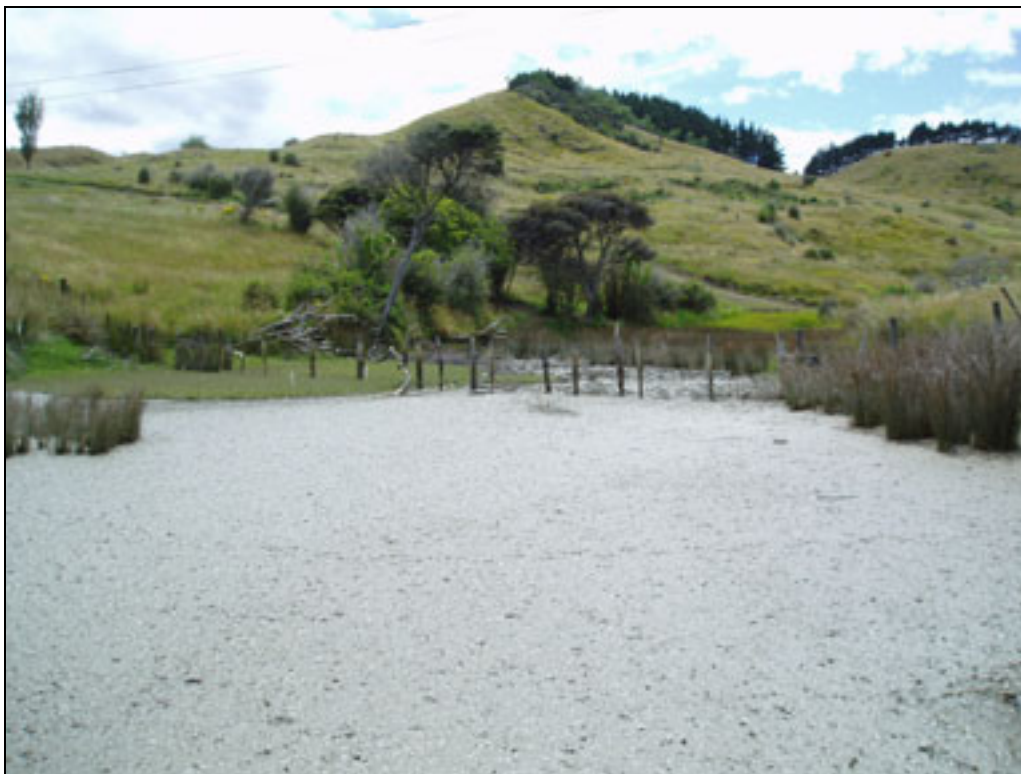
Figure 3: Stock are not fenced from many parts of the harbour. This example is the upper east arm of Te Wharu Bay. The green circular patch of grass growing out into the estuary on the left of the picture is spartina. It is a vivid green where it extends out up into the pasture. 31/1/05

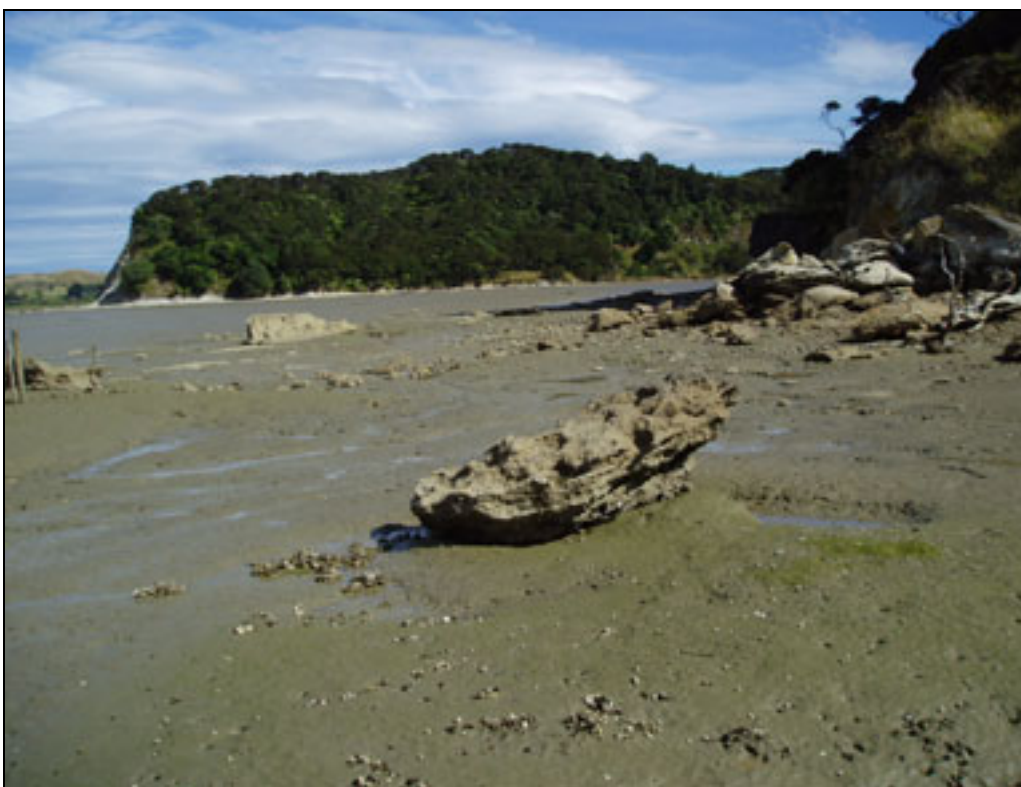
Figure 4: Motutarakatua Point looking back towards Te Wharu Bay. Mexican daisy has established on the cliff faces. 31/1/05

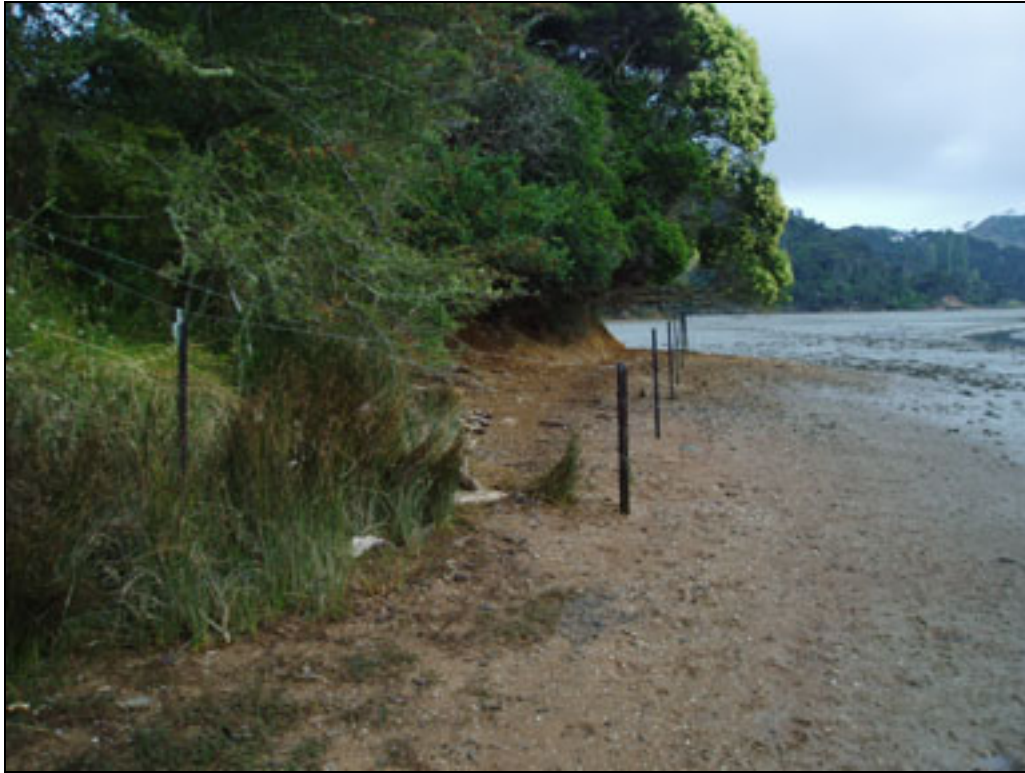
Figure 5: A fence line that allows stock into the harbour, Mangaora Inlet. Note the lack of rush and sea primrose inside the fence, and the riparian vegetation dominated by privet and barberry along this shoreline. 23/2/05

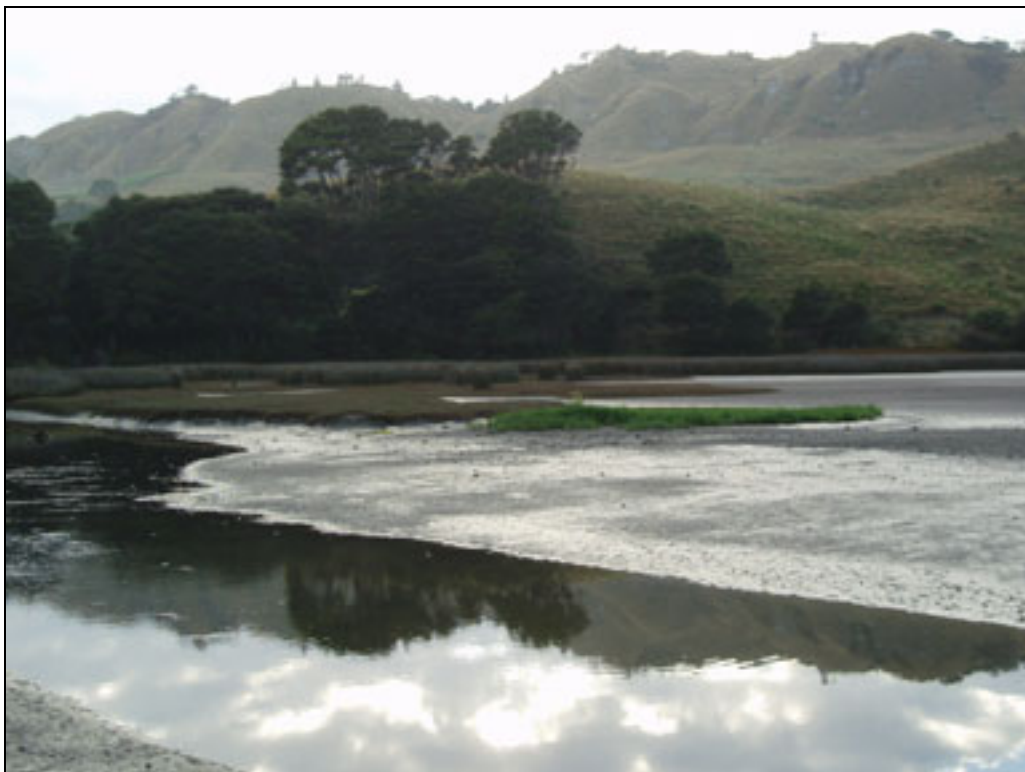
Figure 6: The vivid green patch is one of the two spartina populations at the head of the Mangaora Stream. Between the spartina and sea rush are beds of sea primrose. 23/2/05

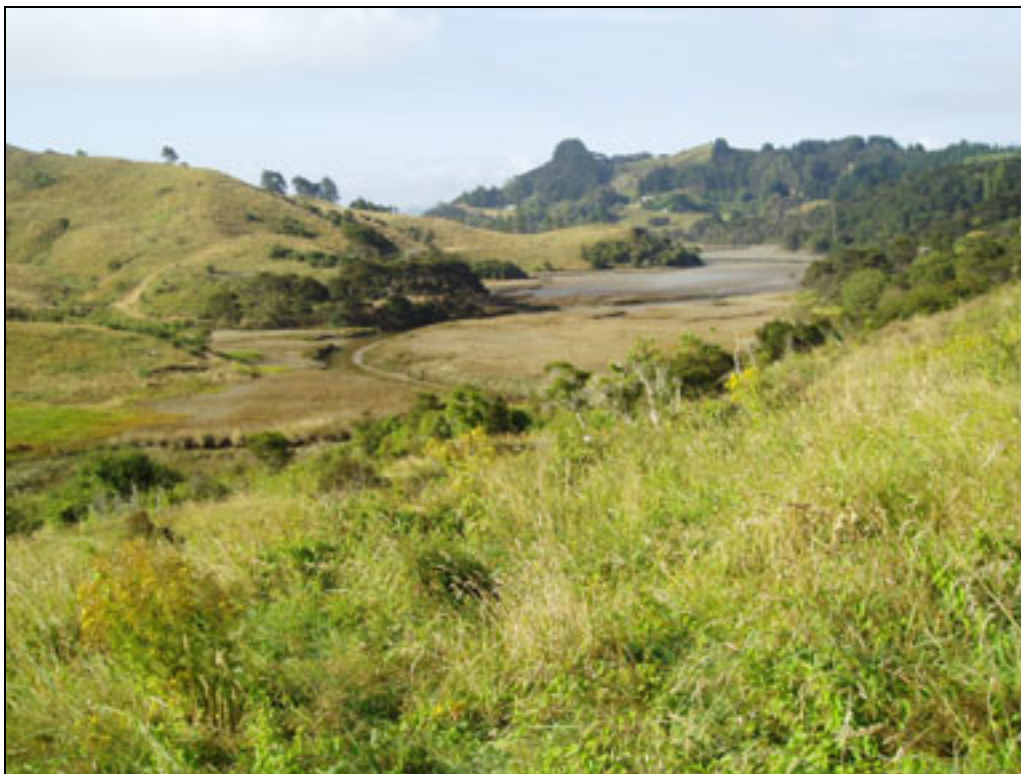
Figure 7: An overview of the head of Mangaora Estuary showing sea rush grading into marsh clubrush upstream (to the left of the photo). There is scattered saltmarsh ribbonwood along the harbour edge behind the rush. 23/2/05

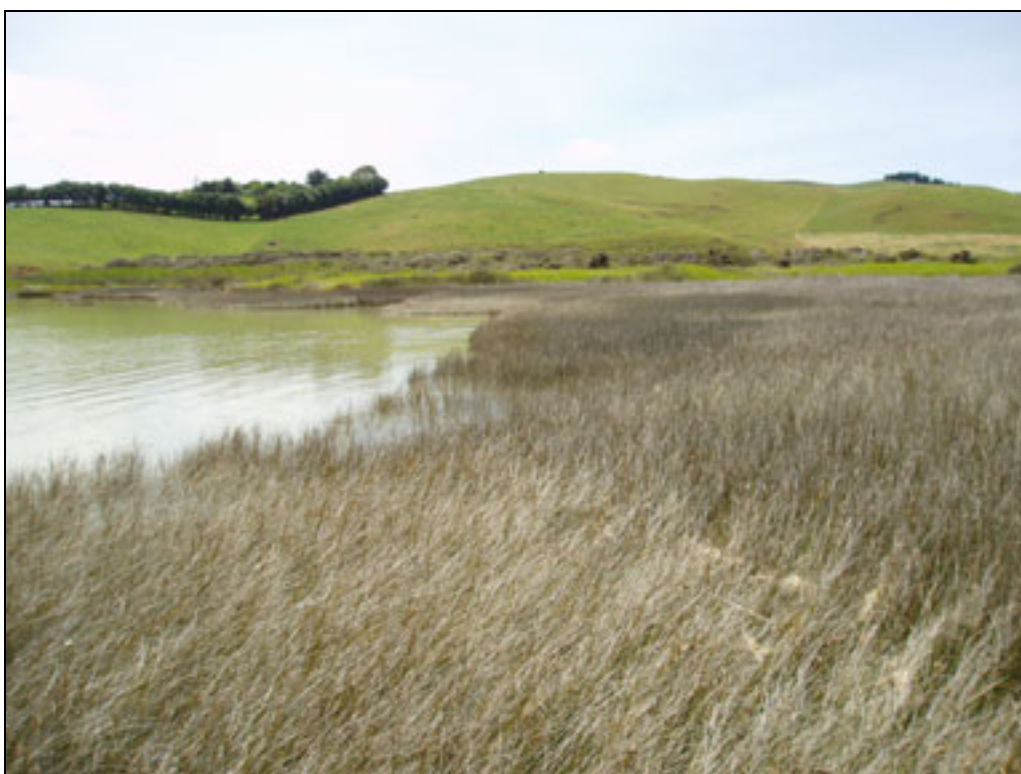
There is a significant wetland at the NE end of the **Tiritirimatangi Peninsula**. Oioi and sea rush is backed by marsh clubrush, saltmarsh ribbonwood, mingimingi, flax, tall fescue, raupo and manuka (Figure 8). This links around the causeway to an even larger wetland complex with an important bird roost. Approximately 60 New Zealand dotterel, 200 South Island Pied Oystercatchers, 150 stilts and 50 godwits were counted here. The rush zone is backed by a substantial saltmarsh ribbonwood and coastal shrub daisy band which grades into a manuka and mingimingi swamp. This wetland system links with a small lake. Unfortunately willow are spreading and dominating in areas. This peninsula would make a great restoration project. Stock have not been fenced from the harbour on the peninsula or causeway.

Figure 8: Looking from the significant Tiritirimatangi Peninsula wetland around to the wetland at the base of the causeway. This wetland complex is composed of oioi and sea rush backed by saltmarsh ribbonwood, coastal shrub daisy, marsh clubrush, mingimingi, flax, tall fescue, raupo and manuka. 29/1/05

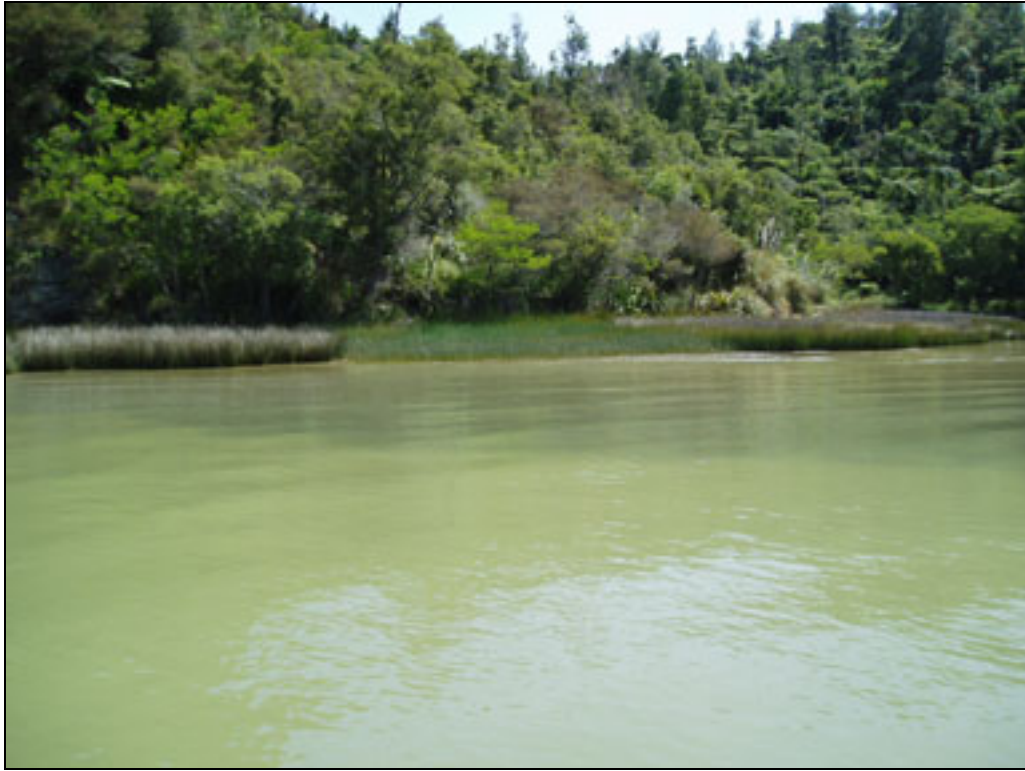
Figure 9: Saltmarsh along the edge of the Te Kauri Stream inlet south-east of Tiritirimatangi Peninsula includes sea rush, oioi and three-square. Remnant coastal forest provides a natural backdrop to the harbour and buffers landuse effects on the harbour. 29/1/05

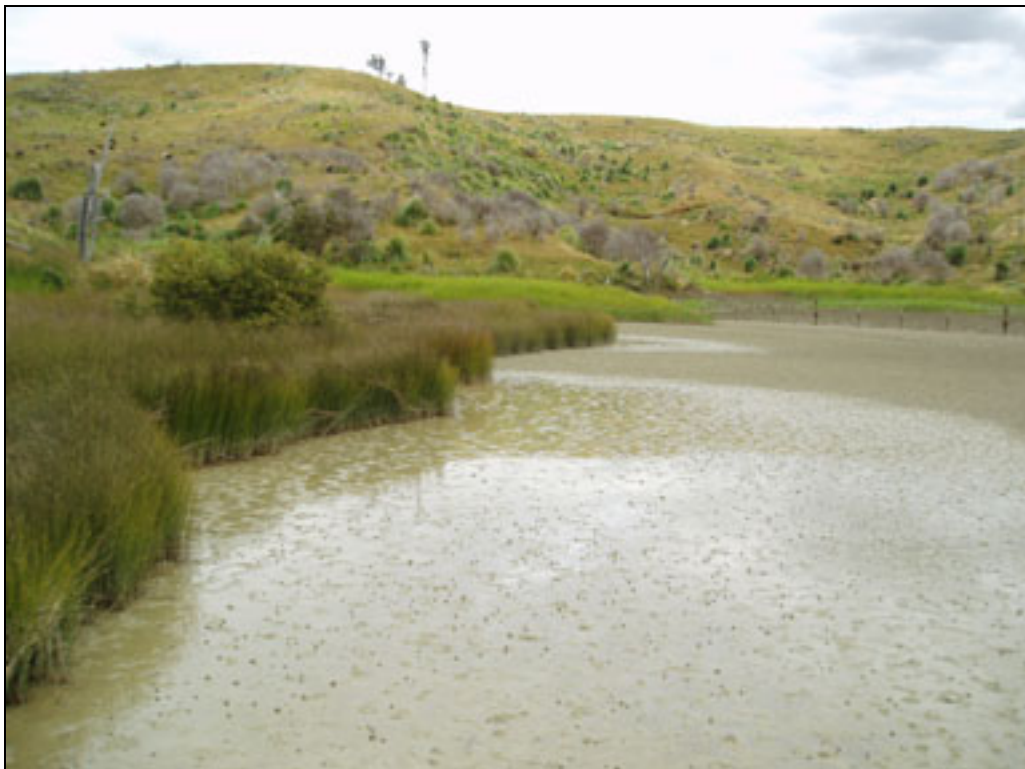
The small bay to the east of the Awaroa entrance has pampas taking over the pasture. The harbour edge is not fenced and there is severe pugging of the rushes and mudflats, and cow dung on the flats (Figure 10 and 11). There is a large mangrove which was in flower but no seedlings were found. Cows are also not fenced from the TRB of the neighbouring **Waikorere Creek** (Figure 12). This bay has two freshwater wetland areas backing the saltmarsh on the eastern side and the head of the arm. A fernbird was heard in each swamp. The wetland at the bay's head is the largest and contains marsh clubrush, raupo and manuka behind oioi and sea rush. The TLB of the bay is fenced hard along the harbour's edge so while there is no room for riparian vegetation to filter land run-off, at least the saltmarsh is undisturbed (Figure 13). **Mahoe Point** at the head of the Waikorere Creek bay has a large saltmarsh fringe backed by a manuka/ coastal shrub daisy /mingimingi freshwater swamp (Figure 14). These swamps provide a significant area of estuarine/freshwater wetland that supports fernbird, and potentially bittern and crake. With the proximity of the Tiritirimatangi Peninsula wetland, and the wetlands in the upper reaches of the peninsula's eastern arm and the Awaroa arm, the area has high wildlife and vegetation value.

Figure 10: In the small bay between the Awaroa Inlet and the Waikorire Creek, a flowering mangrove in amongst a band of oioi has escaped grazing. The swamp clubrush in the middle-ground however is grazed and pugged and the harbour flats pugged. Cow pats were also found on the flats. Note the pampas taking over the pasture and the sprayed kanuka in the background. 31/1/05

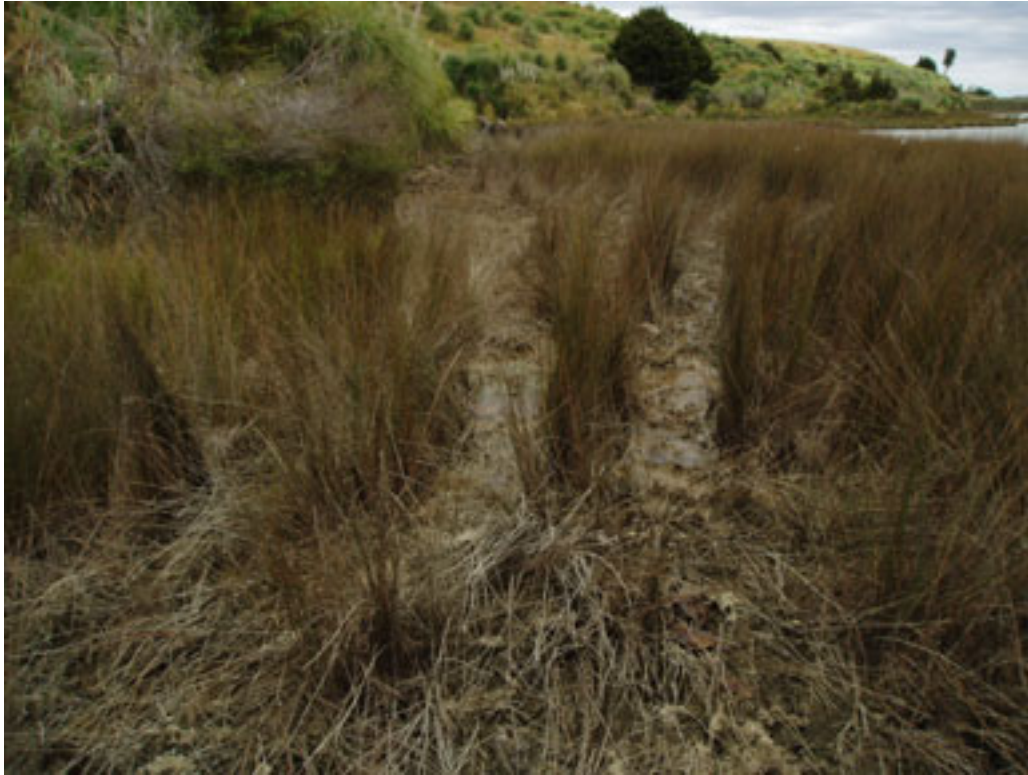
Figure 11 Stock tracks through an oioi fringe along the side of the small bay between the Awaroa Inlet and the Waikorire Creek. 31/1/05

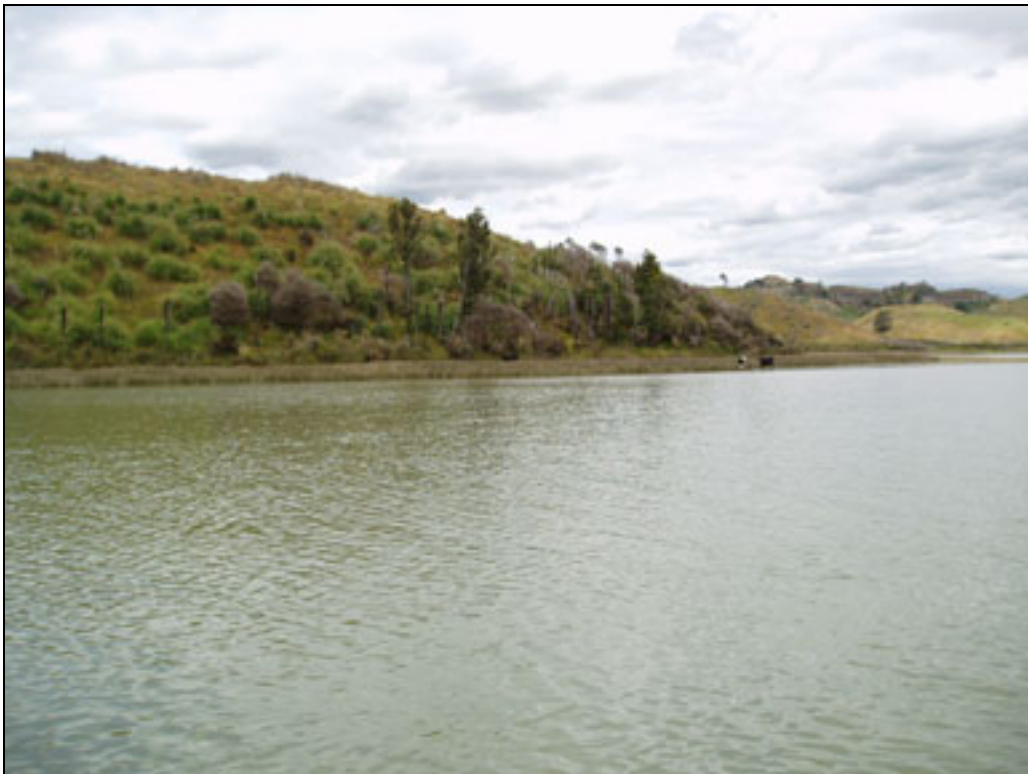
Figure 12: This is a example of poor land management. The True Right Bank (TRB) of the Waikorire Creek arm is not fenced and cattle wander through the saltmarsh and over the flats. Note the important riparian vegetation (kanuka and punga) has been sprayed but the invasive pampas (which is taking over the pasture) has been left unsprayed. 31/1/05

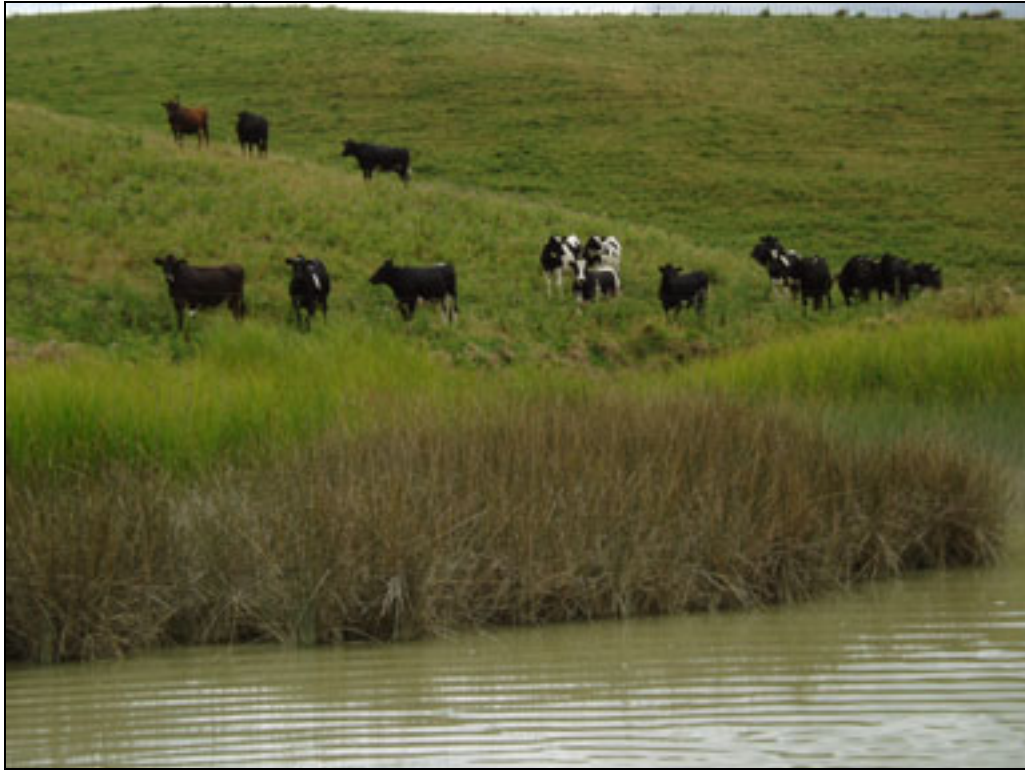
Figure 13 The TLB of the Waikorire Creek arm is fenced hard along the harbour edge. This means that the cattle do not have access to the saltmarsh and harbour flats but there is no room for riparian vegetation to filter land run-off including sediment, nutrients and pathogens. 31/1/05

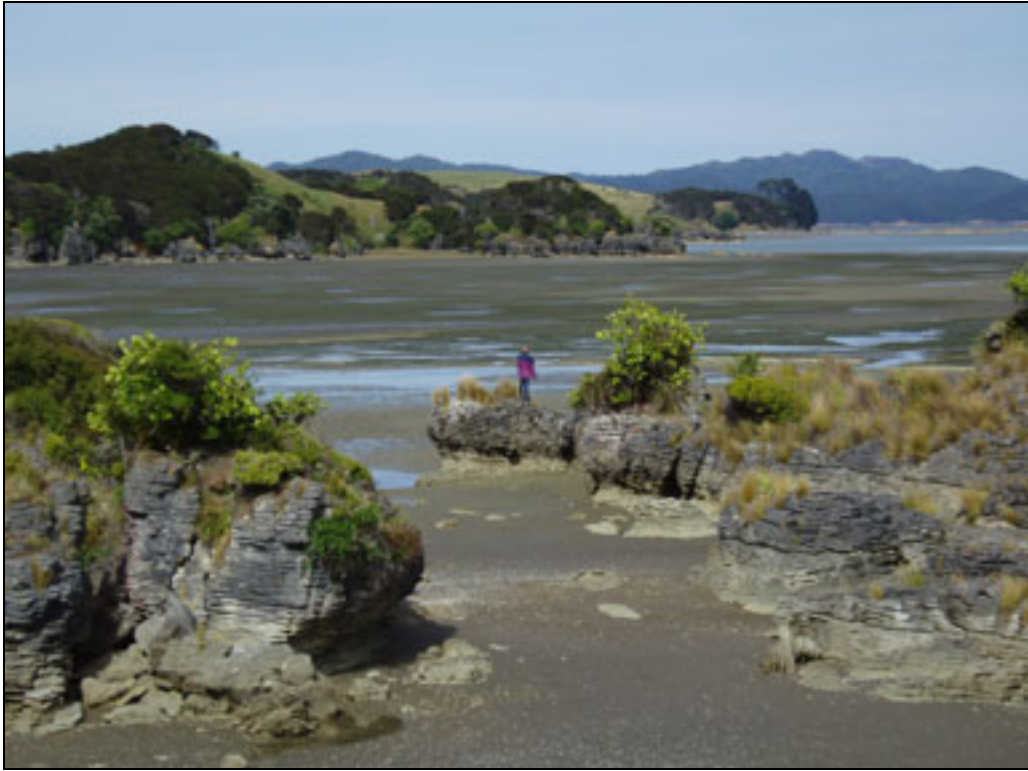
Large seagrass beds extend up to the islands at the mouth of the Rakaunui Inlet (Figure 15). Silver tussock and the native ice plant (*Disphyma australe*) were found on the island rock stacks. The tops of the ice plant were grazed, presumably by birds.

Figure 15: Seagrass beds extend up the harbour to the mouth of the Rakaunui Inlet. Silver tussock and the native ice plant are found on the limestone islands. 30/1/05

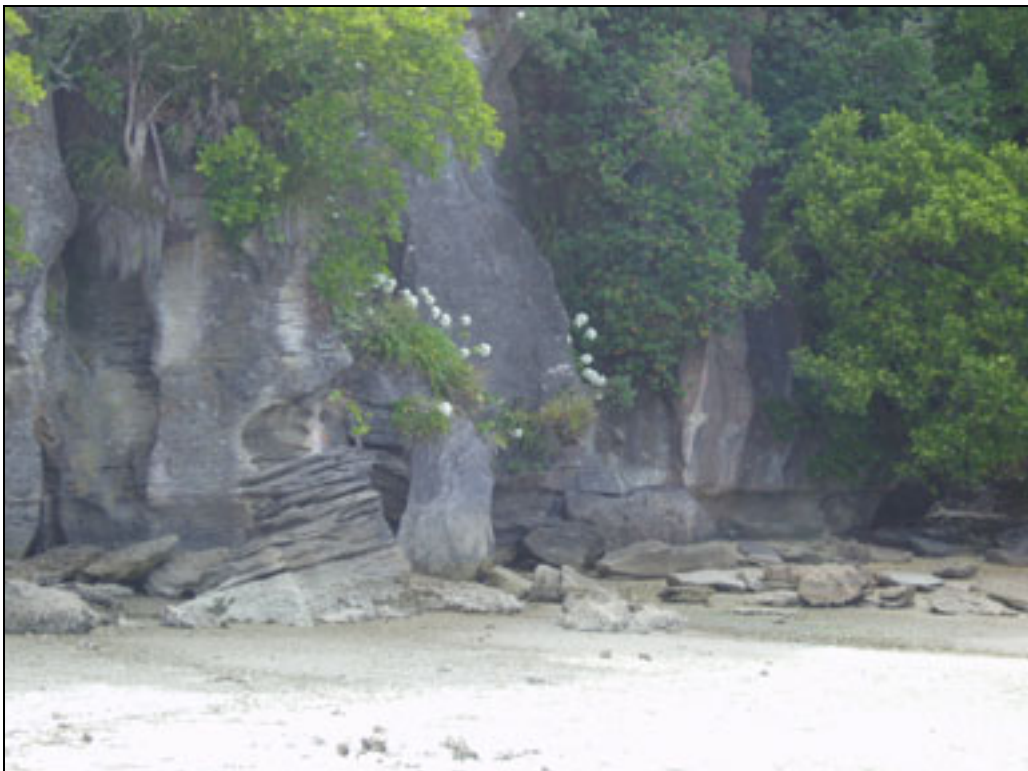
Figure 16: White agapanthus on the limestone cliffs at the mouth of the Rakaunui Inlet. 30/1/05

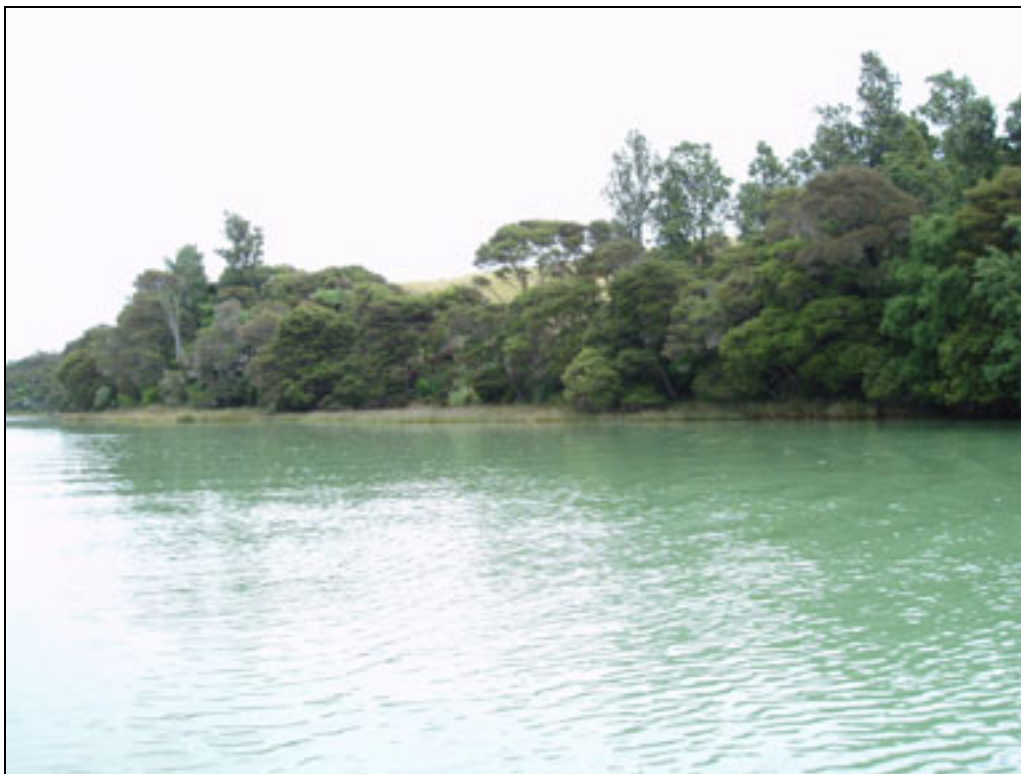
Figure 19: Kaitawa Inlet is not fenced along the TLB but is along the TRB behind the coastal forest edge (shown here). 31/1/05

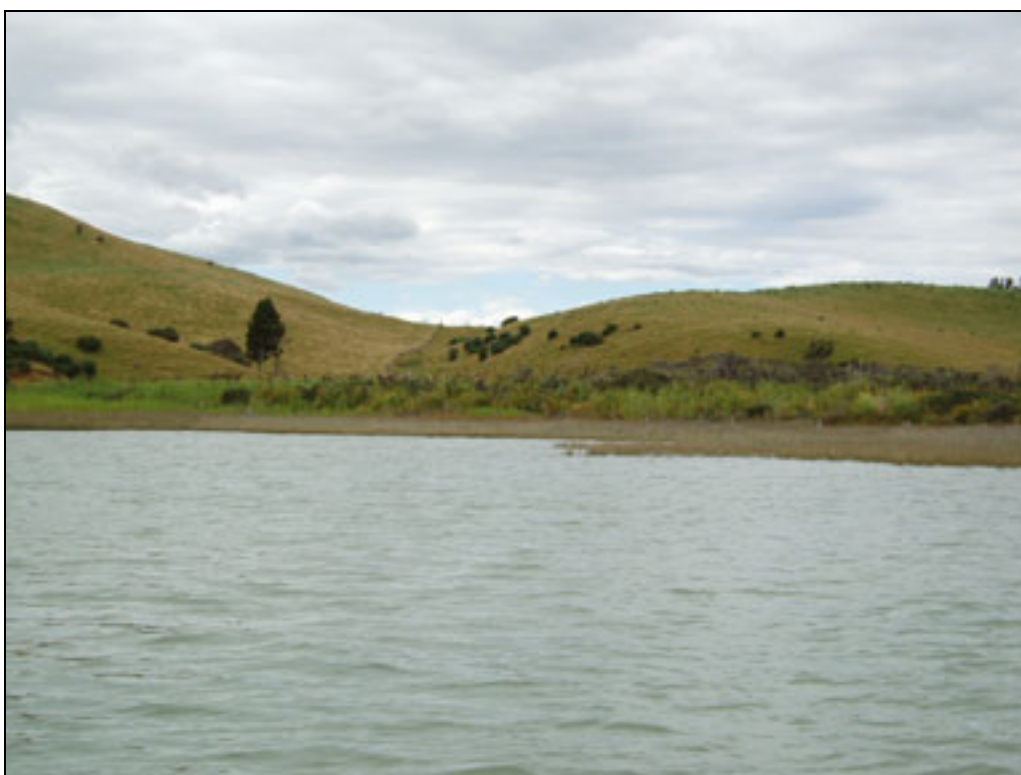
Kaitawa Inlet is not fenced along the TLB but is along the TRB behind the coastal forest edge (Figure 19). There are three main areas of estuarine/freshwater wetland with the largest being around the mouth of the Kaitawa Stream (Figure 20). This wetland contains oioi, sea rush, marsh clubrush, and a small amount of saltmarsh ribbonwood, backed by flax, cabbage trees, manuka, raupo, pampas and willow.

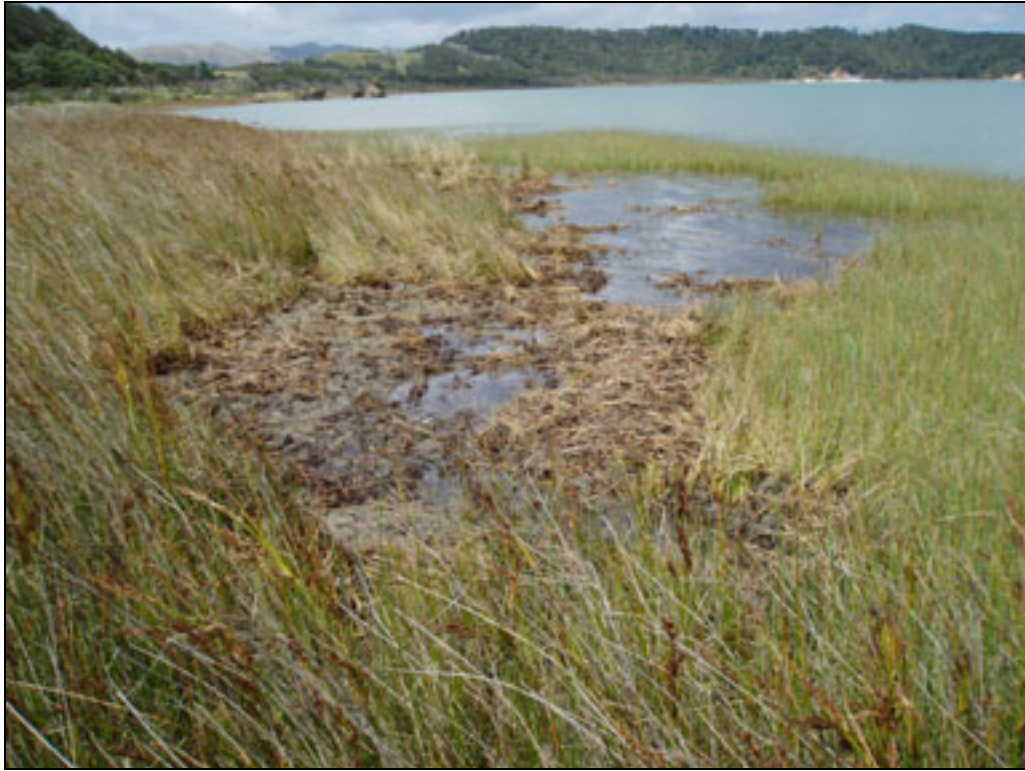
Figure 21: Pig rooting at Arapatiki Bay. 23/2/05

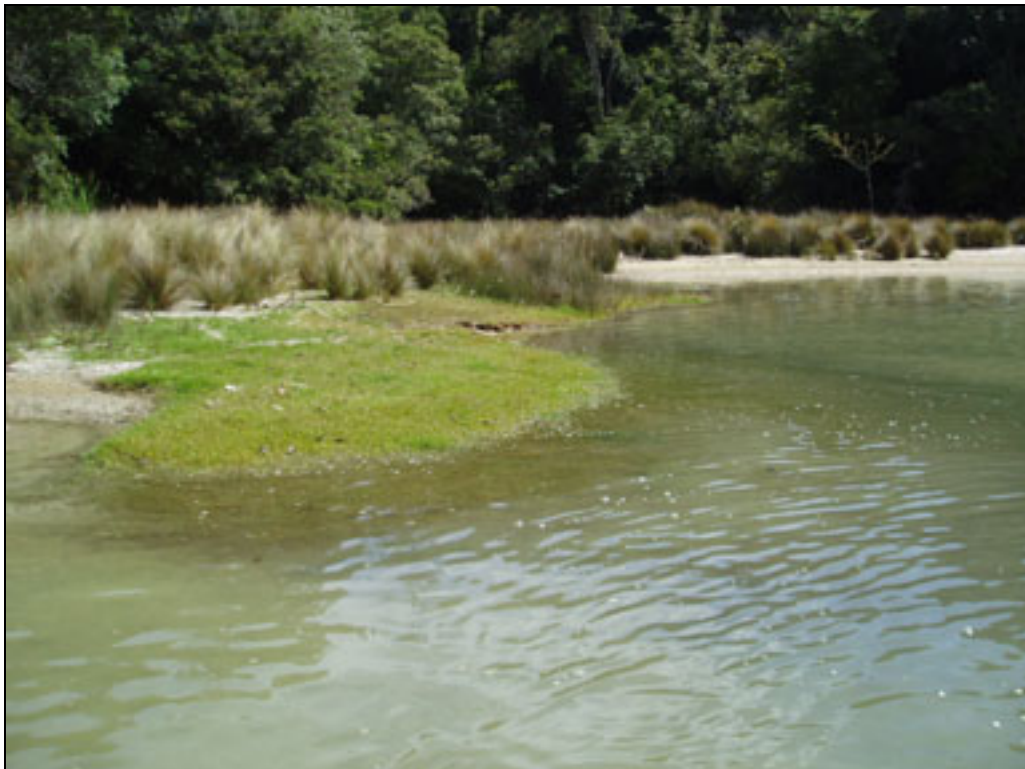
Figure 22: Saltwater paspalum backed by silver tussock and sea rush in a small bay between Te Umuroa Point and Pakingahau Point. 23/2/05

The other significant estuarine weed is saltwater paspalum. This invasive grass is only just starting to establish in Kawhia Harbour. The survey found only four patches of saltwater paspalum. Three patches are small and one patch is composed of a number of vigorous thick sub-patches. This grass has shown itself to be an aggressive spreader throughout the mid and upper tide zones (Graeme & Kendal, 2001). It particularly threatens low-stature sea meadow communities. These few pioneer populations of saltwater paspalum should be eradicated as soon as possible. This can be undertaken using gallant and so it would be a wise use of resources to co-ordinate the spraying of saltwater paspalum with the spartina control programme.

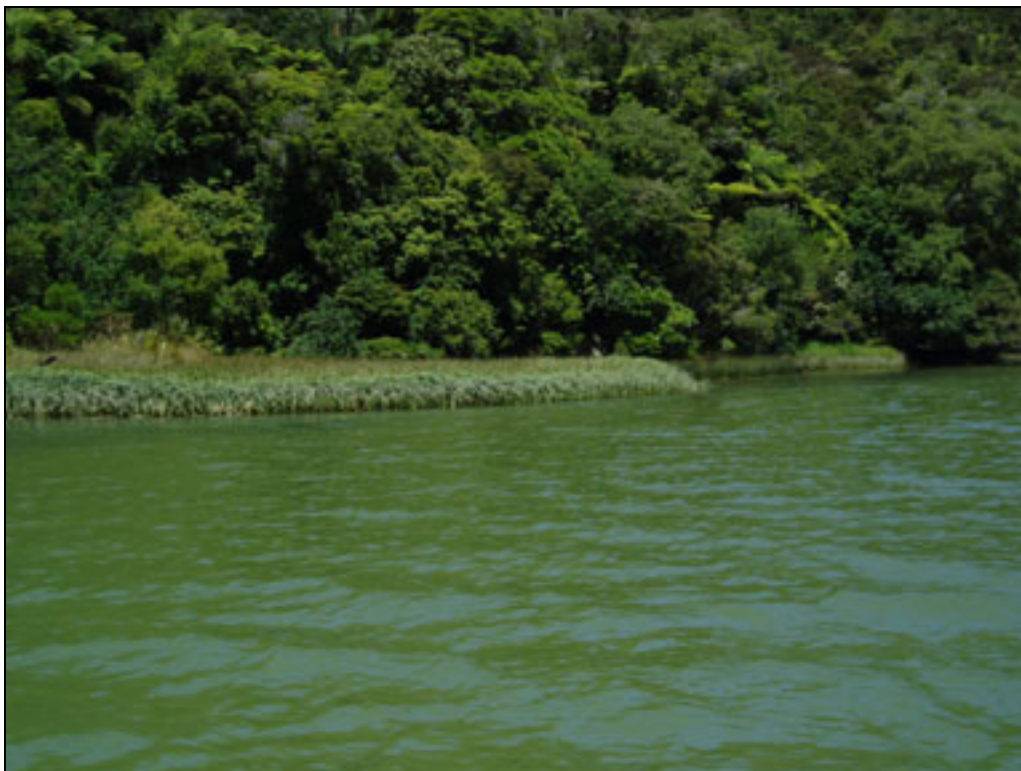
Upstream of the **Waiharakeke causeway** there are many large patches of spartina along the TRB of the **Owhiro Stream** arm. A smaller patch of spartina, upstream of the large sprayed patches, has not been sprayed (Figure 23). The farmland neighbouring these spartina patches has been fenced along its harbour edges with the exception that stock have access at the end of the headland where the farmland abuts native bush. A small mangrove is found downstream of this headland. There are another 8 unsprayed patches of spartina of varying sizes extending upstream from the bush patch. Akeake and kowhai are common in forest edge patches. Sea meadow species found along the TRB near the spartina patches include bachelor's button, leptinella, *Lilaeopsis ruthiana*, remuremu, sea primrose and arrow grass. Much of the TLB of the arm is lined by a significant block of regenerating coastal forest with thin

Figure 23: A small healthy patch of spartina upstream of the Waiharakeke causeway along the TRB of the Owhiro Stream arm. 27/1/05

Most of the *spartina* sites have been sprayed once, however only in a very few places have all the plants within a patch died. Follow-up spraying is essential. Further scattered patches have been noted that were not controlled during the first spray run.

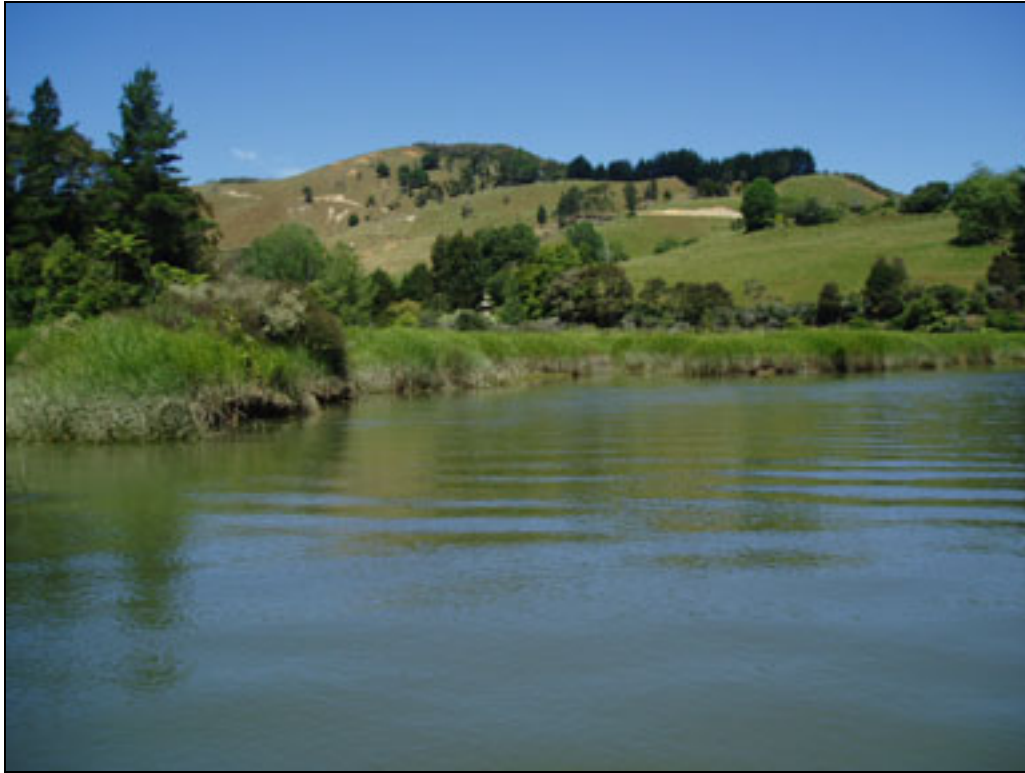
bands of rush. Where the harbour arm narrows, large beds of seagrass are found on either side of the channel (Figure 24). A mangrove is found on the TRB. The arm then winds upstream with scattered oioi lining marsh clubrush beds (Figure 25). A few saltmarsh ribbonwoods are also present. Bachelor's button, slender clubrush, and sharp spike-sedge (*Eleocharis acuta*) replace sea primrose and remuremu as the dominant sea meadow species. The swampy margins turn into marsh clubrush and raupo with remnant manuka, kahikatea and mingimingi swamp forest along the edge. Apart from goats in the forest edges, this arm does not have a stock problem like other arms in the harbour. There is a wide diversity of estuarine vegetation and remnant freshwater wetland habitats up the arm. Fencing of the few areas where stock can still access the harbour and stream edges, as well as goat control, will further enhance the health of the vegetation communities and their wildlife value.

Figure 24: Where the harbour narrows up the Owhiro Stream arm, large beds of seagrass are found on either side of the channel (dark patches in the water). 27/1/05

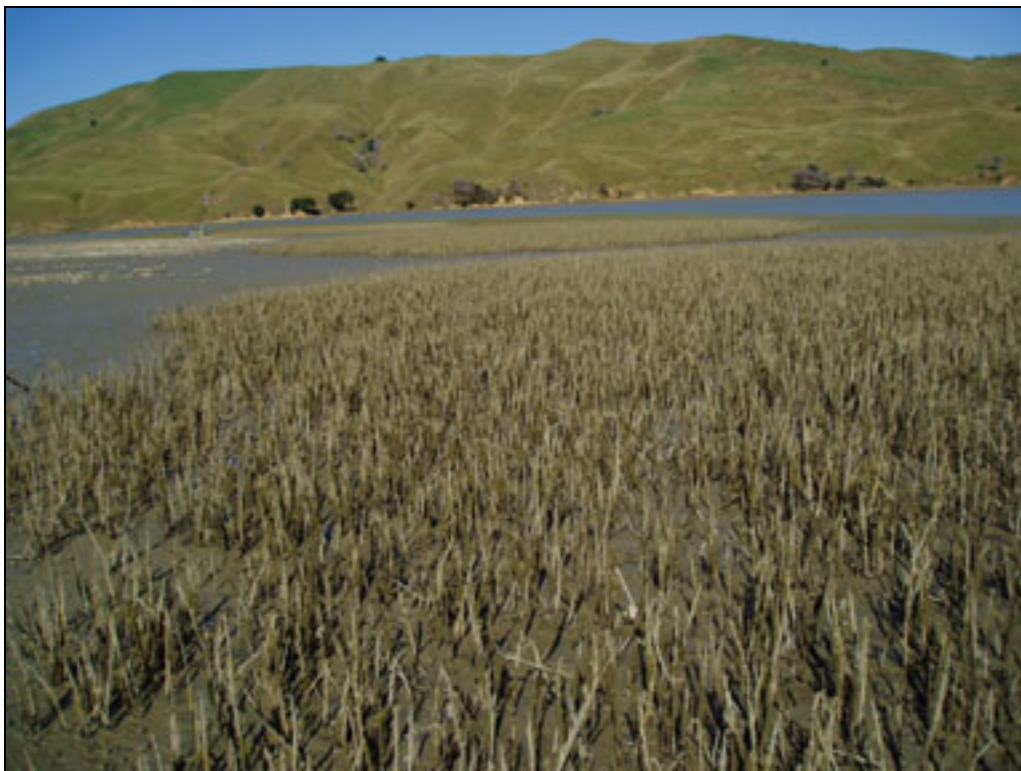
Lemon Point bay (west of Te Waitere) was becoming dominated by spartina until DOC started an eradication programme. The majority of the large patches have died however there are scattered surviving plants that will need follow-up control (Figure 27). Sea meadow species found include sea primrose, remuremu, isolepis and native celery (*Apium prostratum*). Stock access to the upper arm is a serious concern (some of the worst stock damage to the harbour was noted here). The farming practise of not fencing the harbour margin is allowing cattle to regularly wander along the foreshore and over the flats. This is adding increased sediment and pathogens to the harbour, and pugging rush and seagrass communities (Figures 28, 29 and 30). Also the pugging and grazing of spartina dislodges fragments that can float away in the tide and establish new populations. Appropriate fencing is required to rectify this situation (similarly for other sites around the harbour where stock access is an issue). Heading north towards **Nathan Point (Ohaua)** there is very little estuarine vegetation along the harbour margin, however there are scattered patches of seagrass and a small patch of spartina out from an indented cove. Goats were seen around either side of Nathan Point.

Figure 27: Sprayed spartina beds between Te Waitere and Lemon Point. A few scattered spartina plants are still alive and will require follow-up spraying. 27/1/05

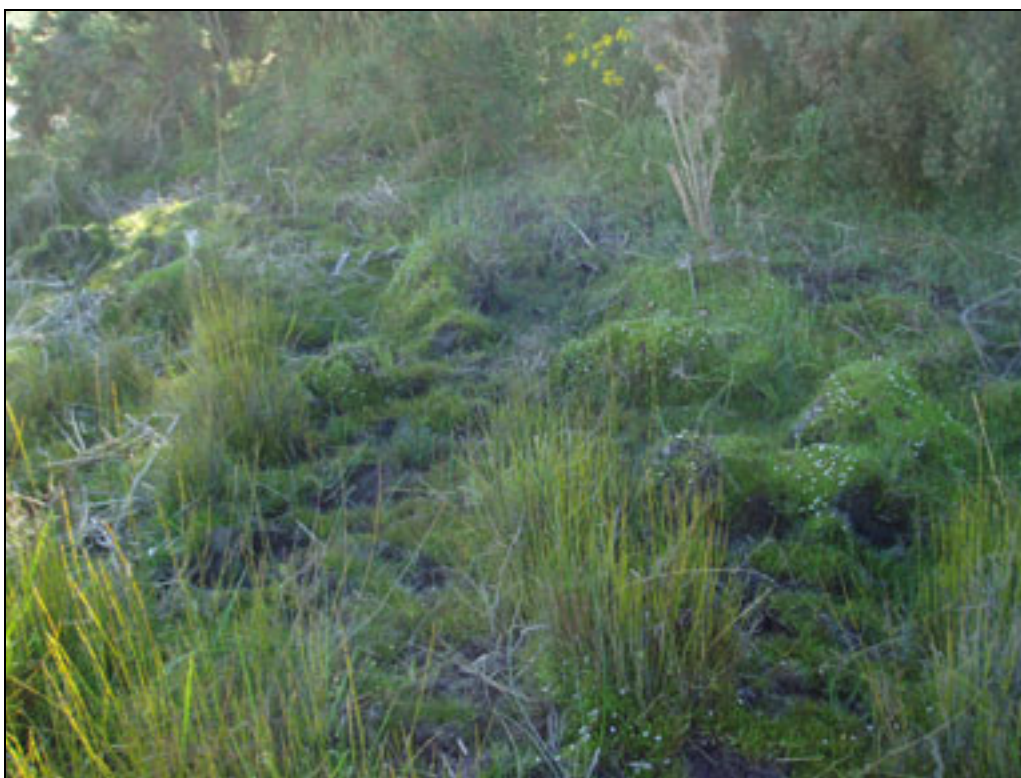
Figure 28: Pugged sea meadow west of Te Waitere, TRB Lemon Point Bay. 27/1/05

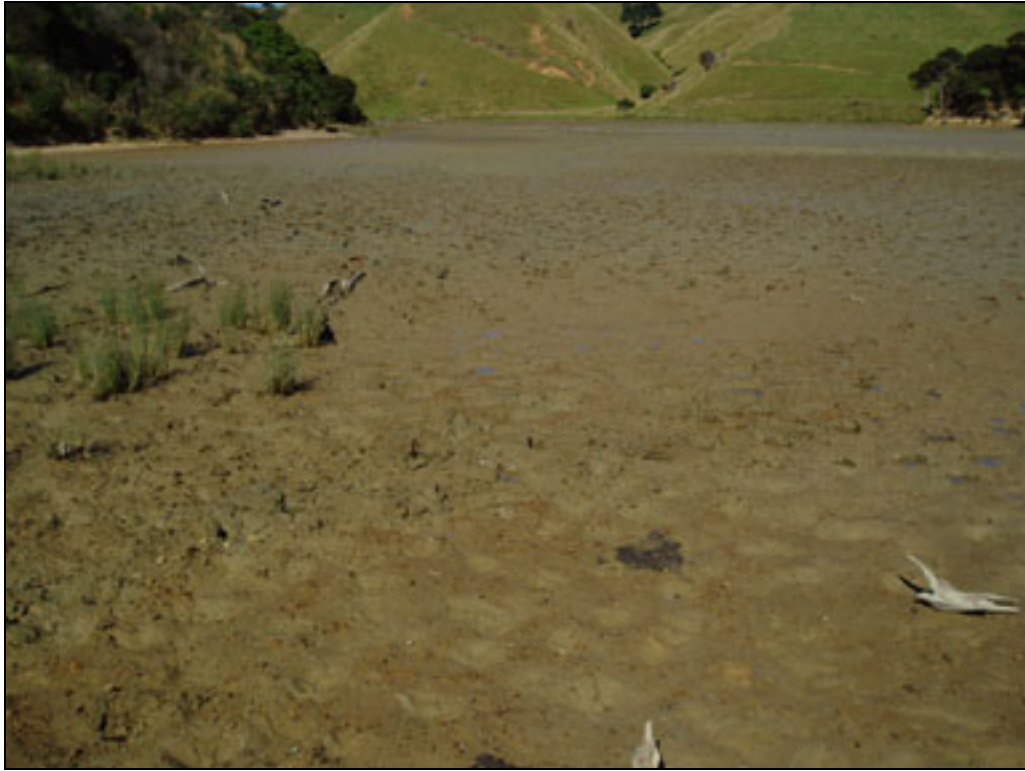
Figure 29: Pugged harbour sediments and cattle dung, west of Te Waitere, TRB Lemon Point Bay. 27/1/05

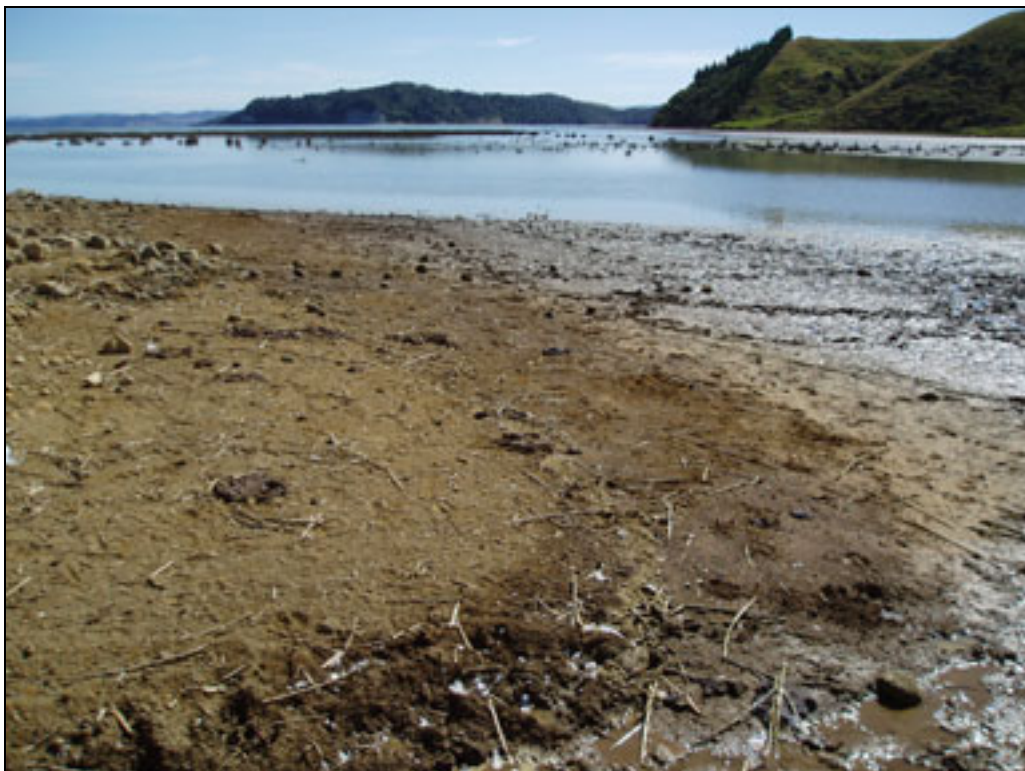
Figure 30: Looking across the pugged TLB foreshore of Lemon Point bay to the forested Pukinghau Point (opposite Te Waitere). Note cattle dung in foreground of photo. 27/1/05

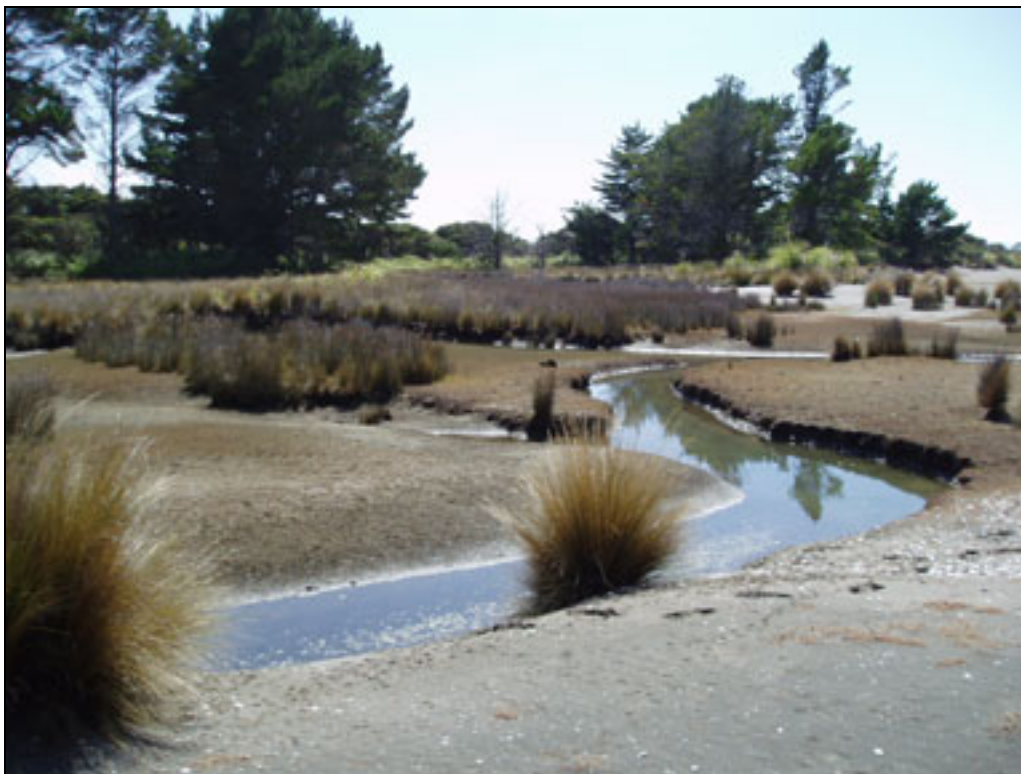
Figure 31: A small side arm of the wetland on Te Motu, dominated by silver tussock, sea rush and sea primrose. Pampas and pine are competing with manuka around the wetland edge. 29/1/05
