Estuarine Vegetation Survey - Kawhia Harbour

Prepared by:
Meg Graeme M.Sc,
Natural Solutions – Marine and Terrestrial Ecologists Ltd

For:
Environment Waikato
PO Box 4010
HAMILTON EAST

29 June 2005

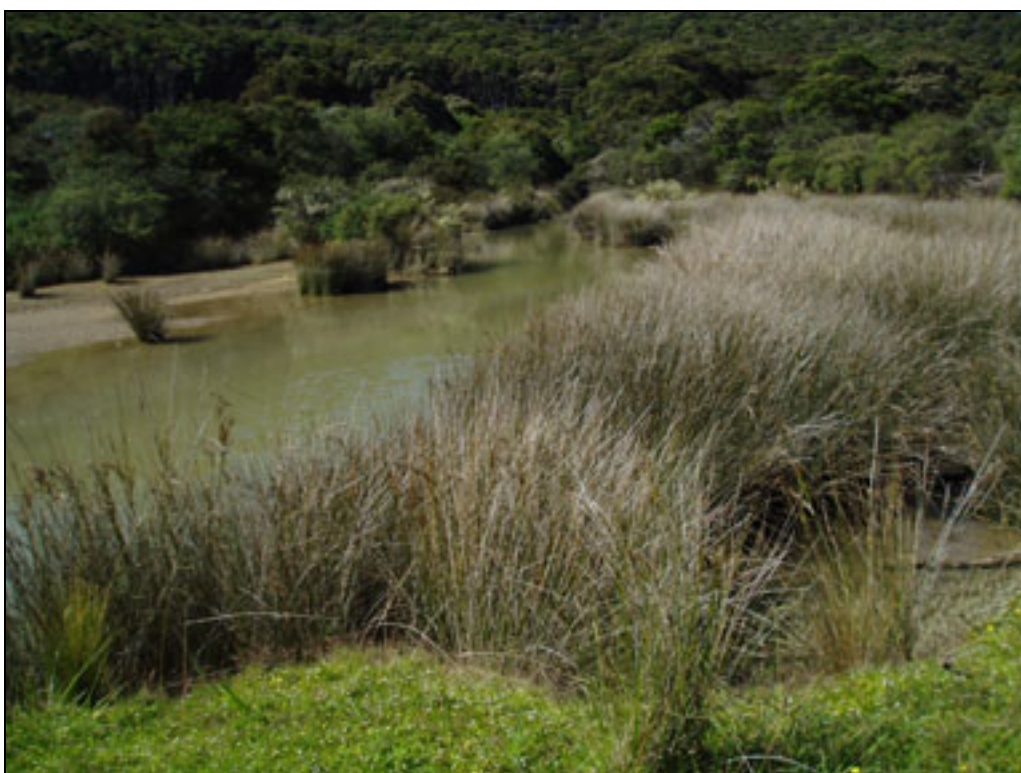
Te Motu has a relatively intact silver tussock/rush wetland with large patches of sea primrose scalloping the island's inlet edge (Figure 31). There are a few small but thick-bladed patches of seagrass in the creek. Other vegetation around the wetland edge

Figure 31: A small side arm of the wetland on Te Motu, dominated by silver tussock, sea rush and sea primrose. Pampas and pine are competing with manuka around the wetland edge. 29/1/05

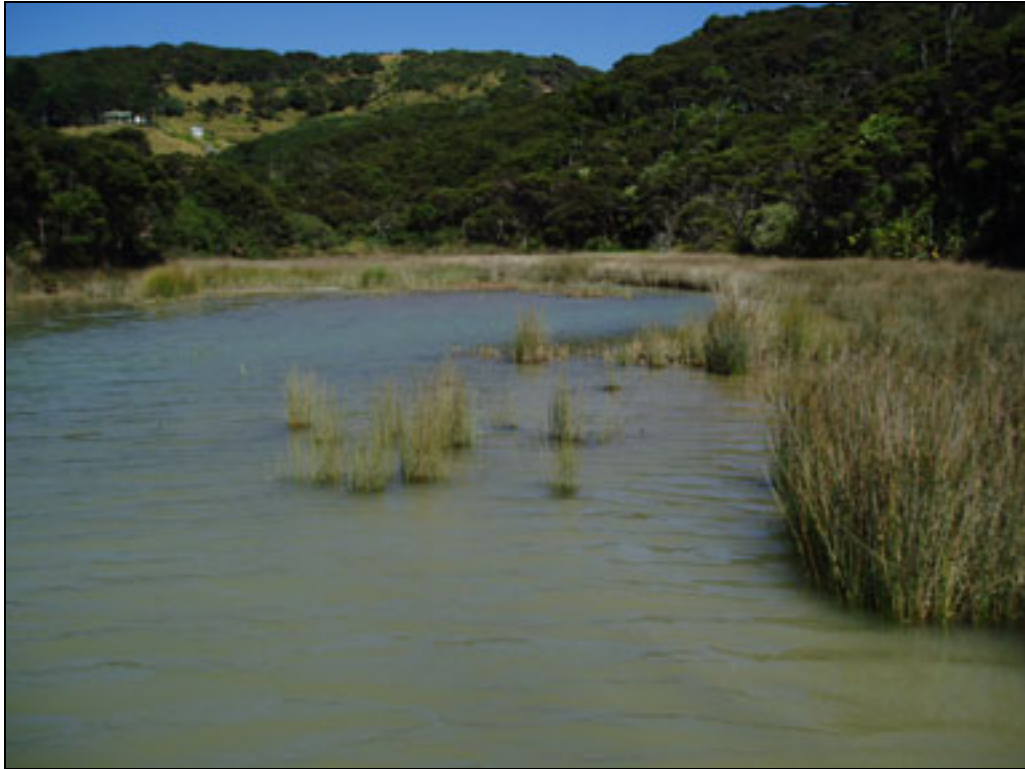
Scattered rush and sea meadow continue around **Totara Point** and into **Waipapa Point** Bay. Sea meadow is composed mainly of remuremu and silver tussock, as well as sea primrose and *isolepis* patches. A ngaio was found along the harbour edge as well as goat prints and dung, 4x4 tracks, cow pats and mustelid tracks on beach. A varied band of saltmarsh is found just north of the house up the eastern side arm which includes coastal shrub daisy, sea rush, saltmarsh ribbonwood, and sea meadow communities. A small patch of *spartina* is found directly in front of the house. At the head of the western side arm there are two small patches of *spartina*, an *eleagnus* patch by a derelict house, and sea meadow amongst rush (Figure 32). Rush lines the bay from **Waipapa Point** to **Onepoto Point** and peters out before **Torea Point**. A patch of *spartina* in front of a band of sea rush has been sprayed at the top of the Onepoto arm (Figure 33). *Eleagnus* was noted just before Torea Point.

Figure 33: Rush and sprayed spartina (in front of rush) up the top of the Oneopoto Arm. 26/1/05

Most of the *spartina* sites have been sprayed once, however only in a very few places have all the plants within a patch died. Follow-up spraying is essential. Further scattered patches have been noted that were not controlled during the first spray run.
