# WAIKATO RIVER

## 2006 SURVEY REPORT

KARAPIRO DAM TO  
NGARUAWAHIA

Prepared for:  
MIGHTY RIVER POWER  
PO BOX 445  
HAMILTON.  
DECEMBER 2006

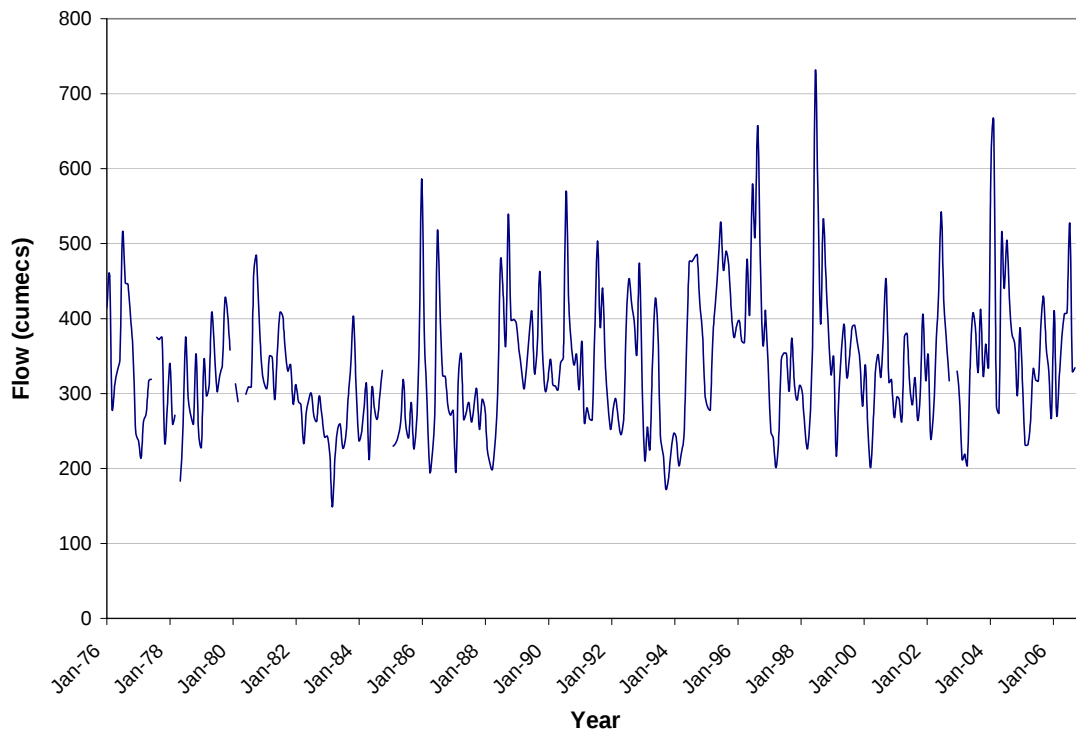
Figure 1 Flow hydrograph for the Waikato River at Hamilton's Victoria Bridge, showing monthly maxima of daily mean flows.

As major morphologic changes are often associated with floods, any analysis of cross-section changes over time should also consider flood history. A hydrograph of monthly maximum daily mean flows at Hamilton's Victoria Bridge is shown for the last 30 years in Fig. 1. During the last decade, three major floods occurred (1996, 1998 and 2004). The 2004 flood occurred after the previous cross-section survey was carried out in 2002 and 2003.

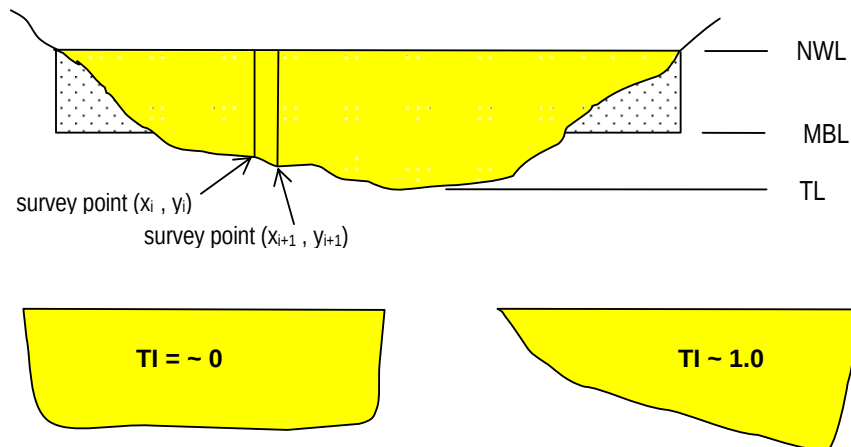
Figure 2 Schematic cross-sections showing Nominal Water Level, Mean Bed Level, Thalweg Level and Thalweg Index.

Volume, MBL and TI all depend on where the NWL datum is placed, however, provided NWL is allocated in a logical manner (and not varied over the years) these parameters will provide valuable information on changes over time and changes between sections.

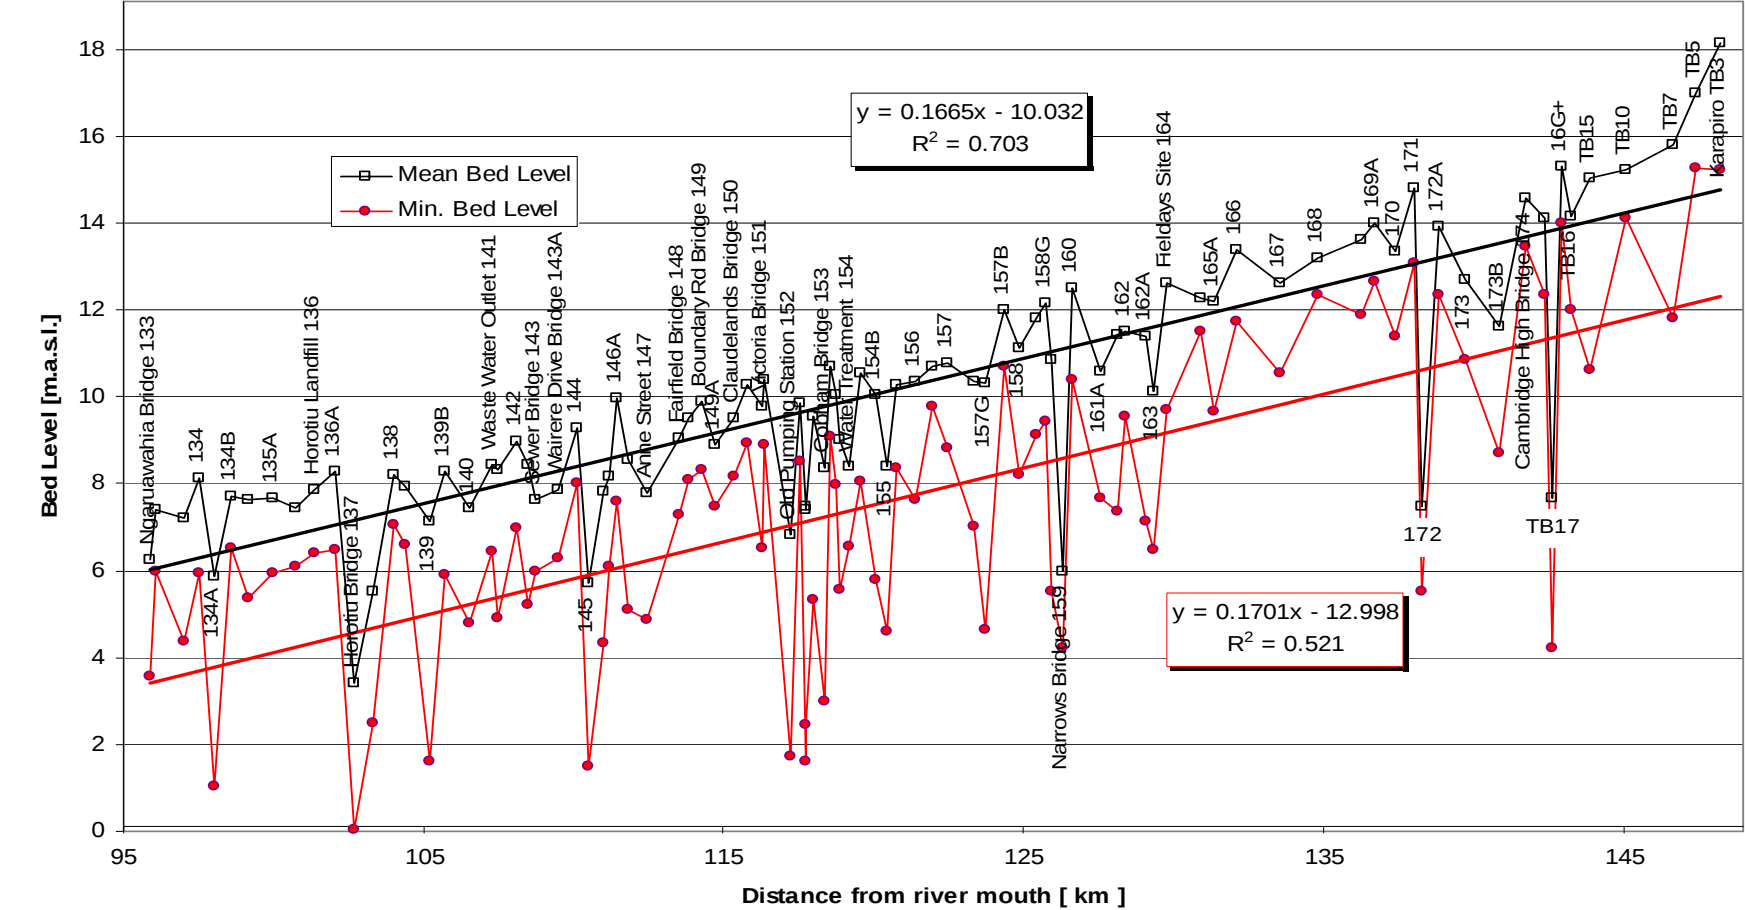
Figure 3 Mean bed levels & thalweg levels from 2006 survey data showing linear trendlines

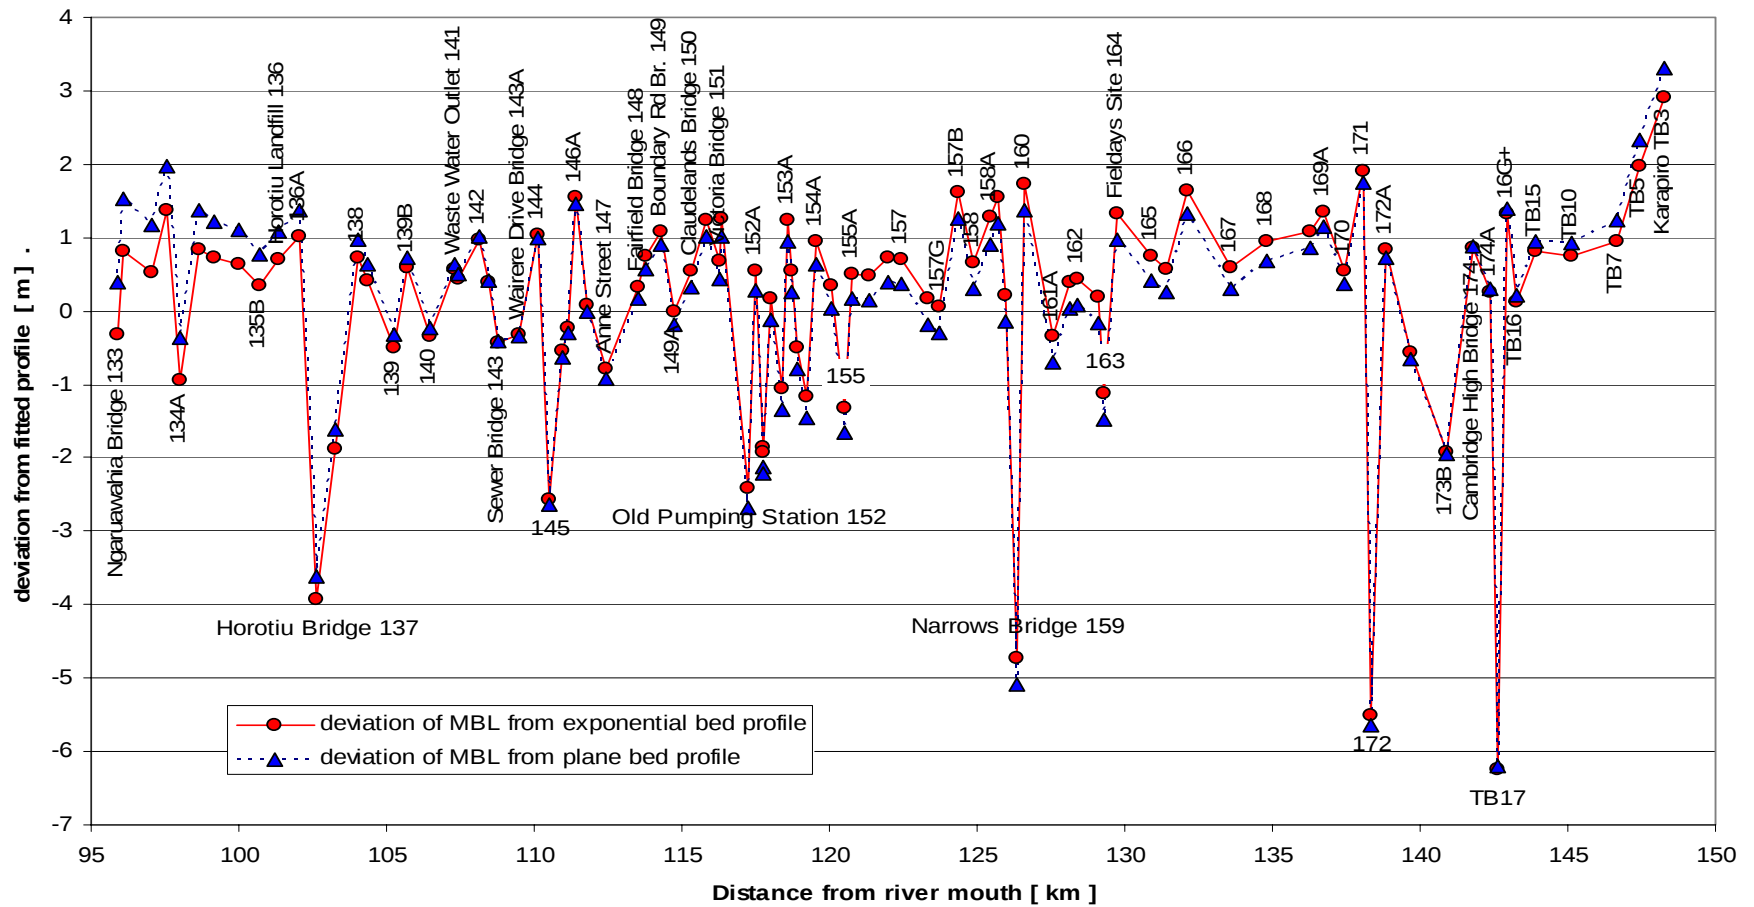
Figure 4 Deviations of mean bed level from fitted profiles using 2006 data.

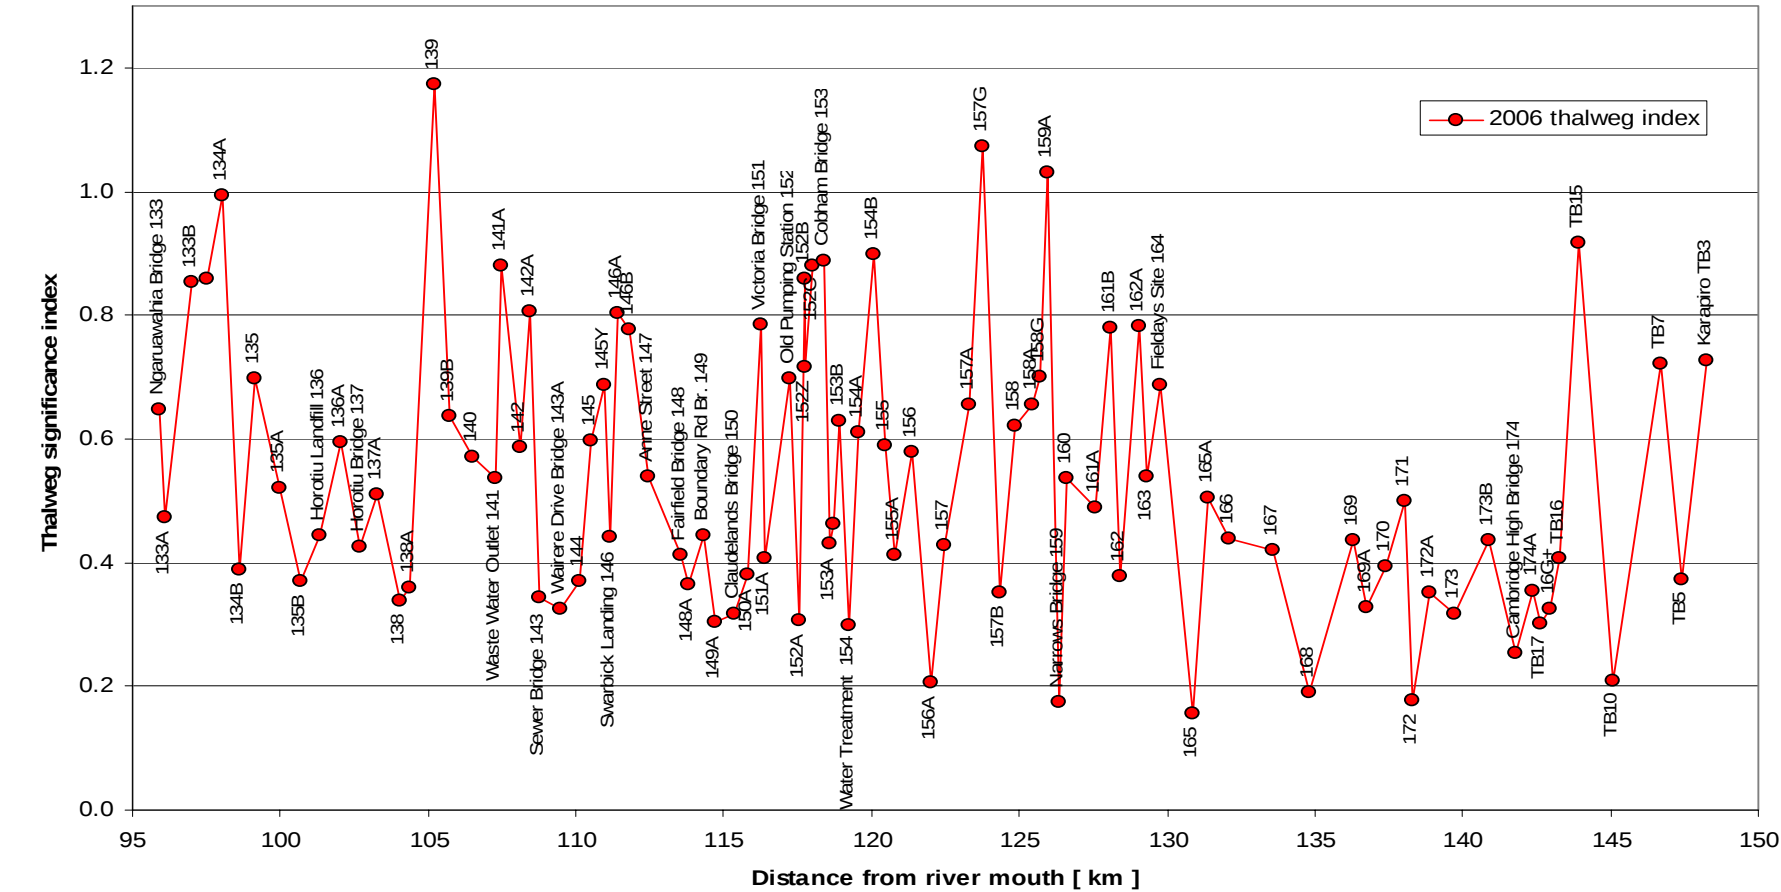
Figure 5 Thalweg significance indicated by 2006 survey

The Thalweg Index (TI), indicating the significance of the thalweg at cross-sections surveyed in 2006, is shown in Fig. 5. Overall there is a tendency for the channel to be more rectangular (low TI value) from section TB16, downstream of Karapiro, to section 165 upstream of the Fieldays site. From the Fieldays site down through Hamilton to section 139 the thalweg effect is more pronounced at every second or third section, indicating alternate outer bank scour. There is a more rectangular series of cross-sections through Horotiu and the thalweg then becomes significant again above Ngaruawahia.

Where cross-sections are located close together the thalweg index can be used to identify the meander wavelength of a river. There is no dominant meander wavelength evident from the sections surveyed in 2006.

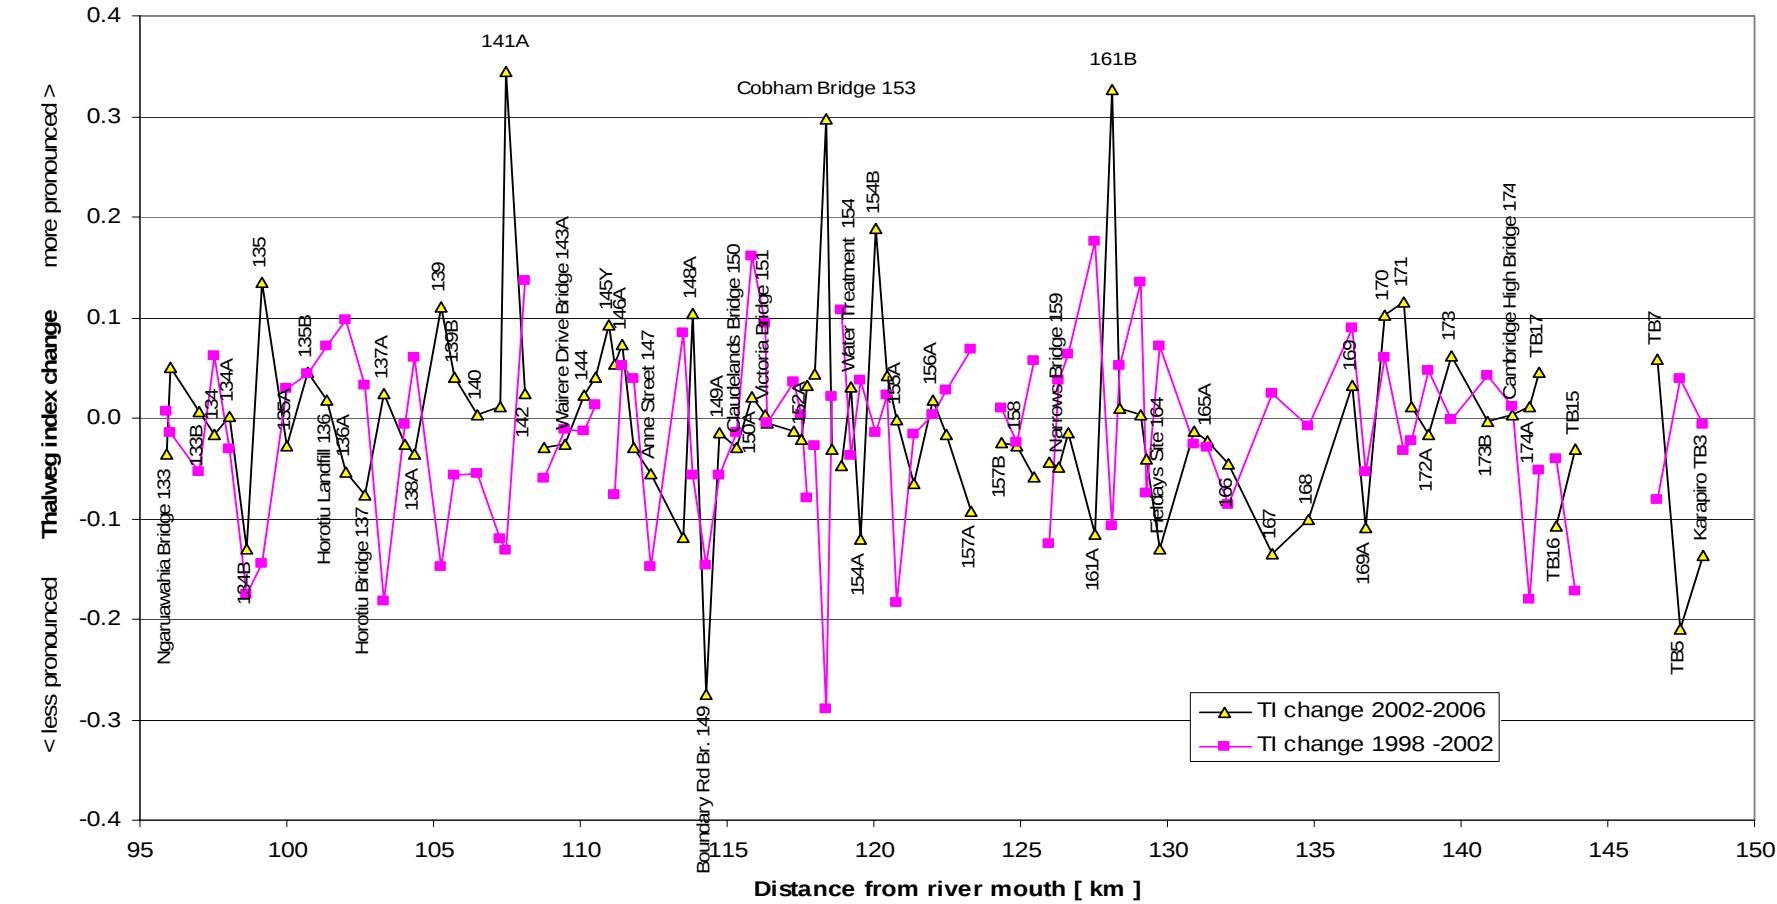
Figure 6 Changes in thalweg significance since 1998

Changes in the thalweg index since 1998 are shown in Fig. 6.

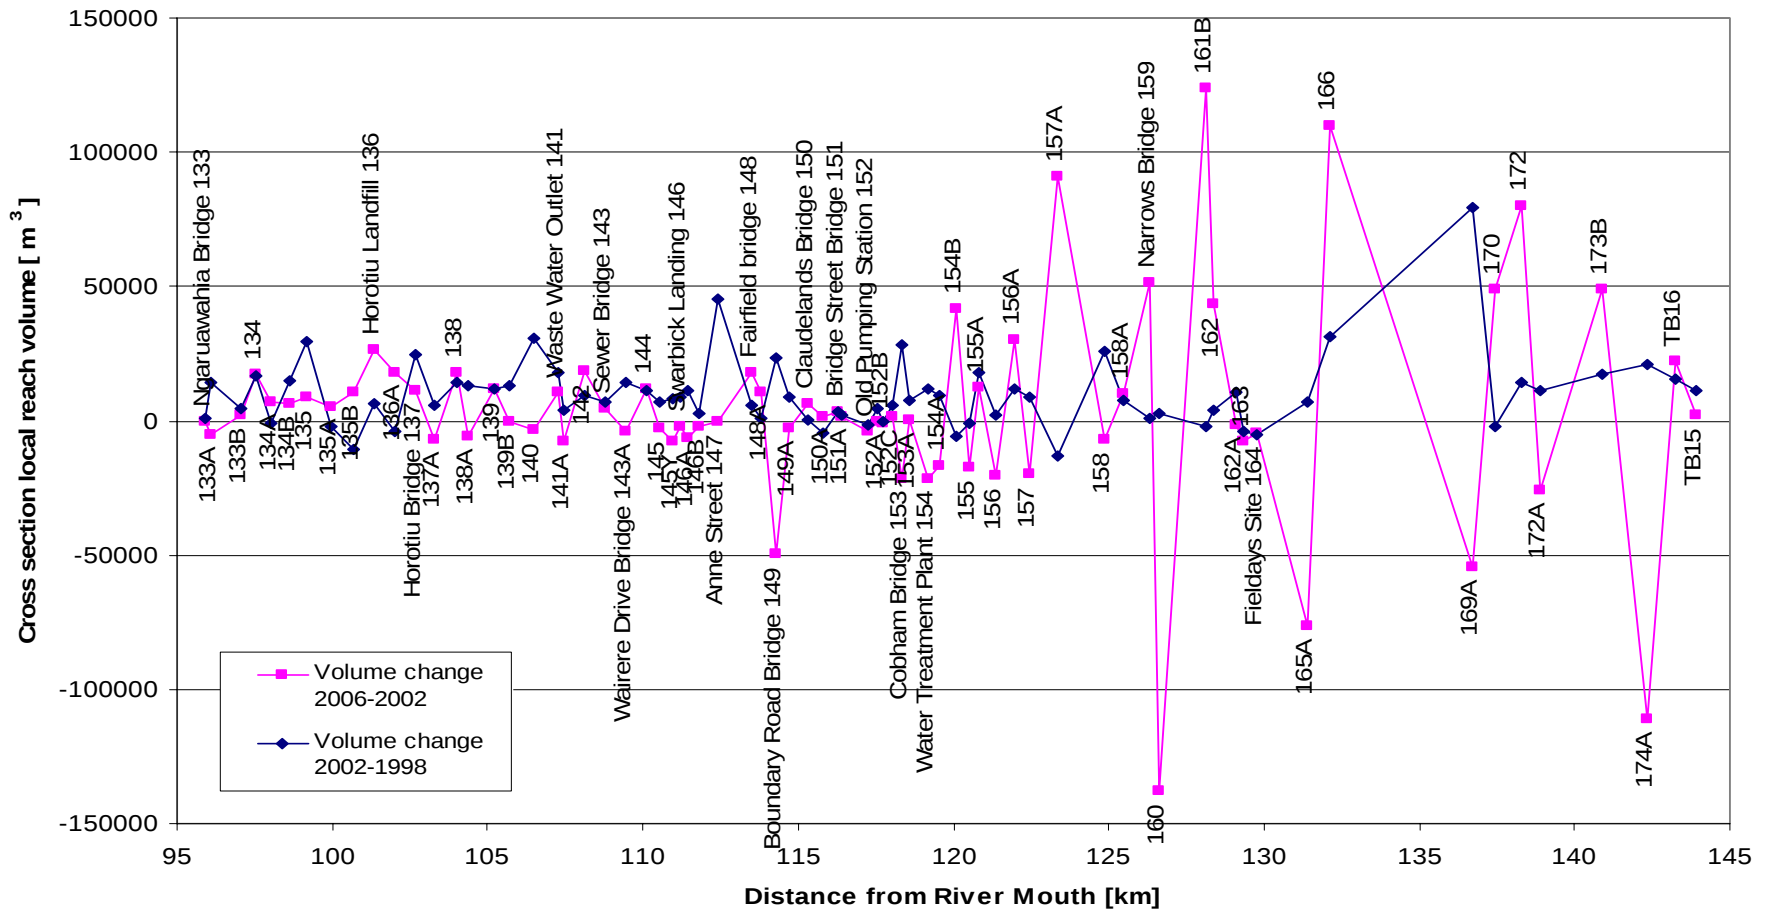
Figure 7 Change in sectional volumes between Karapiro and Ngaruawahia ( a positive change indicates scour, a negative change indicates deposition).

A comparison of the volume change from the 1998 survey to the 2002 survey with the volume change from the 2002 survey to the 2006 survey is given in Fig. 7. Several sections which were degrading from 1998 to 2002 then aggraded from 2002 to 2006. Examples are found at cross-sections 133A, 140, 147, 153, 158, 169A and 174A. Conversely, cross-sections which were aggrading from 1998 to 2002 then degraded from 2002 to 2006. Examples are at cross-sections: 135B, 136A, 154B, 157A, 161B and 170.

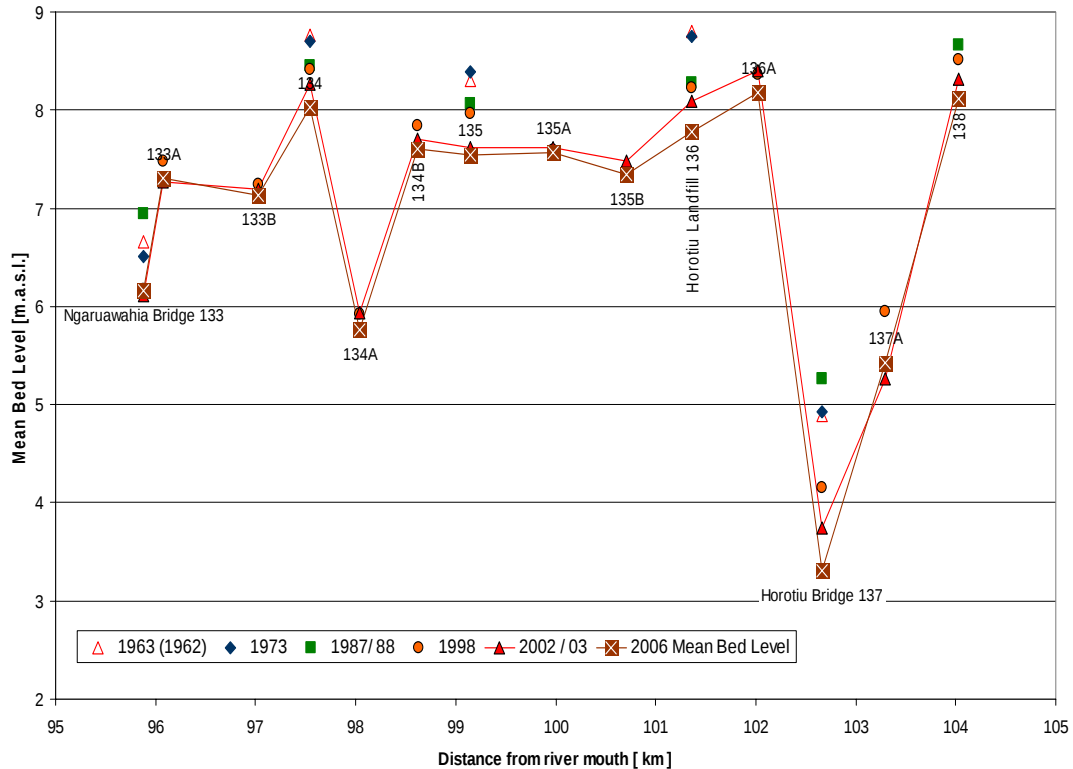
Figure 8 Time evolution of mean bed levels from upstream of Horotiu to Ngaruawahia Bridge

The 2006 survey results for mean bed levels in this reach are compared with earlier data in Fig. 8. Except for an episode of deposition prior to the 1987/88 survey, mean bed levels have continued to fall over time in this reach, especially in the vicinity of Horotiu (sections 136, 136A, 137 and 138).

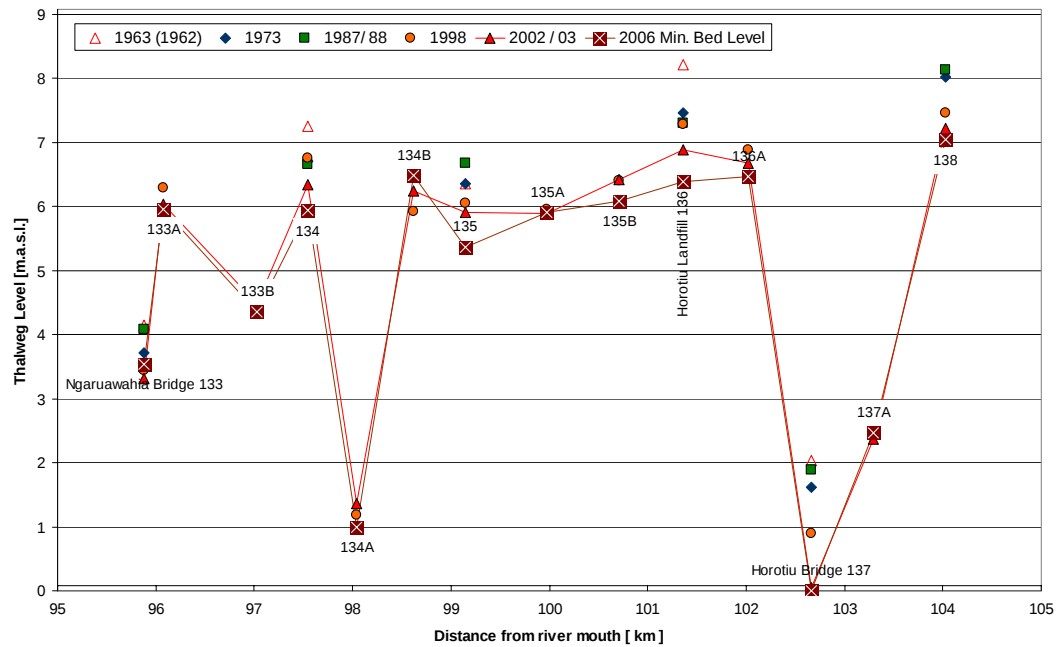
Figure 9 Time evolution of thalweg levels from upstream of Horotiu to Ngaruawahia Bridge

The recent survey results for thalweg levels from upstream of Horotiu to Ngaruawahia Bridge are compared with earlier thalweg levels in Fig. 9. The thalweg level appears to be stable at sections 133B, 135A and 137A. The thalweg has fallen significantly in the vicinity of Horotiu (sections 135, 135B, 136, 137) and risen slightly at section 134B.

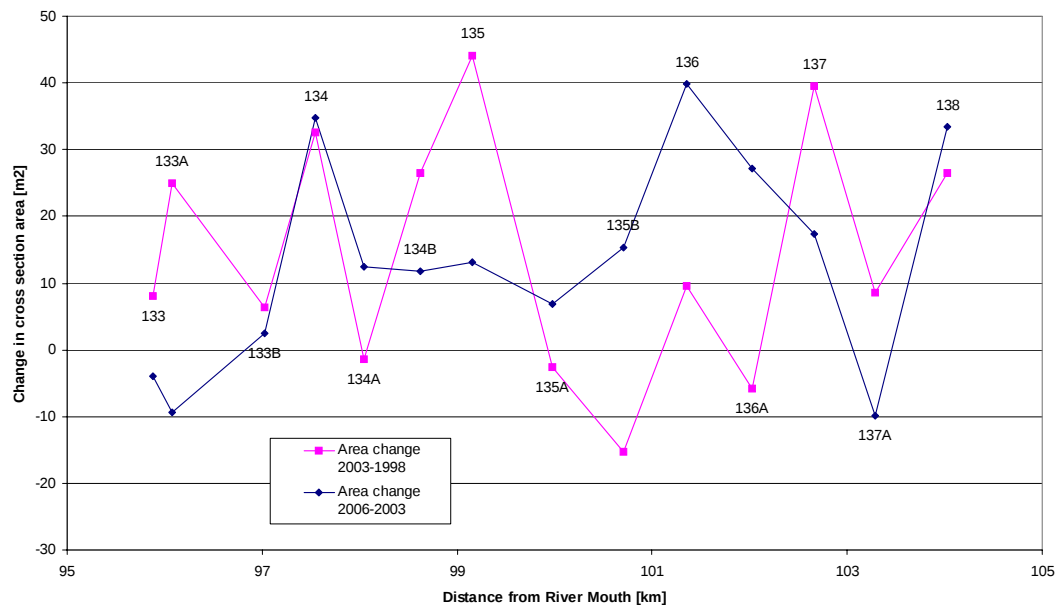
Figure 10 Change in sectional areas from upstream of Horotiu to Ngaruawahia Bridge (a positive change indicates scour, a negative change indicates deposition).

The largest rate of degradation was at section 135 in the 1998 to 2003 period. This section was more stable from 2003 to 2006. The largest rate of degradation in the most recent period was at section 136.

The largest degree of degradation was at sections 134 and 138 which are scouring steadily.

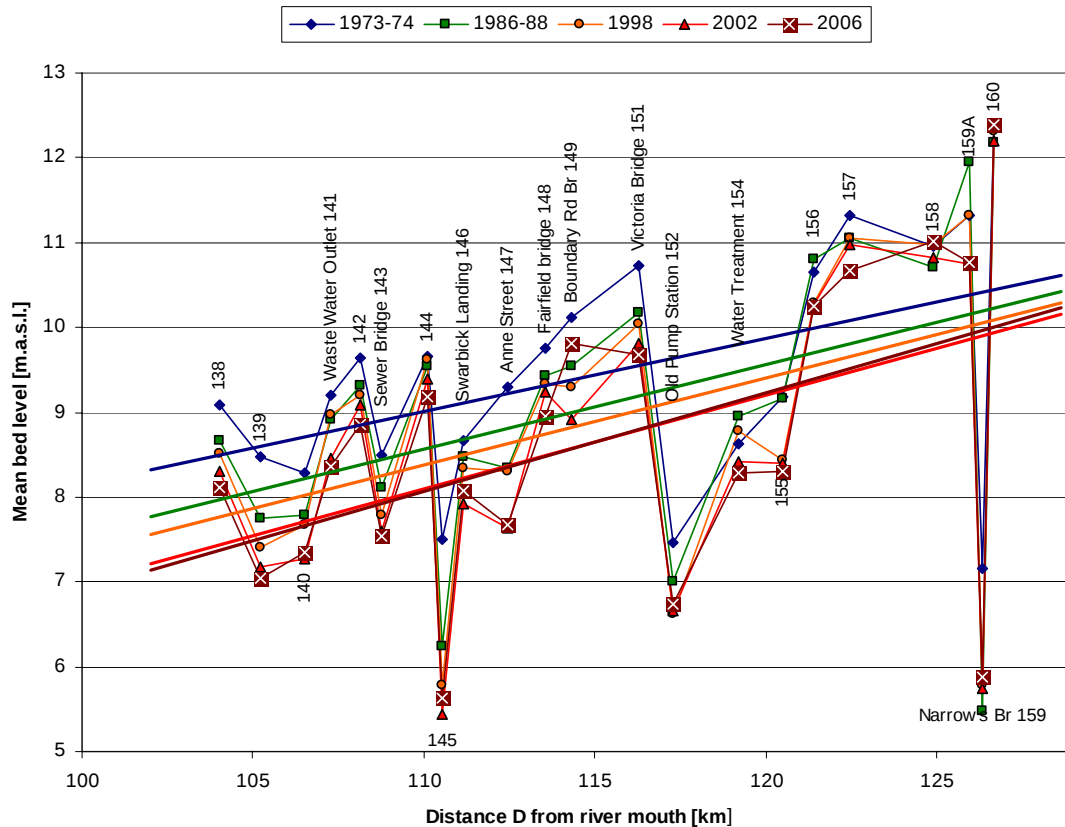
Figure 11 Time evolution of mean bed levels at 22 Hamilton cross-sections. Trendlines show a fitted bed plane.

Representing the bed in this way reveals basic trends that are obscured by local variations in the bed level. Smart (2003) noted that the mean bed level of the Hamilton reach is not only falling but its gradient has been getting steeper with time.

What is evident in the 2006 survey is that there has been less overall degradation from 2002 to 2006 than occurred from 1998 to 2002, mainly due to infilling at the deepest sections and at section 149 near the middle of the reach.

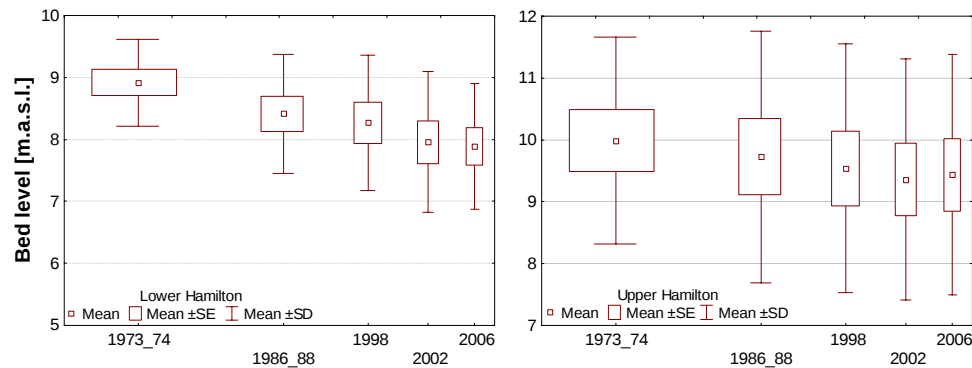
It is not straightforward to establish the significance of the temporal change in Hamilton bed plane slope. To investigate statistical measures, the 22 cross sections are split into two groups of 11 cross sections representing “lower” Hamilton (from upstream of Horotiu Bridge to Fairfield Bridge) and “upper” Hamilton (from Boundary Road Bridge to upstream of the Narrows Bridge). Basic statistics on cross section MBLs of “lower” and “upper” Hamilton are compared in Fig. 12. For lower Hamilton, the graph shows that there was only a small decrease in the average of the section MBLs in 2006, compared to earlier surveys. This could be interpreted as an encouraging sign, however, for upper Hamilton, the MBL rose in the latest survey. This is not an indication of a stabilising bed but demonstrates that there is an active river bed (the deposited material has eroded from somewhere else).

The standard errors and standard deviations on Fig. 12 should be interpreted with caution as some of the variation in cross section mean bed levels is caused by the channel gradient. Upstream cross sections will tend to deviate from the average because they are naturally higher and downstream ones may deviate because they are naturally lower than the average level. Because the upper Hamilton cross sections are spread over a greater length of river than the lower Hamilton sections, if the overall river gradient does not change, there will be greater natural fall through upper Hamilton and a wider variation in bed levels could be expected. Notwithstanding this effect, from Fig. 11 it is clear that there are actually wider fluctuations in the upper Hamilton cross section bed levels compared to those of lower Hamilton.

Figure 12 Hamilton City cross section mean bed level statistics from Fairfield Bridge downstream (left) and from Boundary Rd Bridge upstream (right) showing changes with time. SE = standard error, SD = standard deviation of the cross section mean bed level.

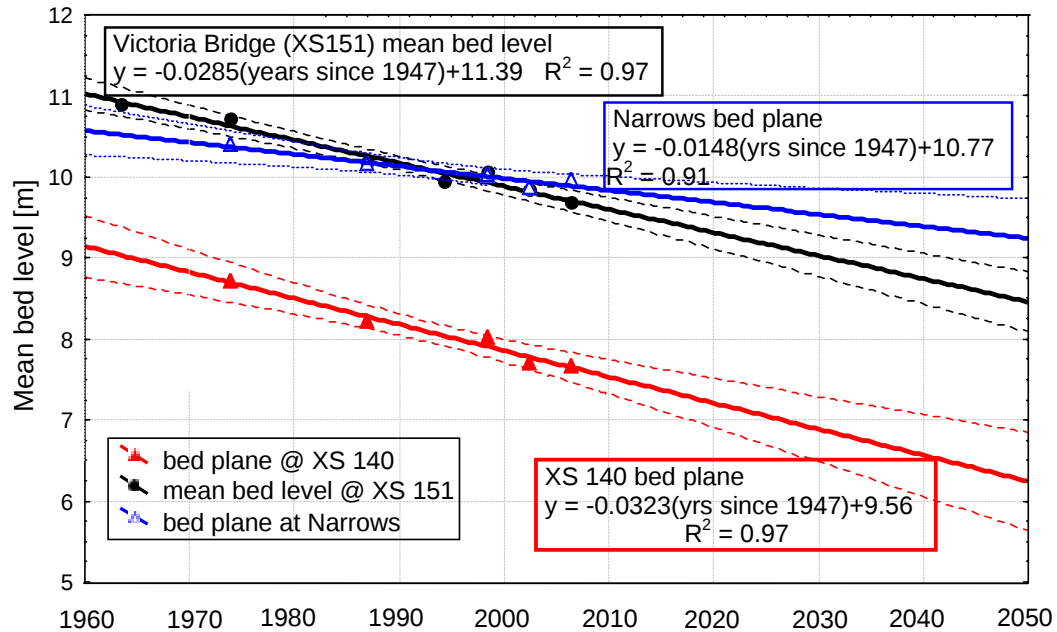
Figure 13 Trends in mean bed level at Victoria St Bridge (Section 151, black line) and trends in level of the bed plane at Pukete Boat Ramp (Section 140, red line) and downstream of Narrows Bridge (km 126, blue line), extrapolated to 2050, showing 95% confidence intervals.

In addition to the 22 reference sections discussed above, there are three index sections within the Hamilton reaches that have been analysed for trend in earlier studies. To update future mean bed level predictions for these sections, the time evolution of MBL and bed plane level is shown in Fig. 13 for Pukete Boat ramp (Section 140, downstream of Hamilton), Hamilton Victoria Bridge (Section 151) and downstream of the Narrows Bridge (upstream of Hamilton). The temporal trend at these locations is extrapolated to year 2050 on Fig. 13.

From the trend equations on Fig. 13 it can be seen that the mean bed levels are dropping at a fairly constant rate of 32 mm/yr in the vicinity of cross-section 140 (just downstream of Hamilton) at 29 mm/yr at Hamilton's Victoria Bridge and at 15 mm/yr upstream, near the Narrows. These rates and the 2050 bed levels that will result if these rates continue, are shown in Table 3. The 95% confidence limits are shown by dashed lines on Fig. 13 and in the final column of Table 3.

Although the most recent survey indicates a reduction in the rate of degradation, the 2006 survey points plot very close to the regression lines in Fig. 13. As these points do

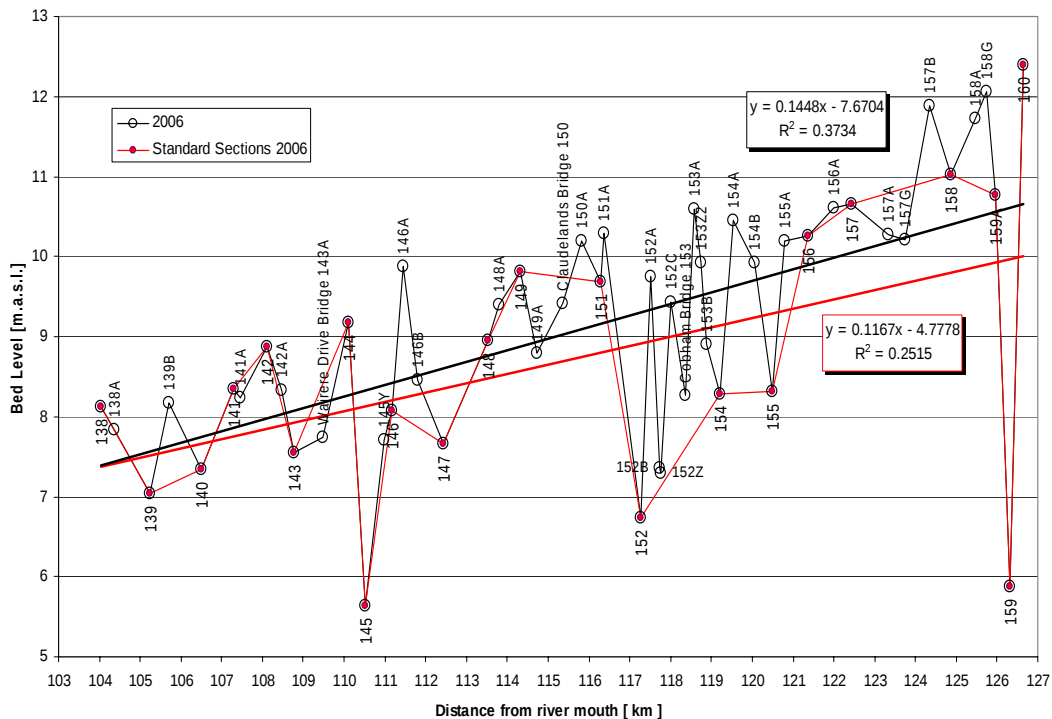
Figure 14 Location of the 22 standard sections (red) and newer sections (black) showing high sills captured in the 2006 survey.

A factor to consider is that recent investigations of river bathymetry have revealed that there are high sills not captured by the 22 reference sections. All cross-sections measured in the 2006 survey and their MBL's are shown in Fig. 14 in relation to the 22 standard reference sections. The inclusion of additional, higher sections changes the position of the average bed trend line and steepens it. As these sills play an important role in controlling water levels and scour depths, future surveys should compare trends which include these sections.

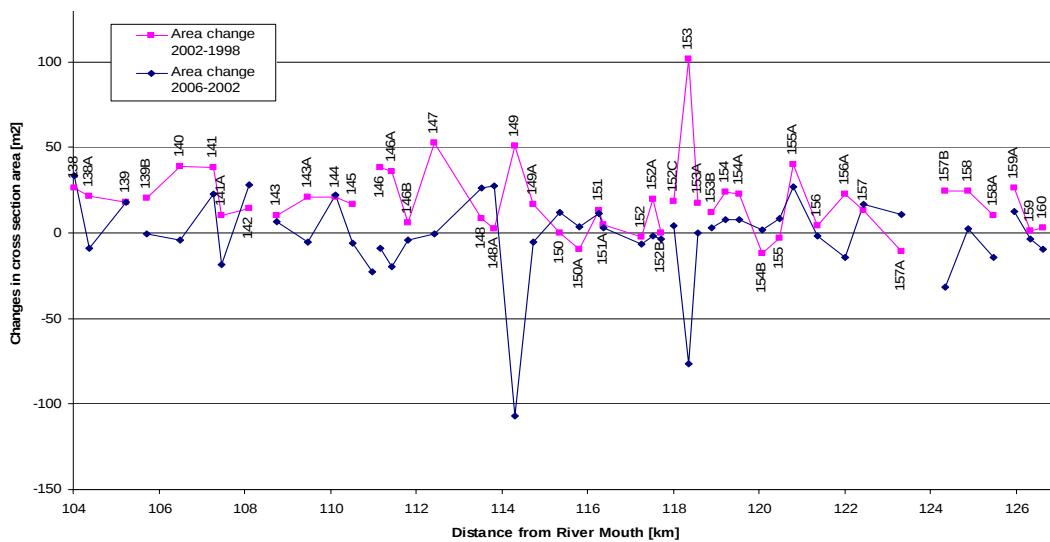
Figure 16 Change in sectional areas for Hamilton reaches (positive change indicates scour, negative change indicates deposition).

The volume changes per unit length for the Hamilton reaches are shown in Fig. 16. In the 2002 to 2006 period significant depositional changes occurred at cross-sections 149 (Boundary Rd Bridge) and 153 (Cobham Bridge). The cross-section 153 deposition follows significant scour at this site in the 1998 to 2002 period. For Hamilton reaches from cross-sections 138A to 159, according to the cross-sections shown in Fig. 16, the overall changes in volume are: 1998 to 2002 377,000 m<sup>3</sup> of scour, 2002 to 2006 114,000 m<sup>3</sup> of scour.

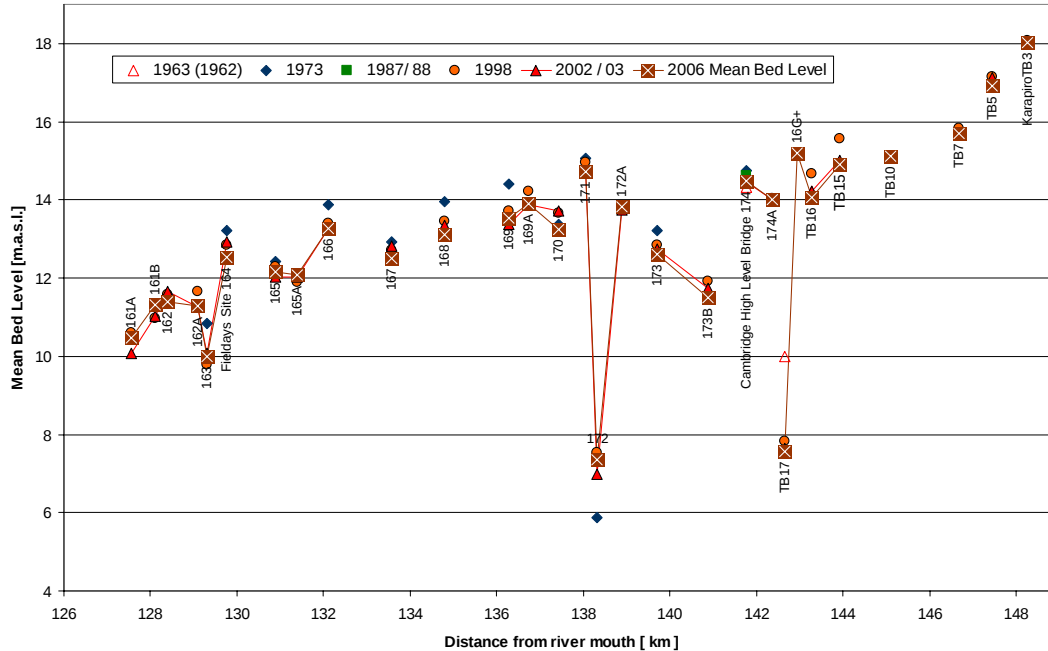
The 2006 survey results for mean bed levels in this reach are compared with earlier data as shown in Fig. 17.

There have been no recent major changes in mean bed level at sections between Karapiro and the Narrows. Between the 2003 survey and the 2006 survey mean bed level degraded at cross-sections 170 ( 0.5 m ) and 164 ( 0.4 m ). Cross-section 161A aggraded by 0.4 m.

Figure 17 Time evolution of mean bed levels from the tailwater of Karapiro Dam to upstream of The Narrows

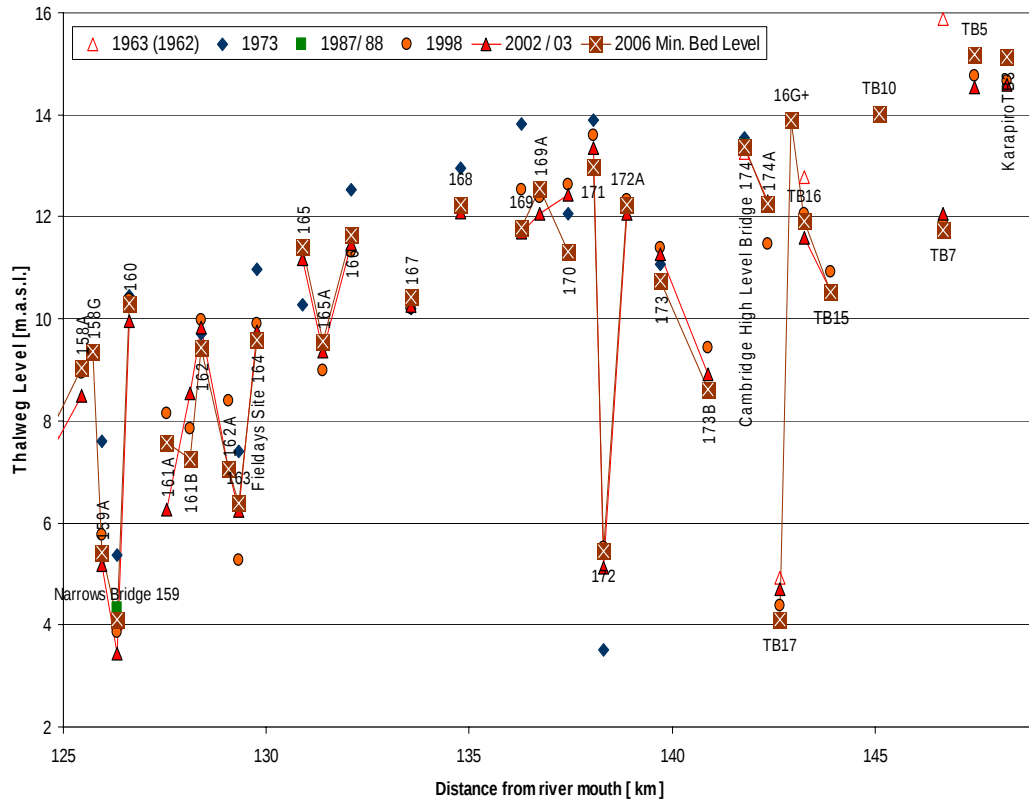
Figure 18 Time evolution of minimum bed levels from the tailwater of Karapiro Dam to upstream of The Narrows.

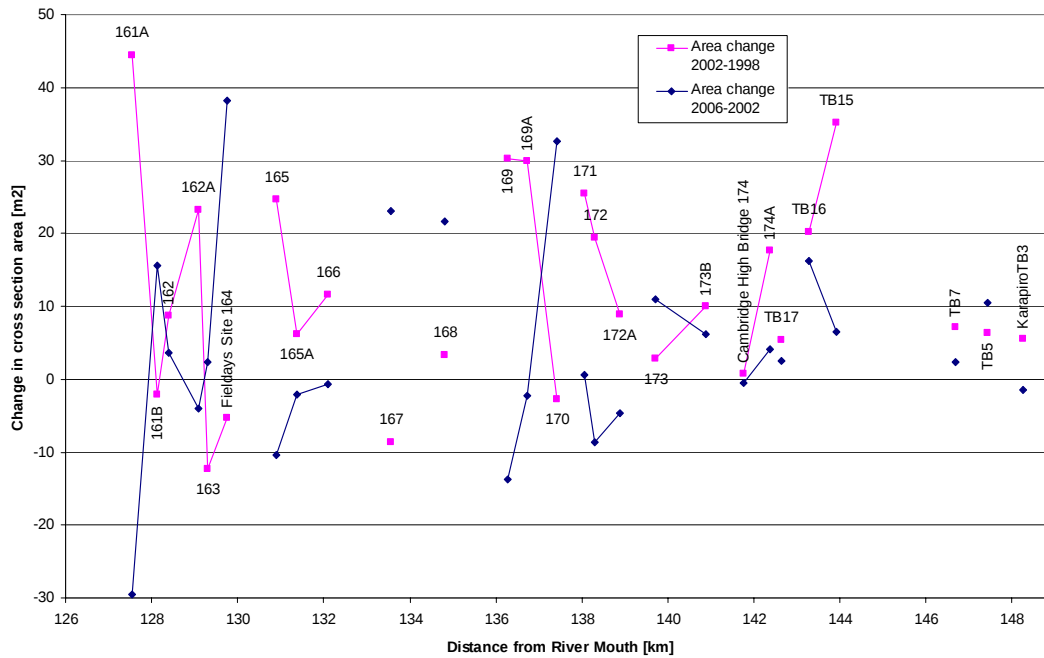
Figure 19 Change in sectional areas between the Narrows and Karapiro ( a positive change indicates scour, a negative change indicates deposition).

The changes in volume per unit length for the Karapiro to Narrows reaches are shown in Fig. 19. Section 161A is the most volatile in this part of the river having scoured in the 1998 to 2003 period and re-filled in 2003 to 2006. Other sections show similar behaviour but to a lesser extent and at times in the reverse order.

For the Karapiro to Narrows reaches defined by the cross-sections shown in Fig. 19, the overall changes in volume are: 1998 to 2003 213,000 m<sup>3</sup> of scour, 2003 to 2006 60,000 m<sup>3</sup> of scour.

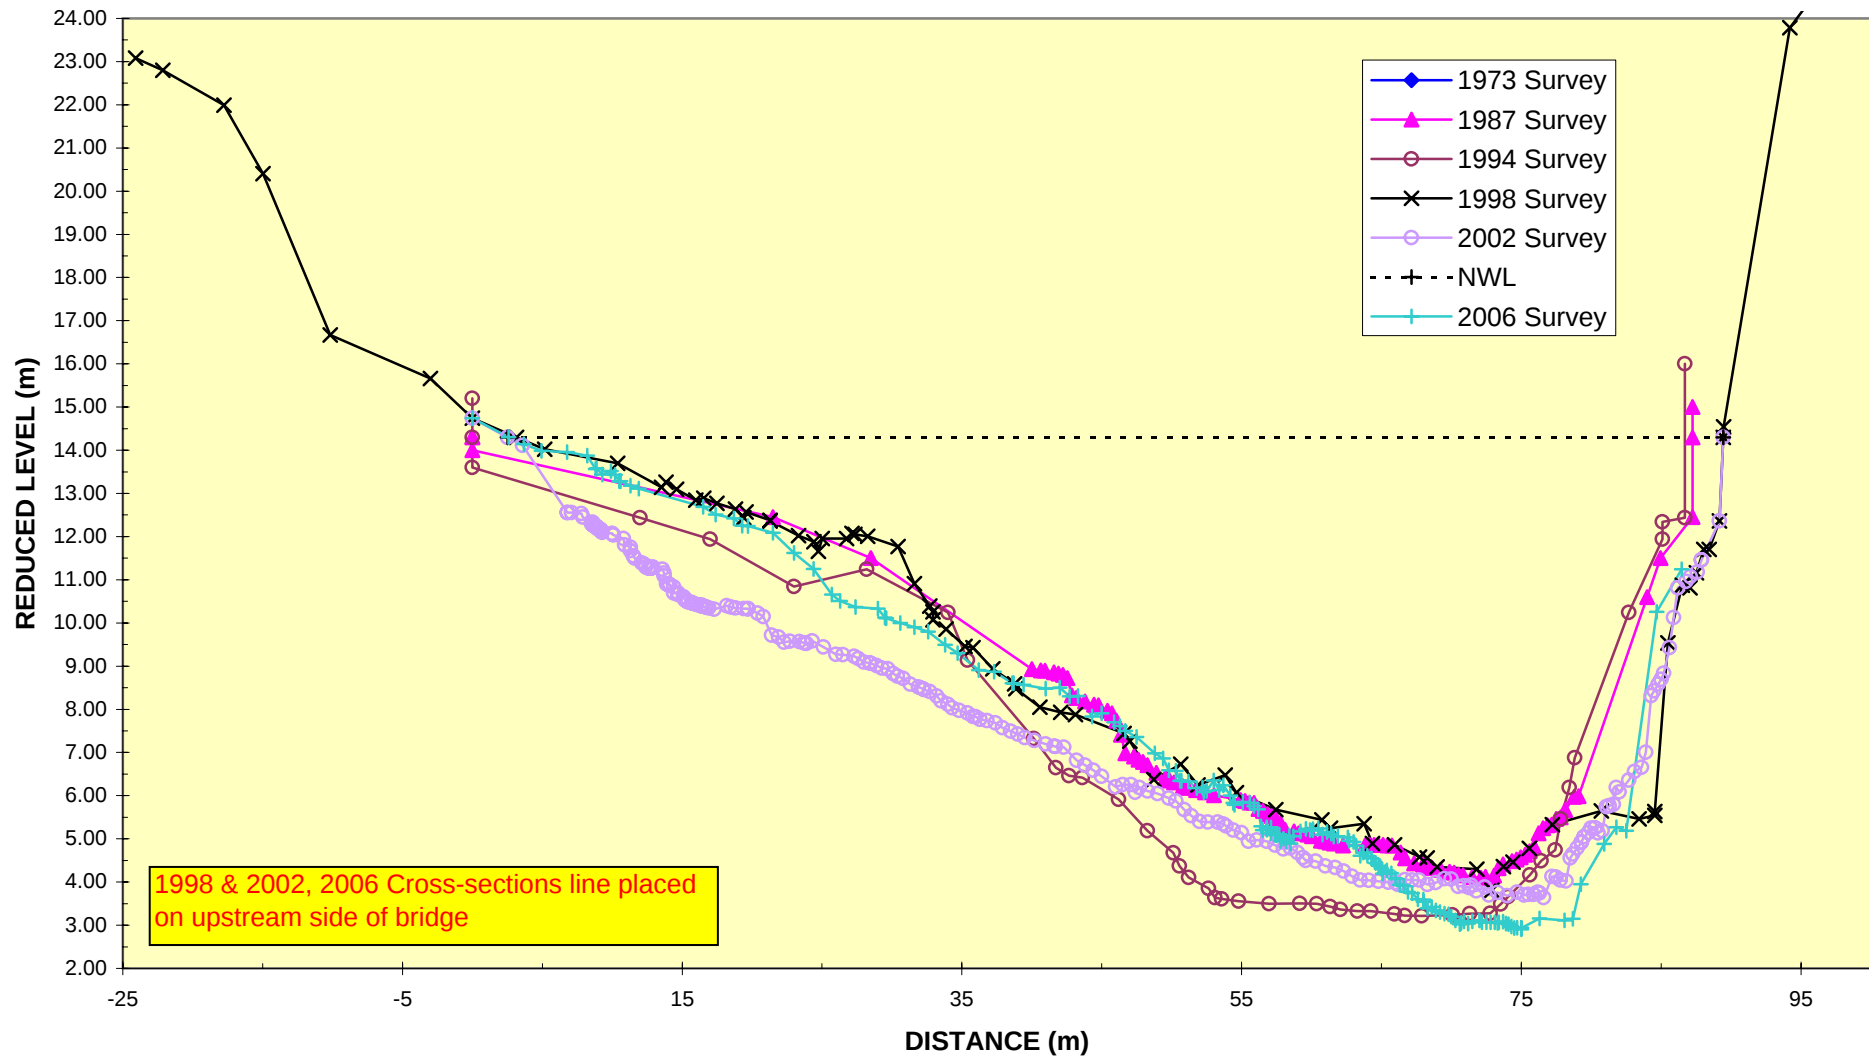
**ENVIRONMENT WAIKATO**  
**WAIKATO RIVER : CROSSECTION 153**  
**Cobham Bridge**

From 1998 to 2002/03 there was little change in the thalweg character. From 2002/03 to 2006 the thalweg became noticeably more pronounced at cross-sections 141A (just upstream of the Hamilton wastewater outlet), 153 (Cobham Bridge) and 161B (upstream of the Narrows). As found for mean bed level, the thalweg level has continued to fall significantly in the vicinity of Horotiu (cross-sections 136 and 137).
