# WAIKATO RIVER

## 2006 SURVEY REPORT

KARAPIRO DAM TO  
NGARUAWAHIA

Prepared for:  
MIGHTY RIVER POWER  
PO BOX 445  
HAMILTON.  
DECEMBER 2006

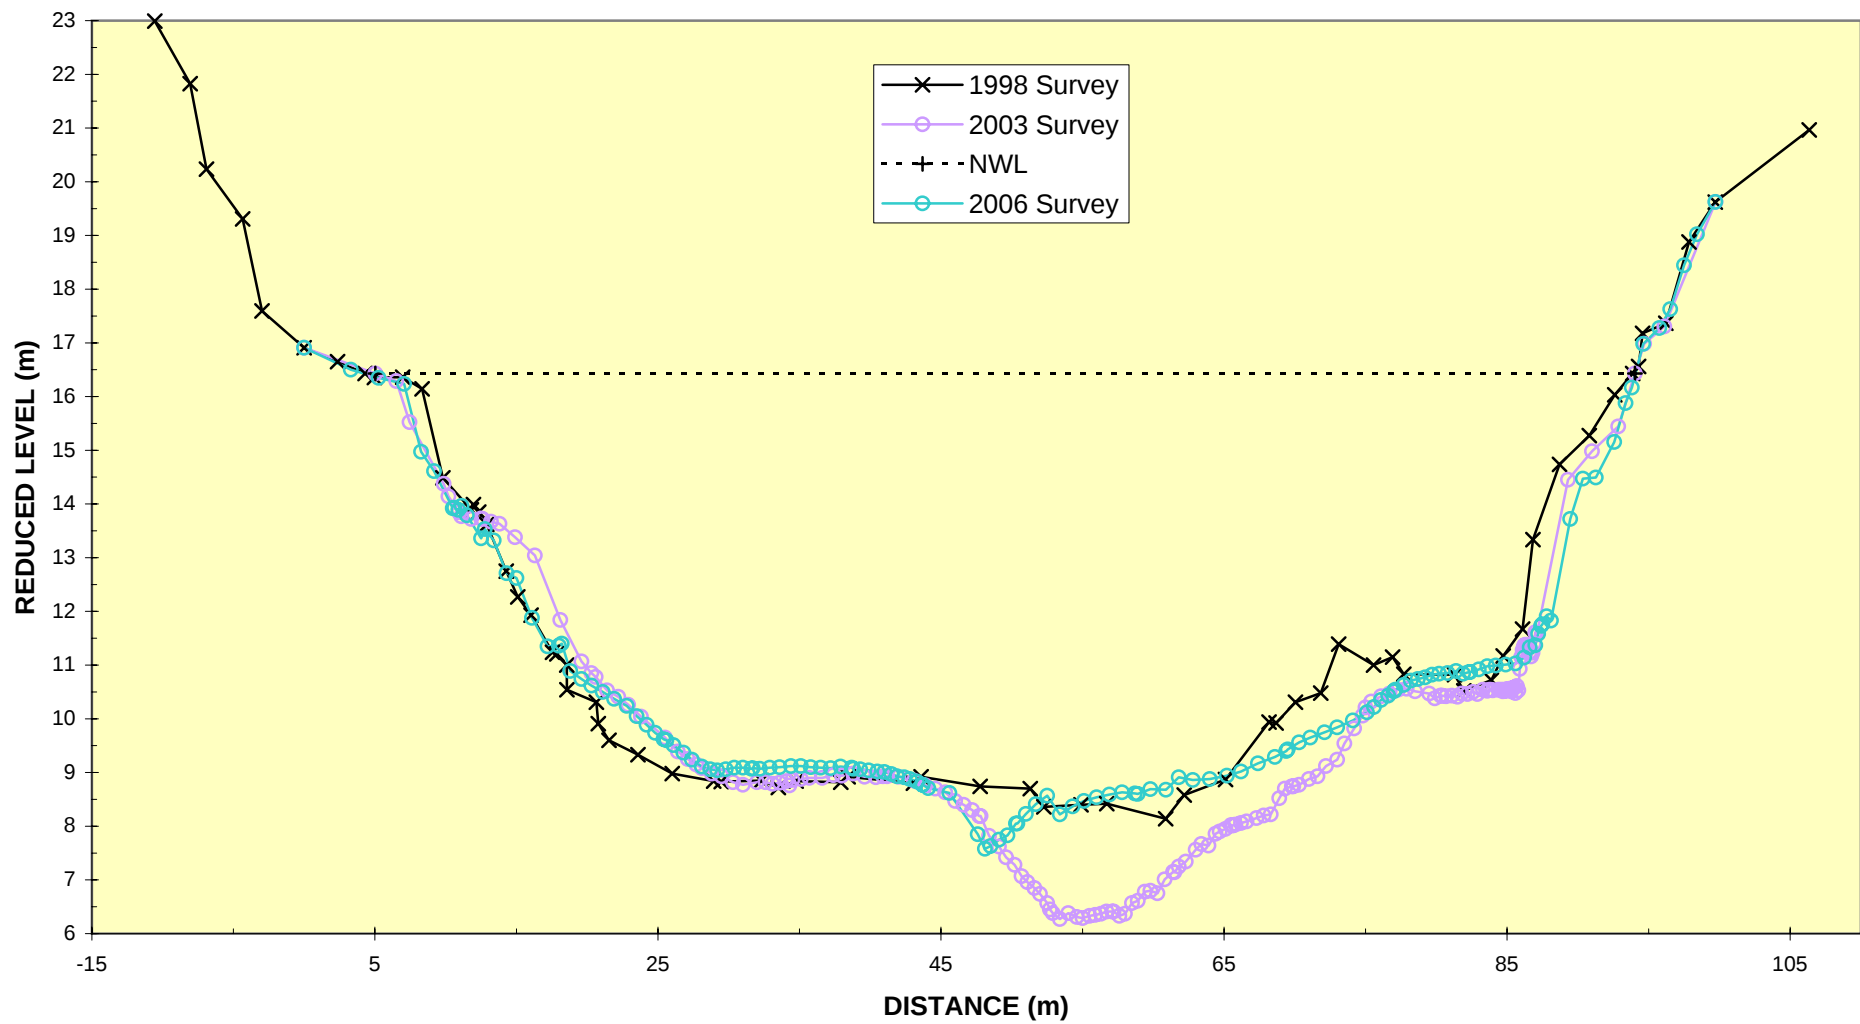
## WAIKATO RIVER : CROSSECTION 161A

There have been no recent major changes in mean bed level at sections between Karapiro and the Narrows. Between the 2003 survey and the 2006 survey mean bed level degraded at cross-sections 170 ( 0.5 m ) and 164 ( 0.4 m ). Cross-section 161A aggraded by 0.4 m.

In the Karapiro to Narrows reaches there was a markedly lower degradation rate between 2003 and 2006 than occurred between 1998 and 2003. Cross-section 161A was the most volatile having scoured in the 1998 to 2003 period and re-filled from 2003 to 2006. Several other cross-sections in this part of the river show similar behaviour but to a lesser extent.

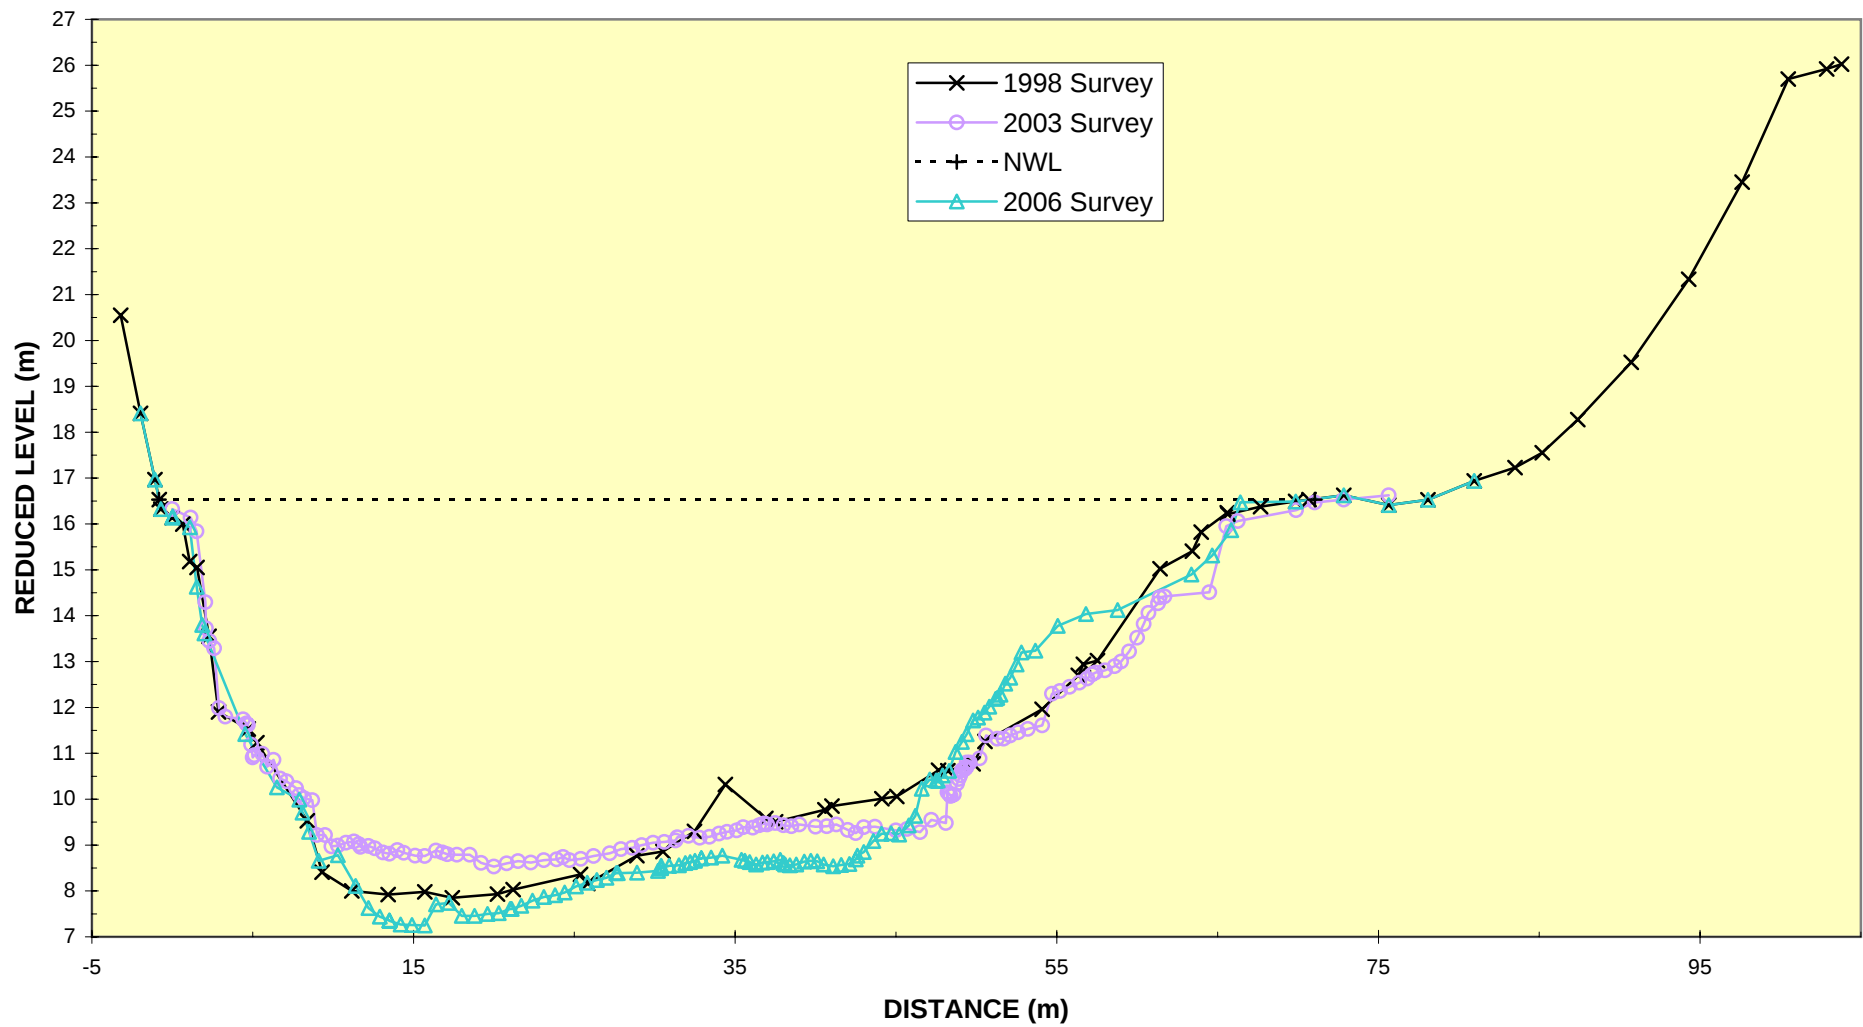
## WAIKATO RIVER : CROSSECTION 161B

From 1998 to 2002/03 there was little change in the thalweg character. From 2002/03 to 2006 the thalweg became noticeably more pronounced at cross-sections 141A (just upstream of the Hamilton wastewater outlet), 153 (Cobham Bridge) and 161B (upstream of the Narrows). As found for mean bed level, the thalweg level has continued to fall significantly in the vicinity of Horotiu (cross-sections 136 and 137).
