*Middle Waikato Bed Degradation  
Investigation Stages III & IV.*

*Contract number: AM2004/5-30*

**Proposed Middle Waikato River  
Bed Degradation Management  
Strategy - Appendices**

Mid-Waikato Bed Degradation Investigation Stages III and IV  
River Bank and Infrastructure Condition Photographs - May 2005

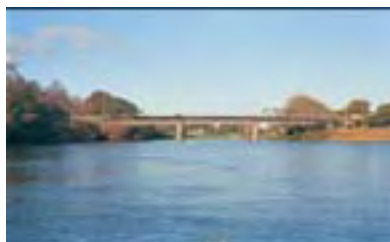
km 95.7a

| Distance from river mouth, km | Projected 100 years bed degradation, m | Beca waypoint/ cross-section No. | Photos | Bank | Feature | Land/ Property/ Infrastructure | Subjective risk assessment | Comments and Options to address bed degradation |
|---|---|---|---|---|---|---|---|---|
| 95.7 | 3.7 | | Yes | | NIMT Railway Bridge 267 and SH1 Road Bridge, Ngaruawahia | Infrastructure | Severe | Two piers in river, two piers close to top of bank. Review record drawings for impact of any bed degradation. |

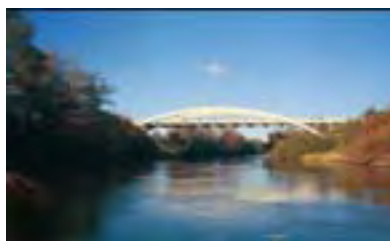
km 102.5

| Distance from river mouth, km | Projected 100 years bed degradation, m | Beca waypoint/ cross-section No. | Photos | Bank | Feature | Land/ Property/ Infrastructure | Subjective risk assessment | Comments and Options to address bed degradation |
|---|---|---|---|---|---|---|---|---|
| 102.5 | 3.4 | CS82 | Yes | | Horotiu Road Bridge | Infrastructure | Slight | Arch springs from foundations set back from river edge |

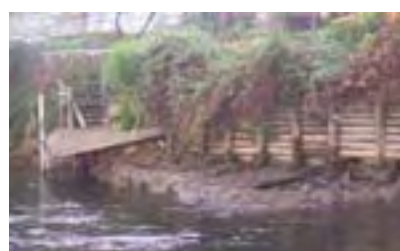
km 110.4aR

| Distance from river mouth, km | Projected 100 years bed degradation, m | Beca waypoint/ cross-section No. | Photos | Bank | Feature | Land/ Property/ Infrastructure | Subjective risk assessment | Comments and Options to address bed degradation |
|---|---|---|---|---|---|---|---|---|
| 110.4 | 3.1 | WP162 | Yes | R | Timber retaining wall and landing | Property | Moderate | Landing has failed. Timber retaining wall scheduled to be replaced by sheet pile wall in near future. |

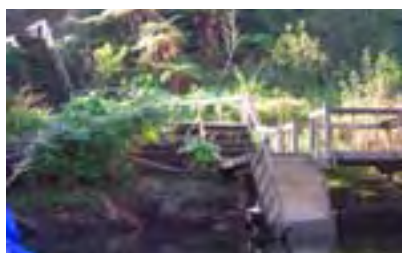
km 110.8R

| Distance from river mouth, km | Projected 100 years bed degradation, m | Beca waypoint/ cross-section No. | Photos | Bank | Feature | Land/ Property/ Infrastructure | Subjective risk assessment | Comments and Options to address bed degradation |
|---|---|---|---|---|---|---|---|---|
| 110.8 | 3.0 | WP169 | Yes | R | Private landing | Property | Moderate | Steps failing, would need extending. |

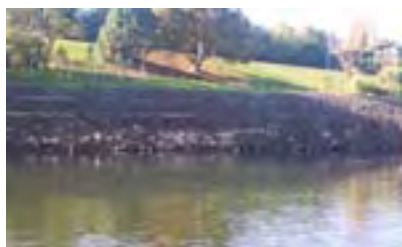
km 111.1R

| Distance from river mouth, km | Projected 100 years bed degradation, m | Beca waypoint/ cross-section No. | Photos | Bank | Feature | Land/ Property/ Infrastructure | Subjective risk assessment | Comments and Options to address bed degradation |
|---|---|---|---|---|---|---|---|---|
| 111.1 | 3.0 | WP171 | Yes | R | 30-m long riprap revetment, with concrete steps to above water level | Property | Moderate | Riprap will need top-up, and steps extending as river degrades. |

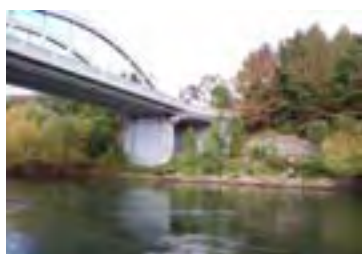
km 113.5bL

| Distance from river mouth, km | Projected 100 years bed degradation, m | Beca waypoint/ cross-section No. | Photos | Bank | Feature | Land/ Property/ Infrastructure | Subjective risk assessment | Comments and Options to address bed degradation |
|---|---|---|---|---|---|---|---|---|
| 113.5 | 2.9 | CS61 | Yes | | Fairfield Bridge | Infrastructure | Severe | Two piers in river. Review record drawings for impact of bed degradation |

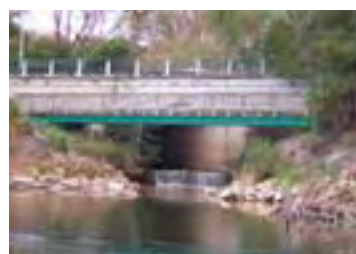
km 113.6L

| Distance from river mouth, km | Projected 100 years bed degradation, m | Beca waypoint/ cross-section No. | Photos | Bank | Feature | Land/ Property/ Infrastructure | Subjective risk assessment | Comments and Options to address bed degradation |
|---|---|---|---|---|---|---|---|---|
| 113.6 | 2.9 | WP195 | Yes | L | Waitawhiriwhiri Stream outfall under Victoria Street | Infrastructure | Moderate | Review record drawings for impact of bed degradation. Will need more riprap for scour protection. |
