Estuarine vegetation survey : Whangapoua Harbour

Estuarine Vegetation Survey Whangapoua Harbour

Estuarine Vegetation Survey – Whangapoua Harbour, June 2010

Natural Solutions Contract Report 10/095

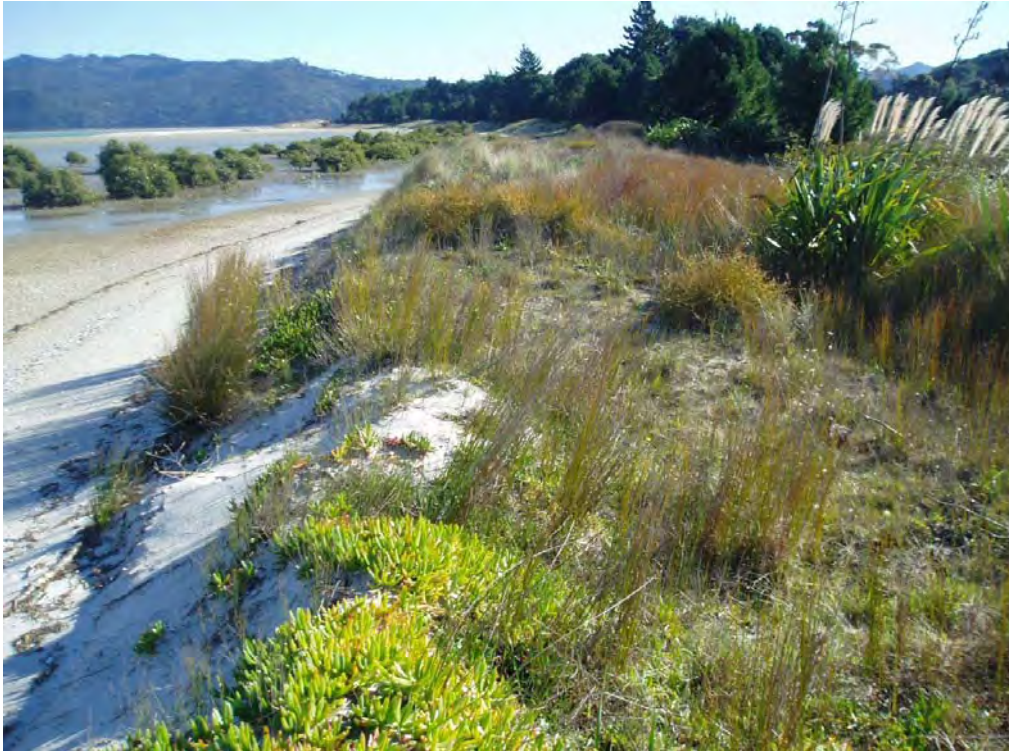
Figure 2: This is the seaward extent of mangroves at Matarangi Spit. On the exposed chenier ridge in the foreground is the golden sand coprosma (mid-picture).

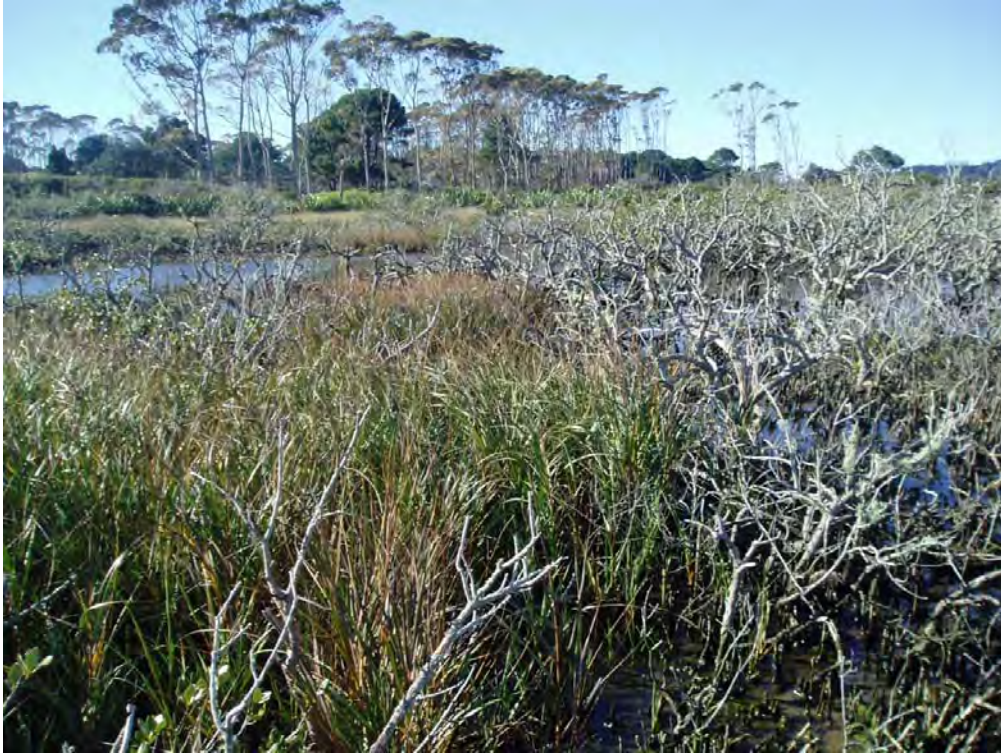
Figure 4: A few patches of healthy spartina occur within the dead mangrove zone.

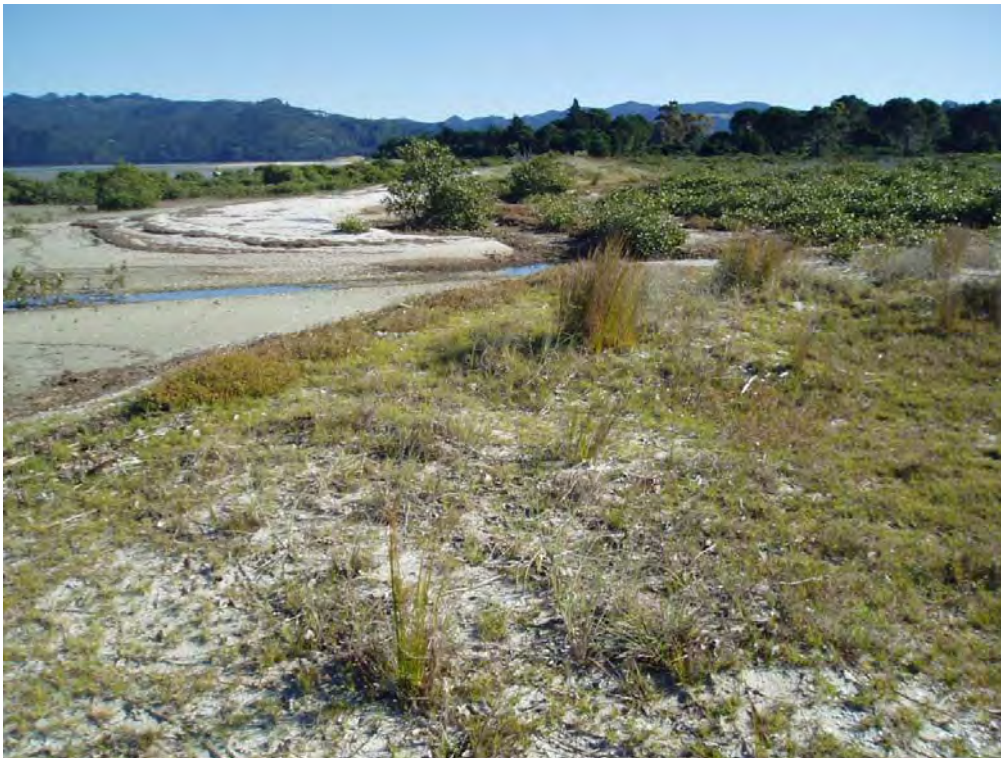
Figure 5: Mangroves seaward and landward of the Matarangi chenier ridge complex. Saltwater paspalum is mixed with glasswort, sea primrose and coast spear grass in the foreground on the lee side of the chenier.

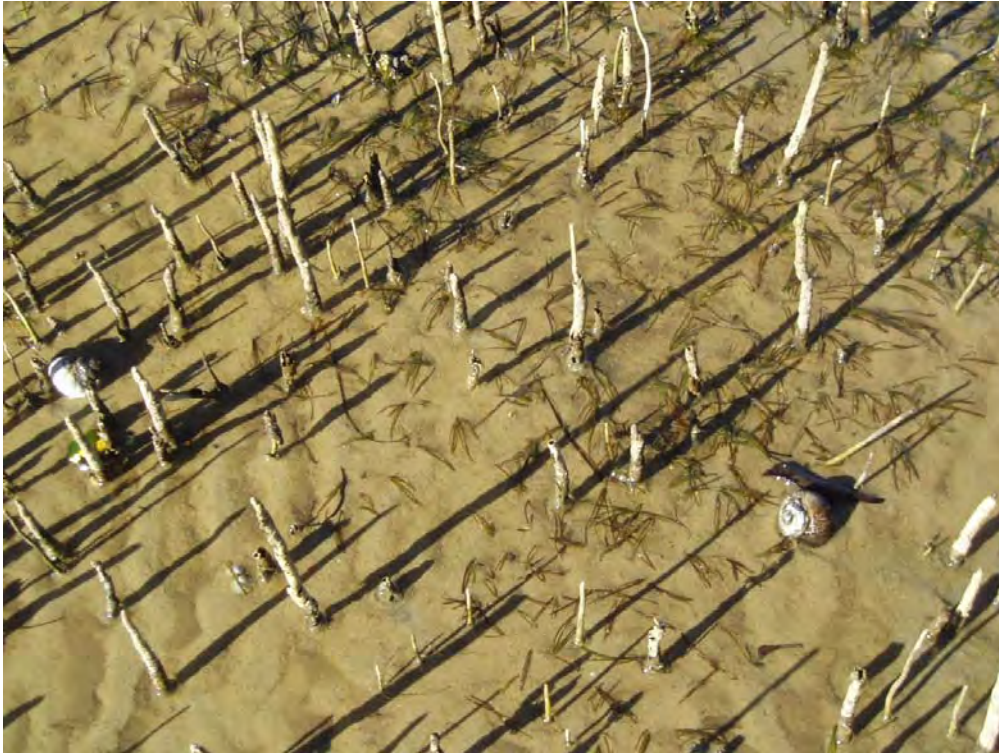
Figure 6: A few very large cats eye snails (30-45mm wide) and some sparse seagrass were found amongst mangrove pneumatophores.

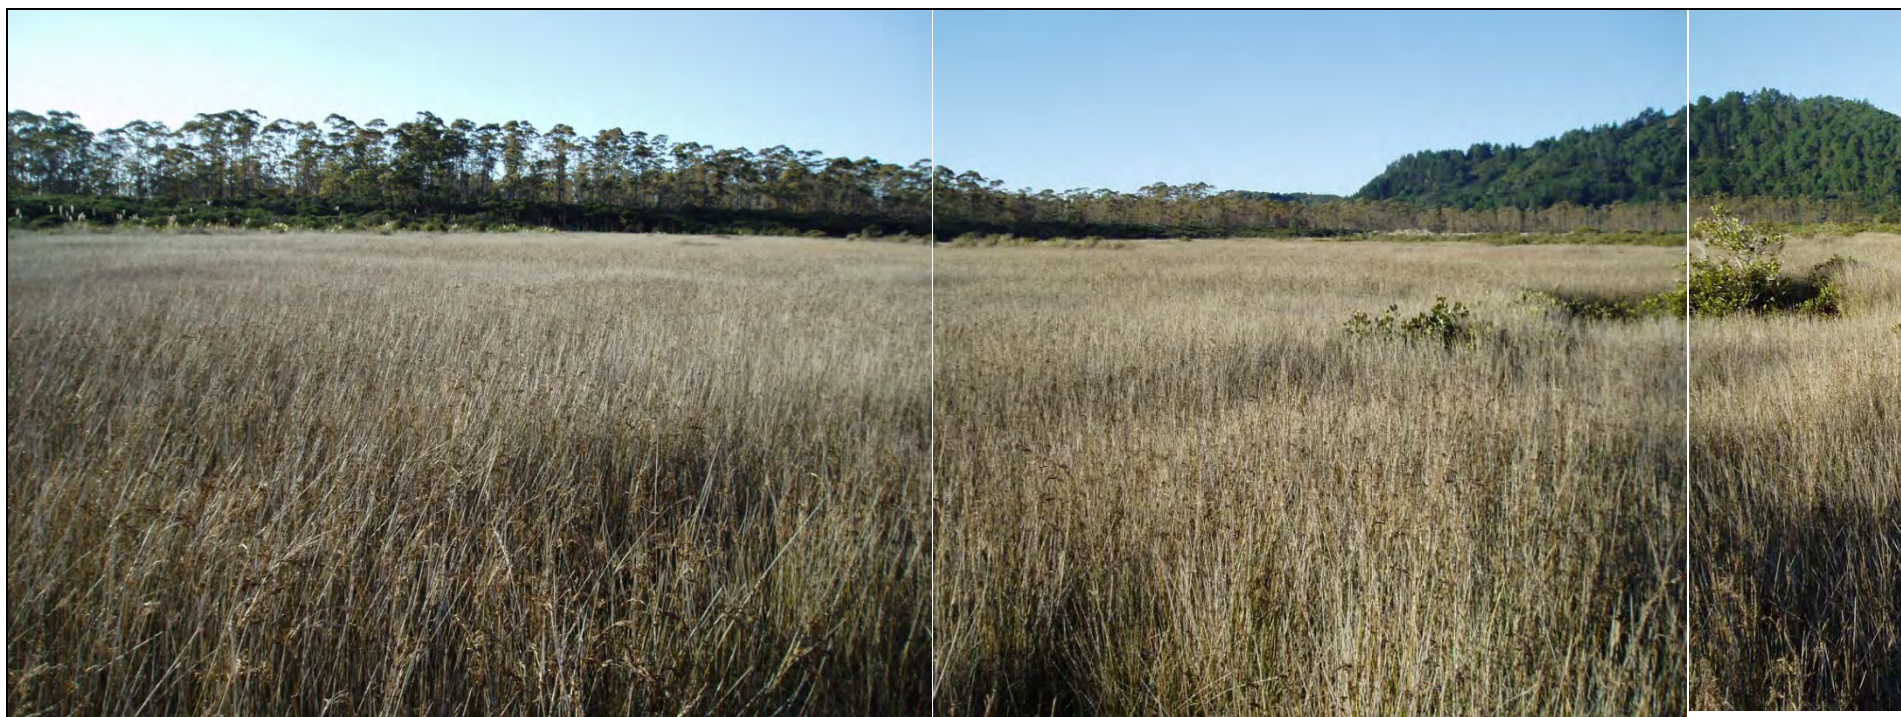
Figure 10: A wide sea rush band extends from the mangroves (RHS) inland to the manuka edge. The eucalypt trees are an un-natural canopy to an otherwise intact and highly significant coastal freshwater wetland remnant.

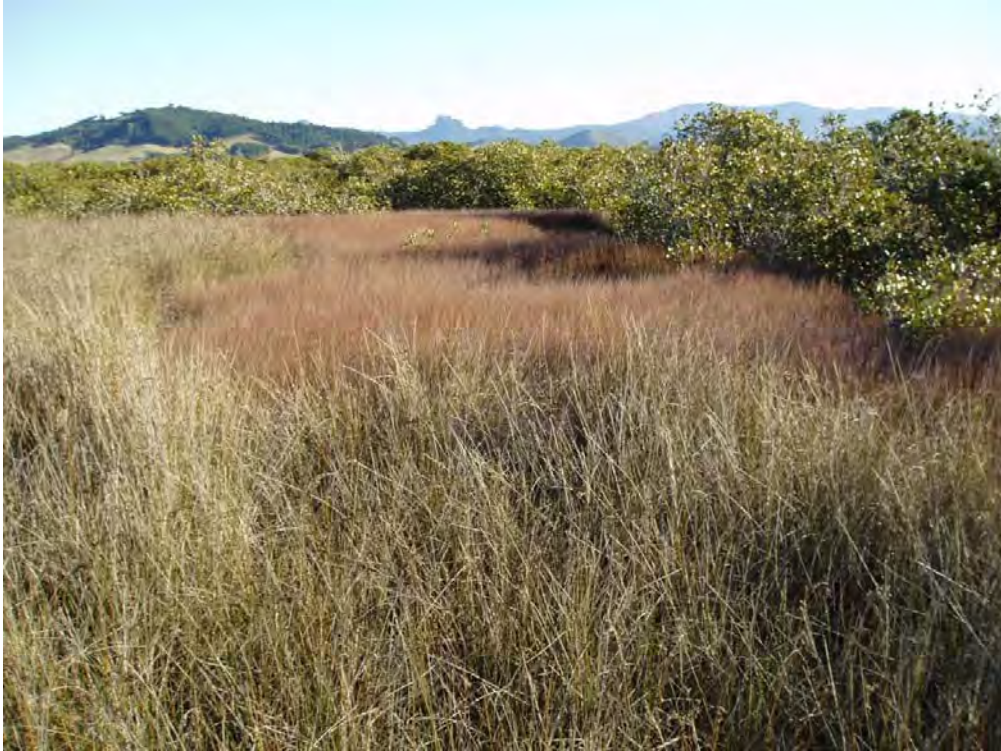
Figure 11: Short (young) oioi is common at the sea rush-mangrove interface of the Matarangi side of the Mapauriki arm.

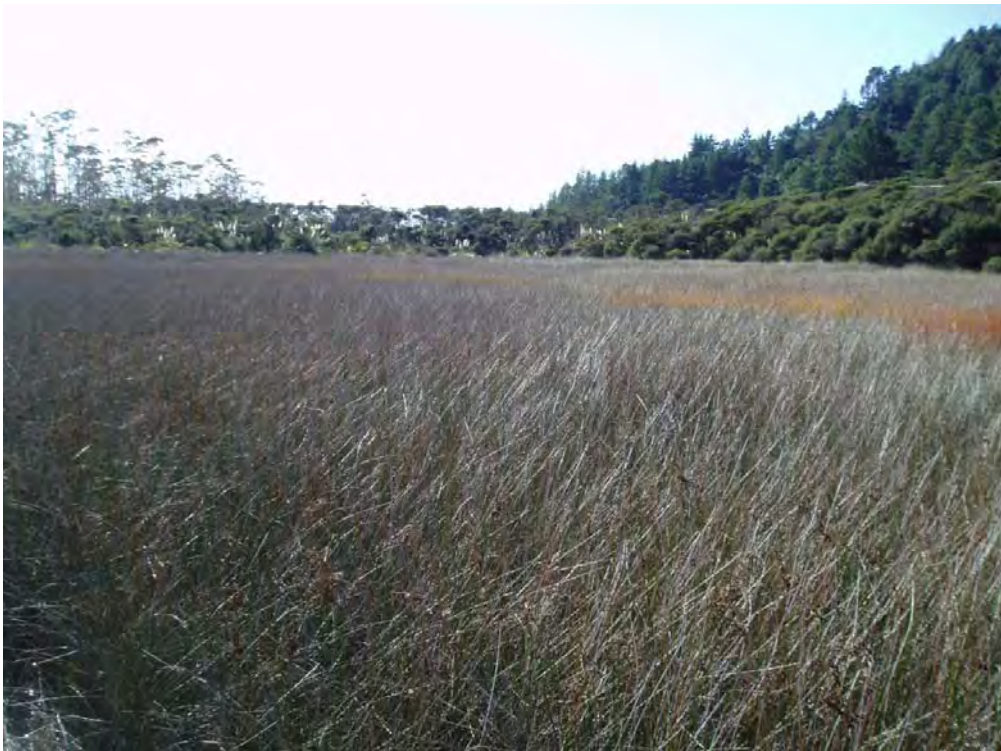
Figure 12: A wide oioi and searush band behind mangroves along the Mapauriki Channel. Manuka with flax and pampas border the rush/sedgeland.

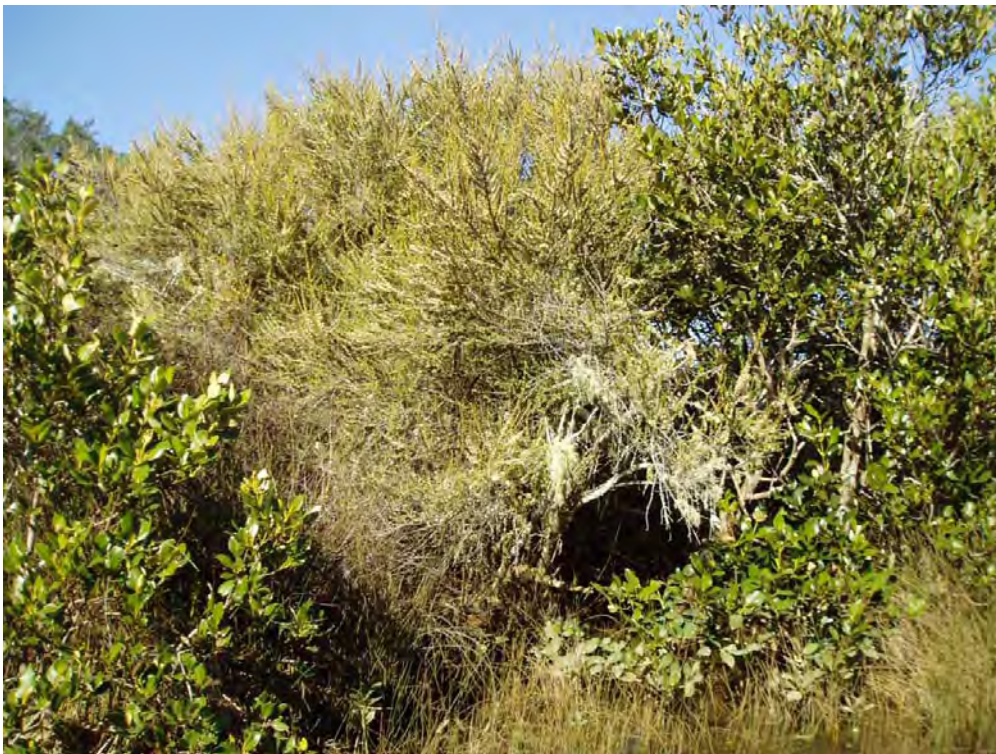
Figure 14: An uncommon large coastal daisy (*Olearia solandri*) amongst mangroves and saltmarsh ribbonwood lining the Mapauriki Stream.

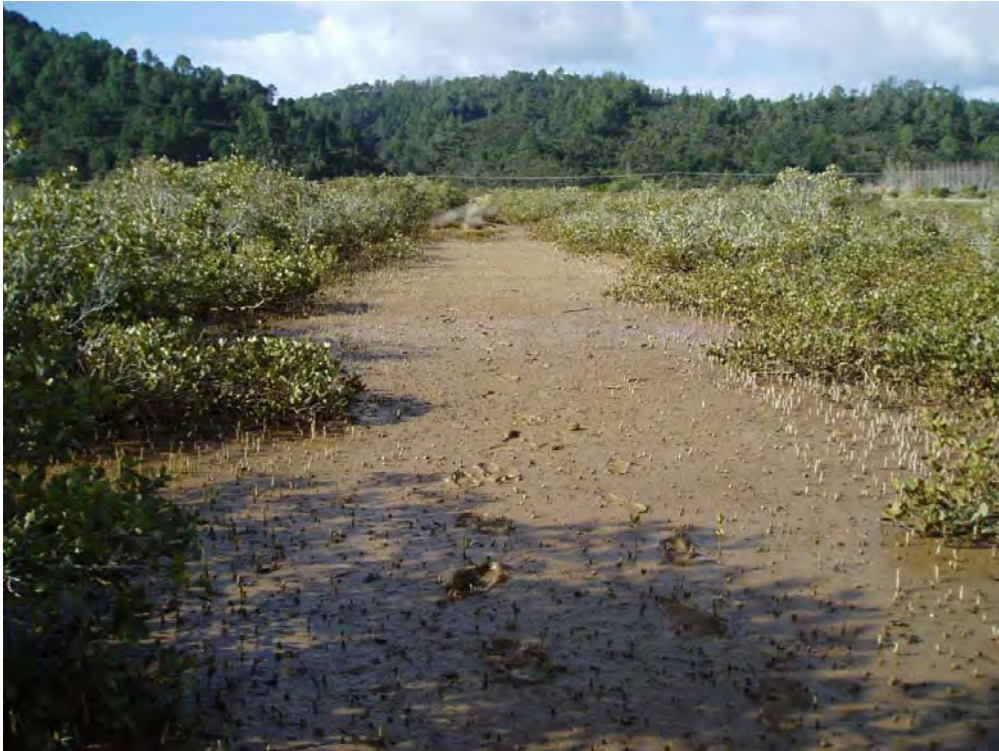
Figure 15: This bare area indicates the remnant line of an old stopbank with patches of higher ground still remaining in places.

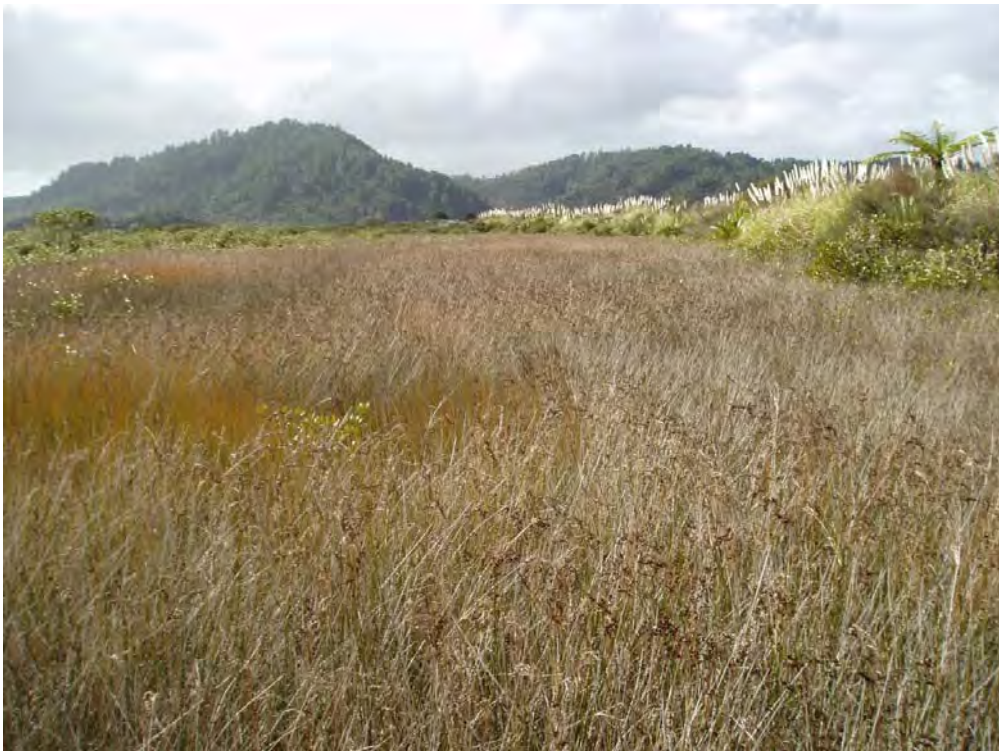
Figure 16: Mangroves grade into a mixed mangrove-rush/sedgeland and then into pure rush/sedgeland. Mangroves also line the edge of the stopbank.

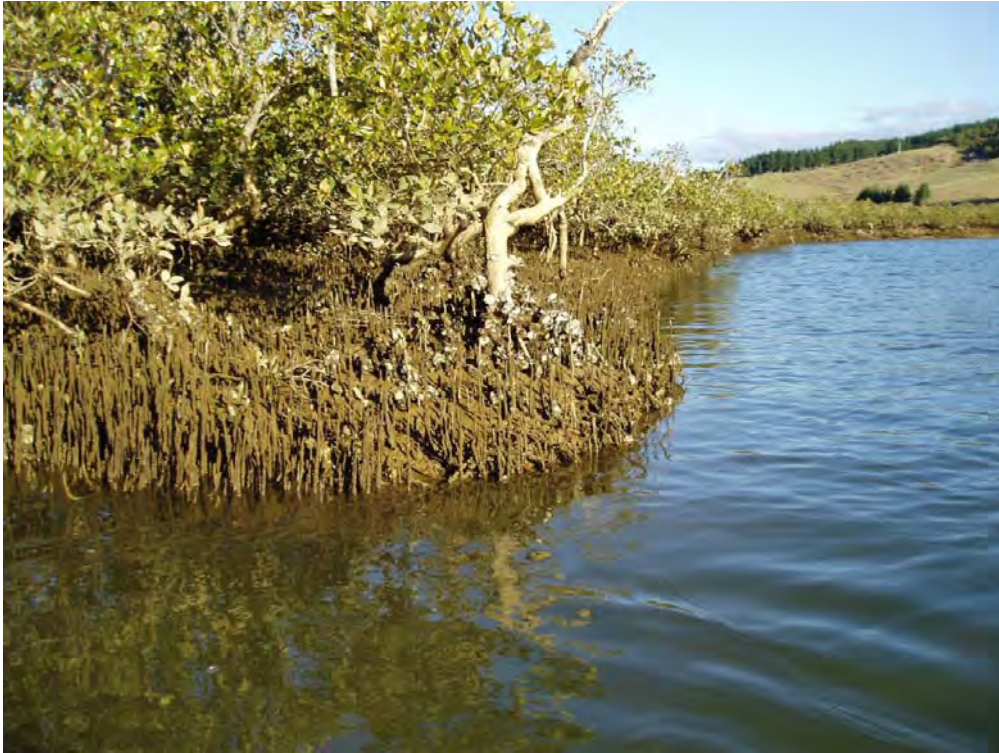
Figure 18: Dense mangrove pneumatophores provide a stable edge to the lower Otanguru Stream channel. Large oysters occur amongst the pneumatophores.

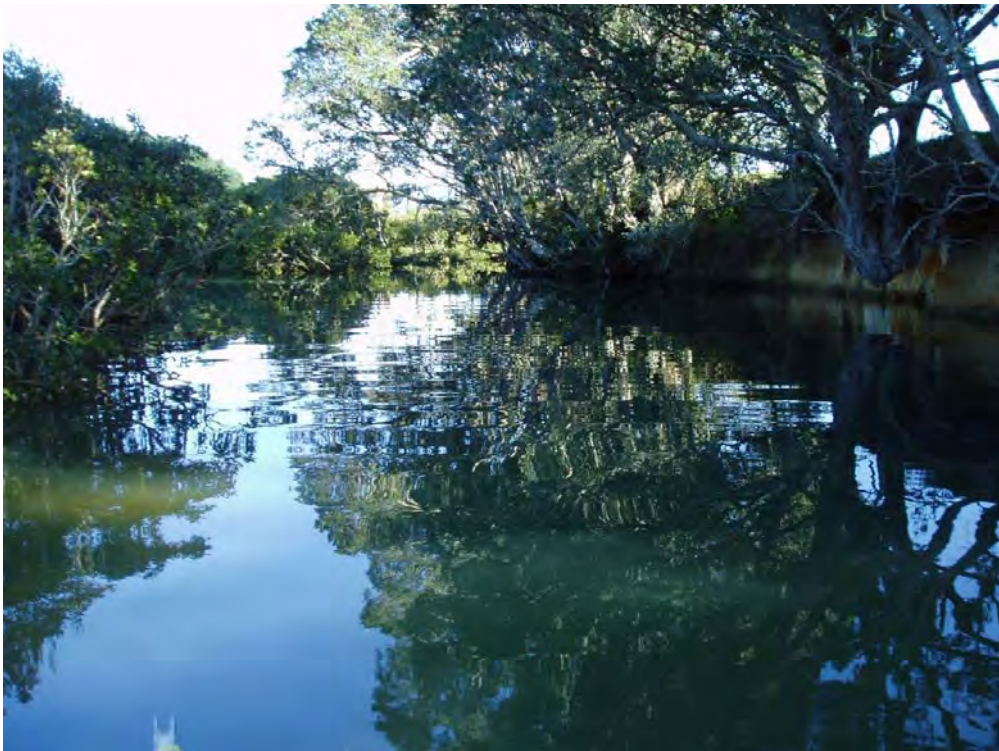
Figure 19: A view looking upstream along the lower Otanguru Stream. Old remnant pohutukawa line the land edge where stock cannot reach them.

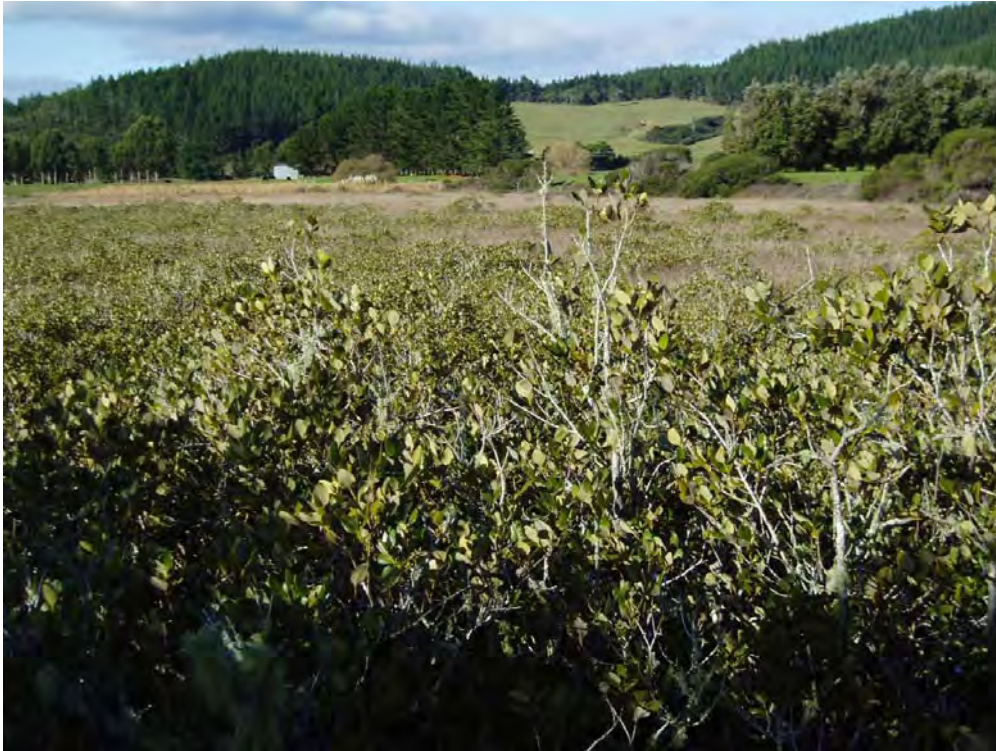
Figure 20: A view from a relict stopbank over a large mangrove-rush/sedgeland embayment, with ribbonwood and manuka along the land edge (RHS) and a raupo swamp (LHS).

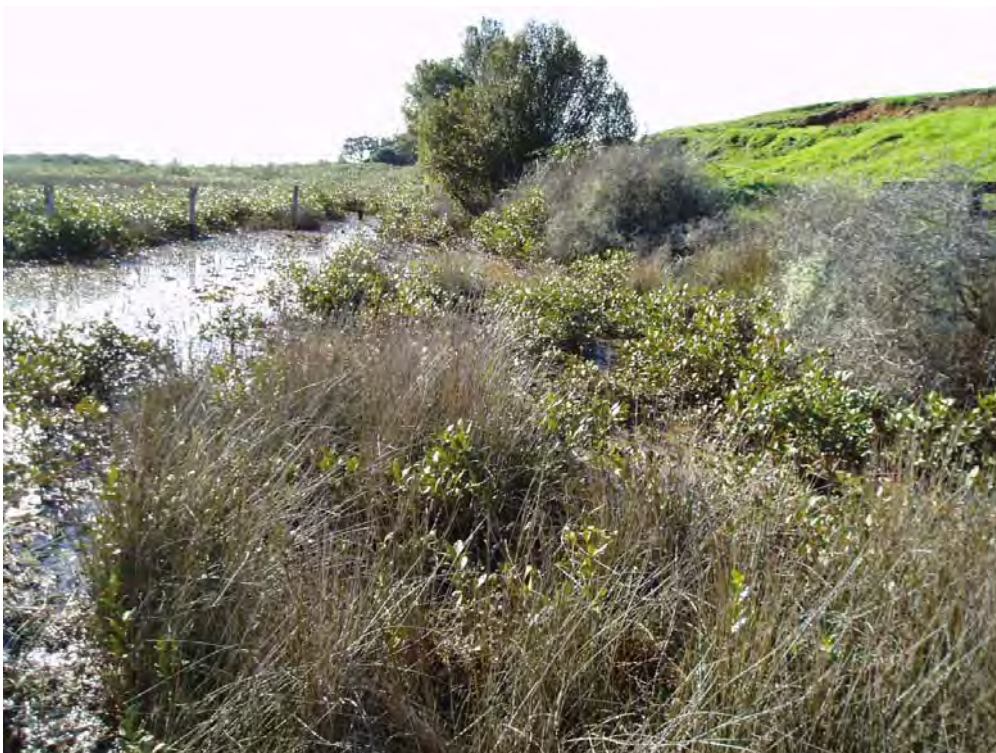
Figure 21: An old fence line in the harbour and a new fence line behind the saltmarsh ribbonwood at the toe of the land.

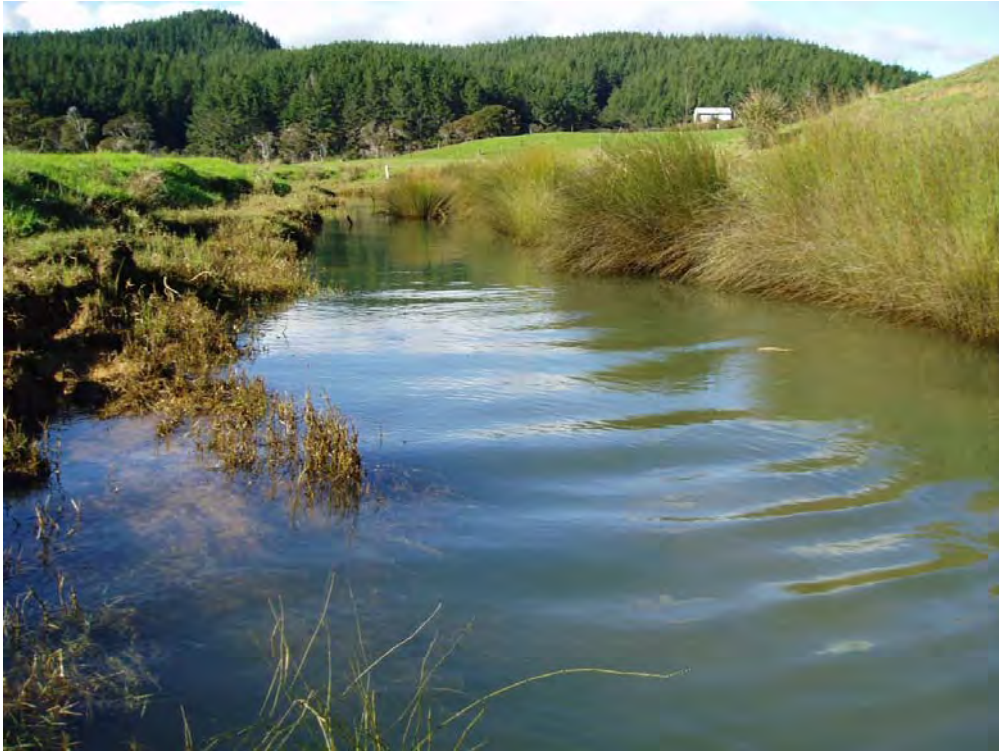
Figure 24: Oioi (TLB) and Mercer grass (TRB) dominate the stream edges at the upper salt limit of the Otanguru Stream. Stock are not fenced from these banks.

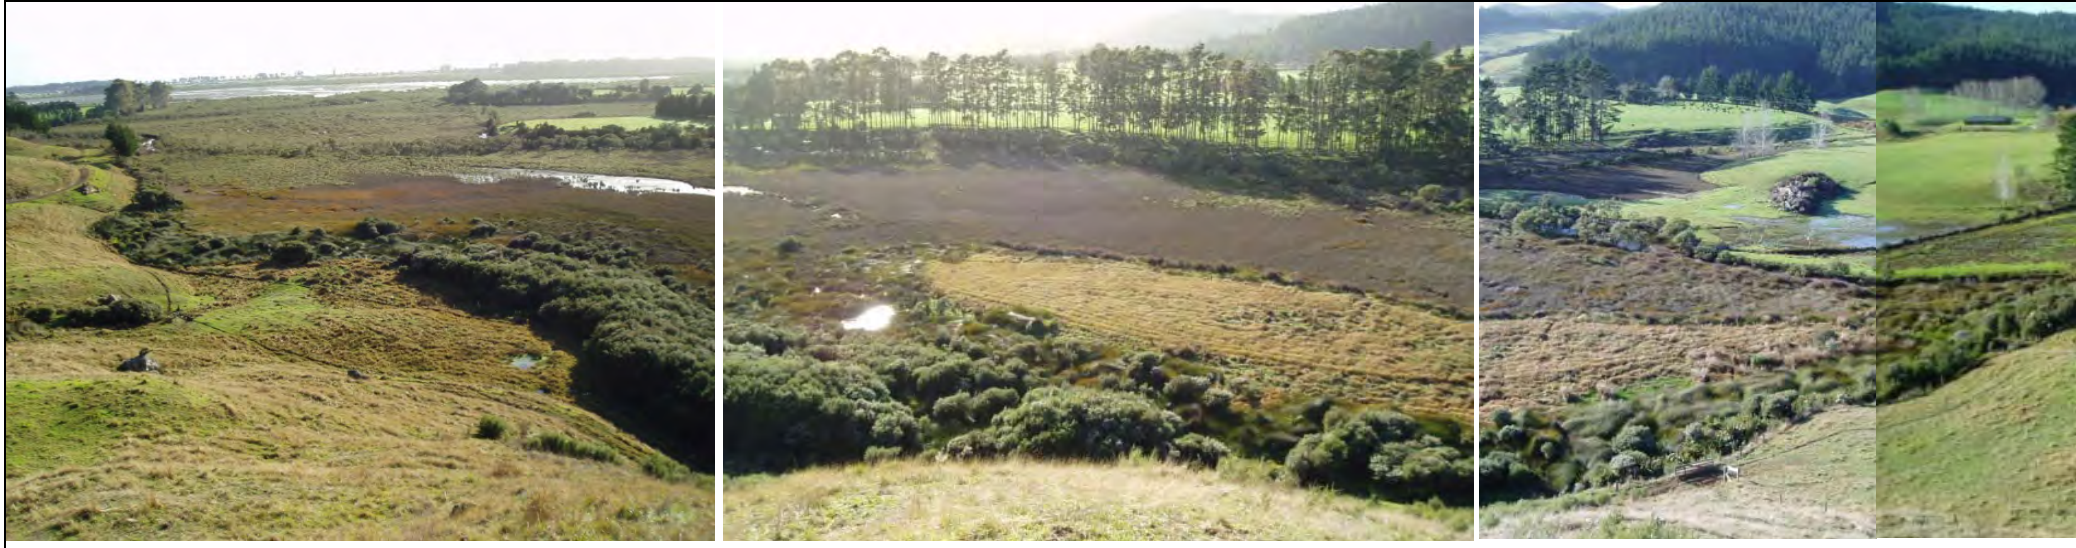
Figure 25: An overview of the Otanguru Stream arm. The estuarine vegetation and riparian edge of the TLB (forefront of photo) is well protected. The island of higher ground in the middle right of the picture with rank grass is soon to be planted with coastal species.

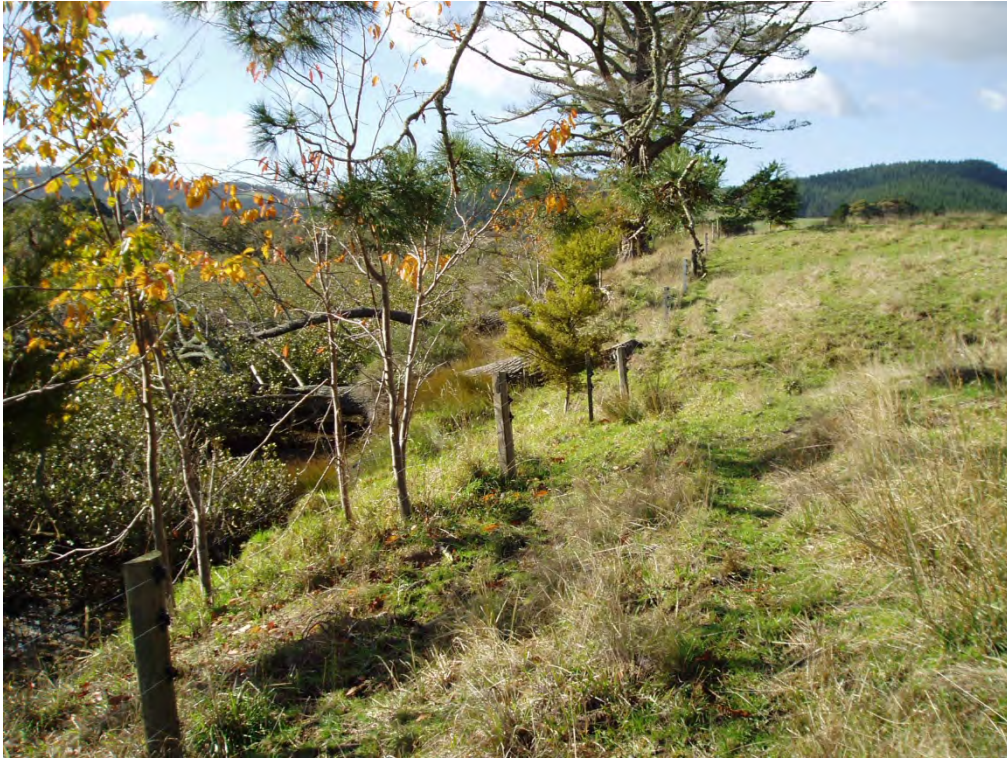
Figure 26: Good stock fencing that restricts stock access to the harbour but also provides enough room for riparian plantings (totara, cabbage tree, flax and exotics are planted here). Manuka is regenerating naturally and the wilding pines have been felled or ringbarked.

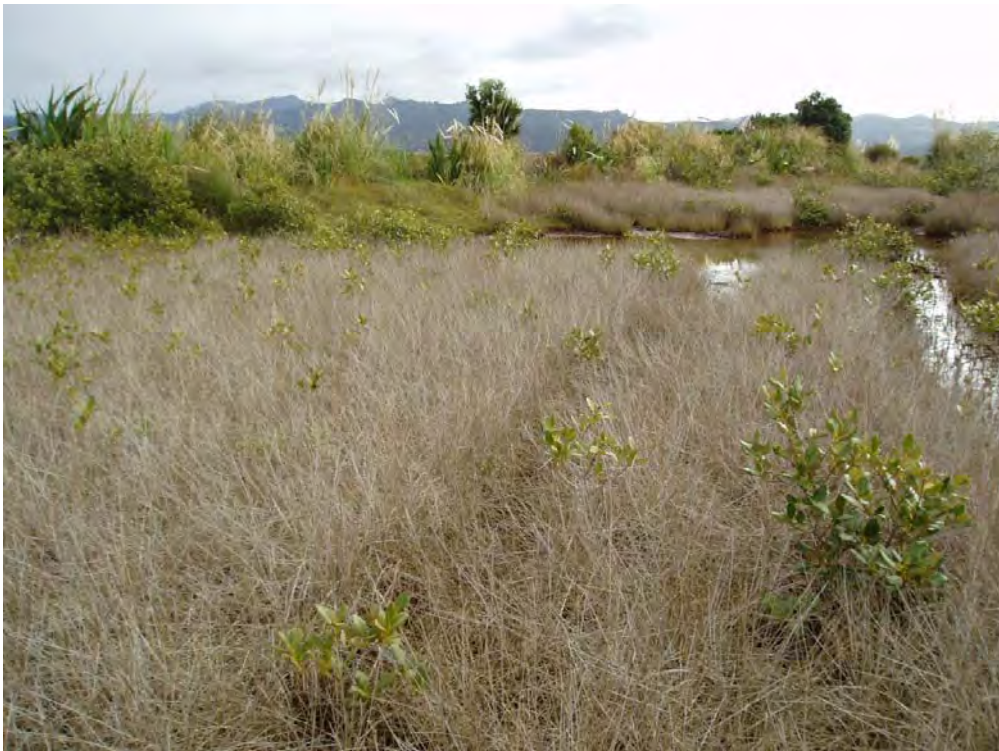
Figure 29: A mixed mangrove/rush zone. Saltwater paspalum occurs along the seaward edge of the stopbank behind an open pool area. A number of these pools beside the stopbank had saltwater paspalum associated with them.

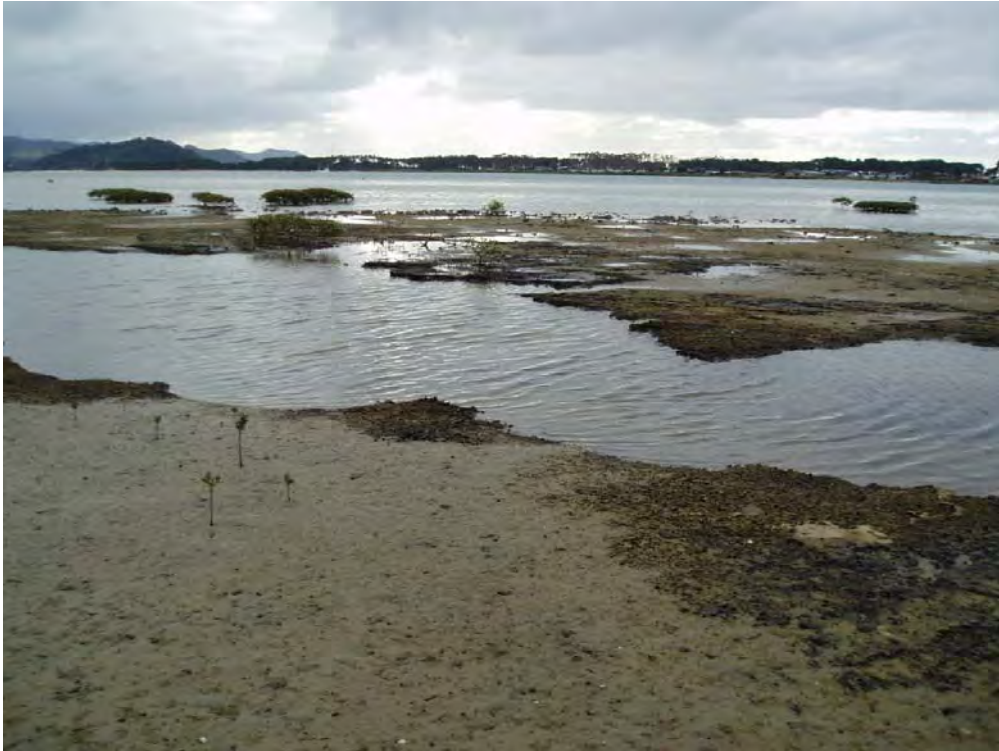
Figure 30: An area with an exposed hard organic bed pan. Very few mangroves have managed to establish due to the lack of a good rooting base and wave exposure. A band of loose oyster clumps occur out at the water's edge.

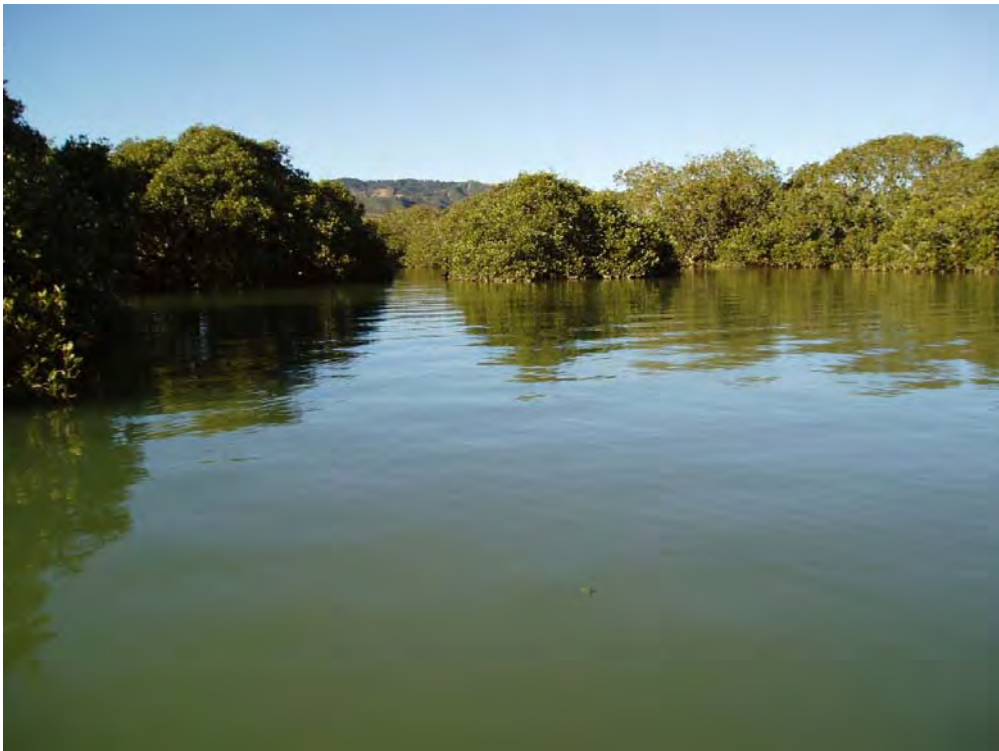
Figure 33: Tall mangroves (varying from 4-6m tall) form islands and winding channels along the TRB of the Oweria River mouth.

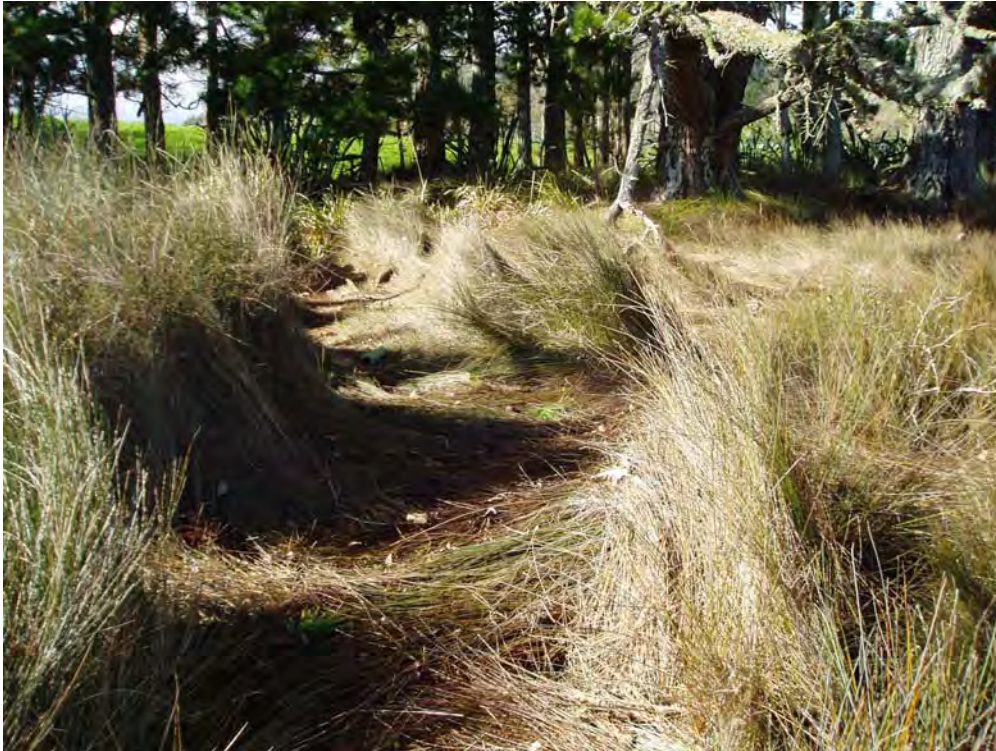
Figure 34: This fenced coastal edge with pines, flax, *Baumea juncea* and giant umbrella sedge must have a gap in it as evidenced by the extensive stock tracking, grazing and dung along the coastal edge here.

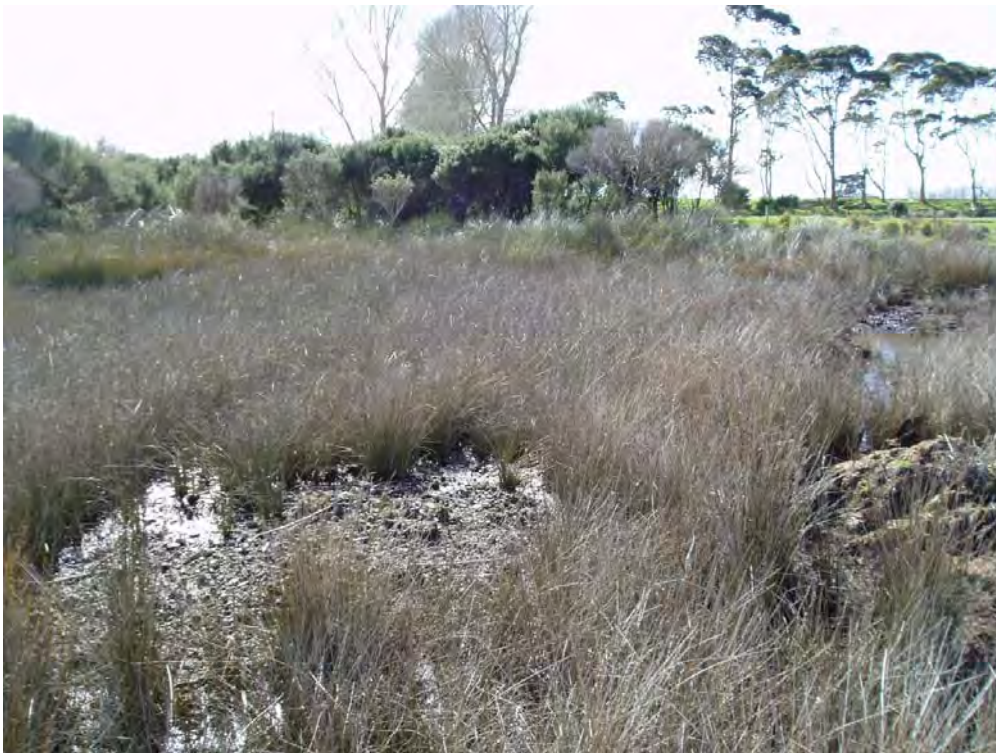
Figure 35: A remnant natural coastal riparian edge beside an area of infill (grassy edge) and earthworks within the rush/sedgeland.

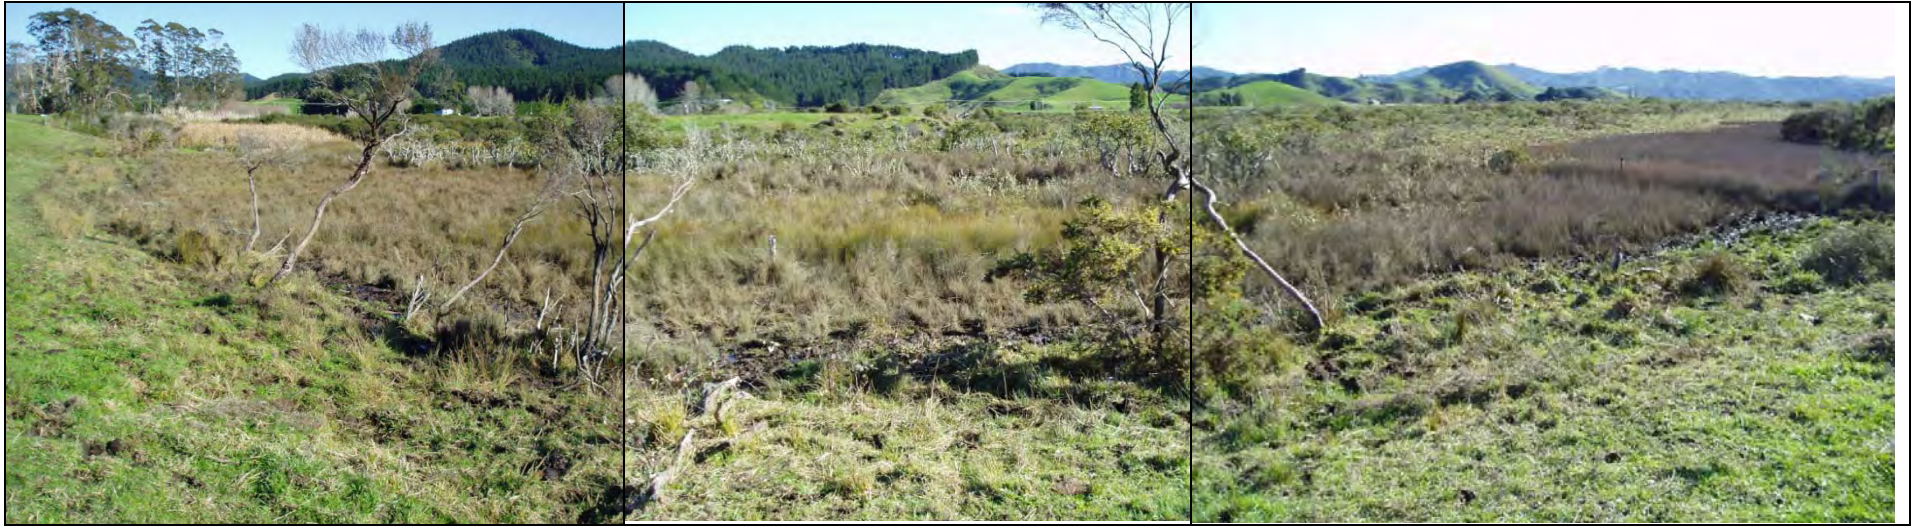
Figure 41: Unfenced estuarine wetland grading into a freshwater raupo/manuka wetland at head of this arm.

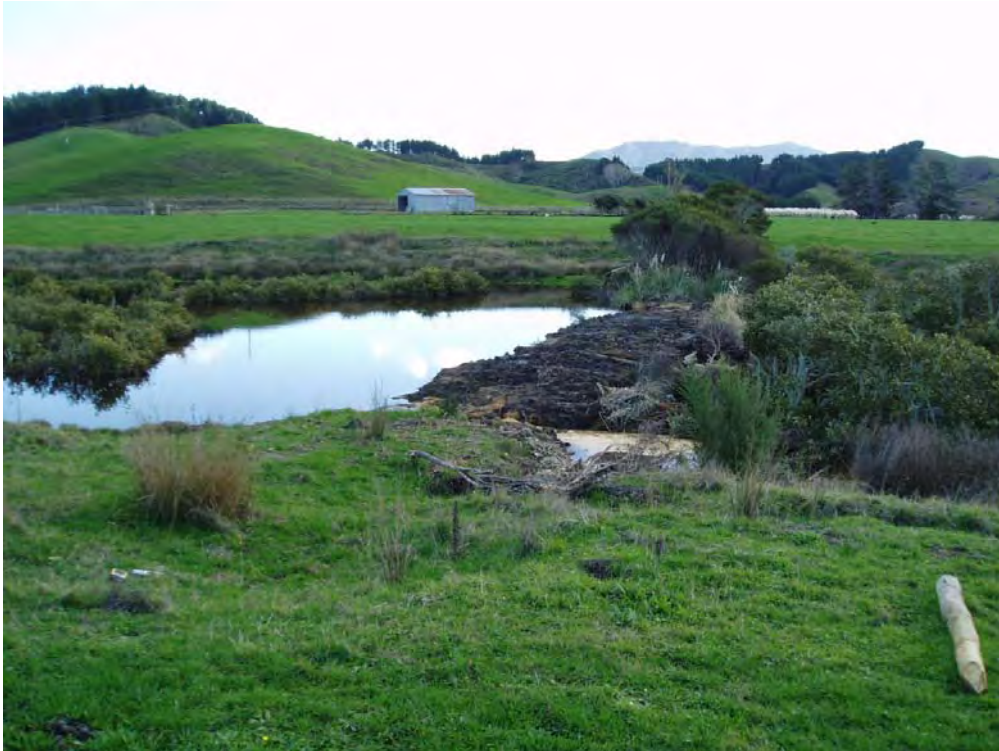
Figure 42: An earth dam prevents the natural flow of salt water upstream.

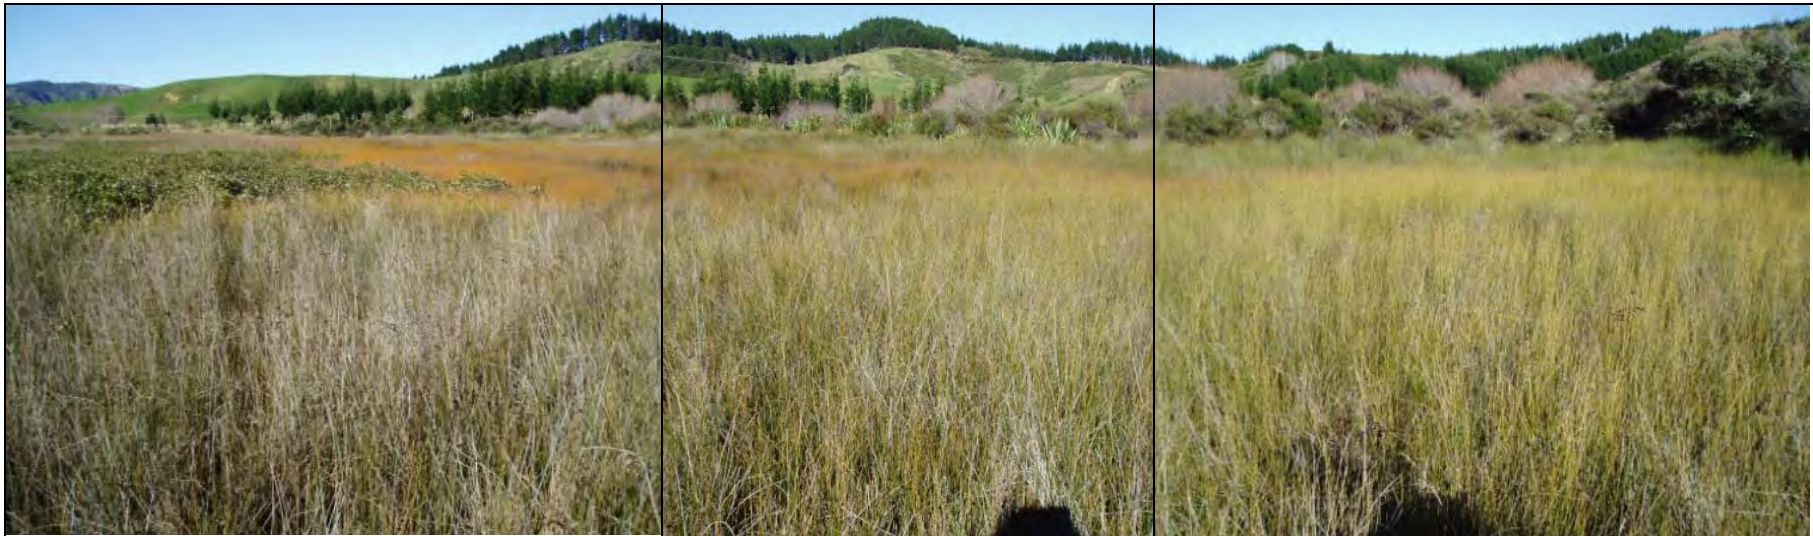
Figure 44: A view over a natural sequence of mangroves – sea rush and oioi –freshwater wetland (manuka, flax, *Baumea spp.* and raupo). The only unnatural feature in this locally uncommon sequence is the willow invading the freshwater wetland.

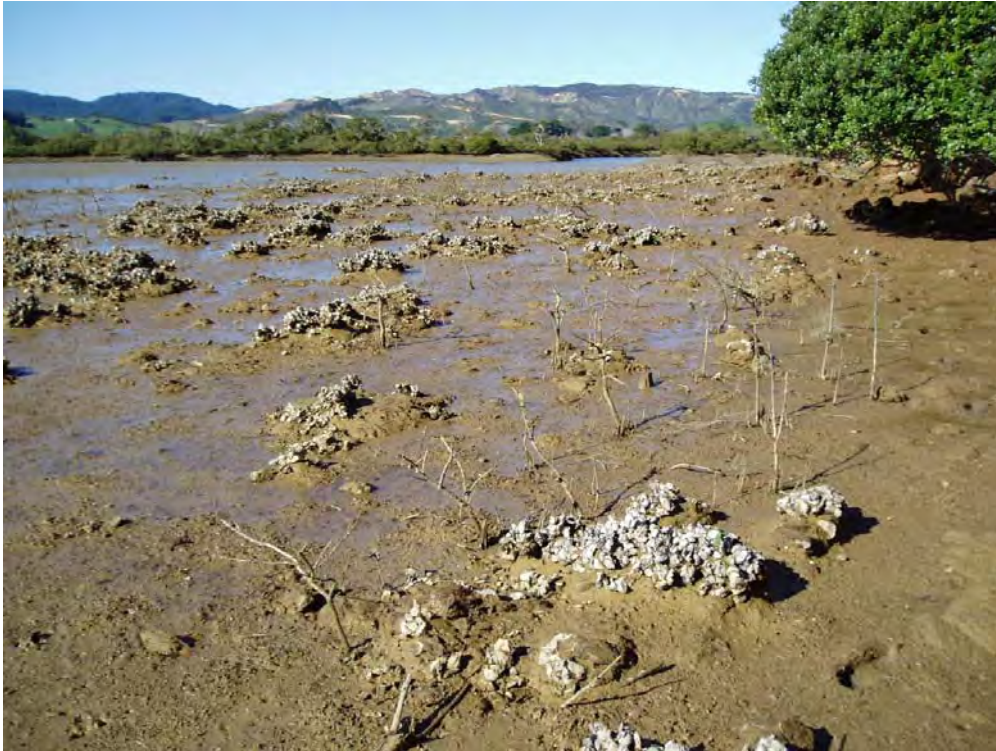
Figure 47: Mangroves stripped where stock have access to the harbour. Areas of exposed bed rock are often covered with oysters.

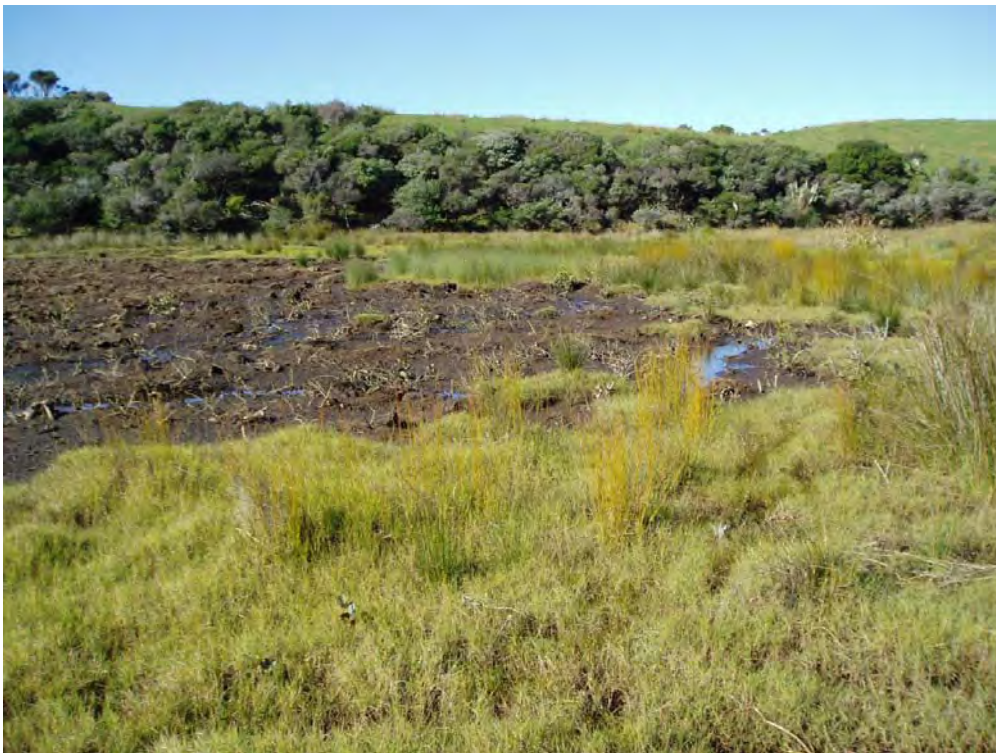
Figure 48: A 'ploughed' area with grazed mangroves, saltwater paspalum, sea rush and oioi grading into a freshwater wetland.
