Estuarine vegetation survey : Whangapoua Harbour

Estuarine Vegetation Survey Whangapoua Harbour

Estuarine Vegetation Survey – Whangapoua Harbour, June 2010

Natural Solutions Contract Report 10/095

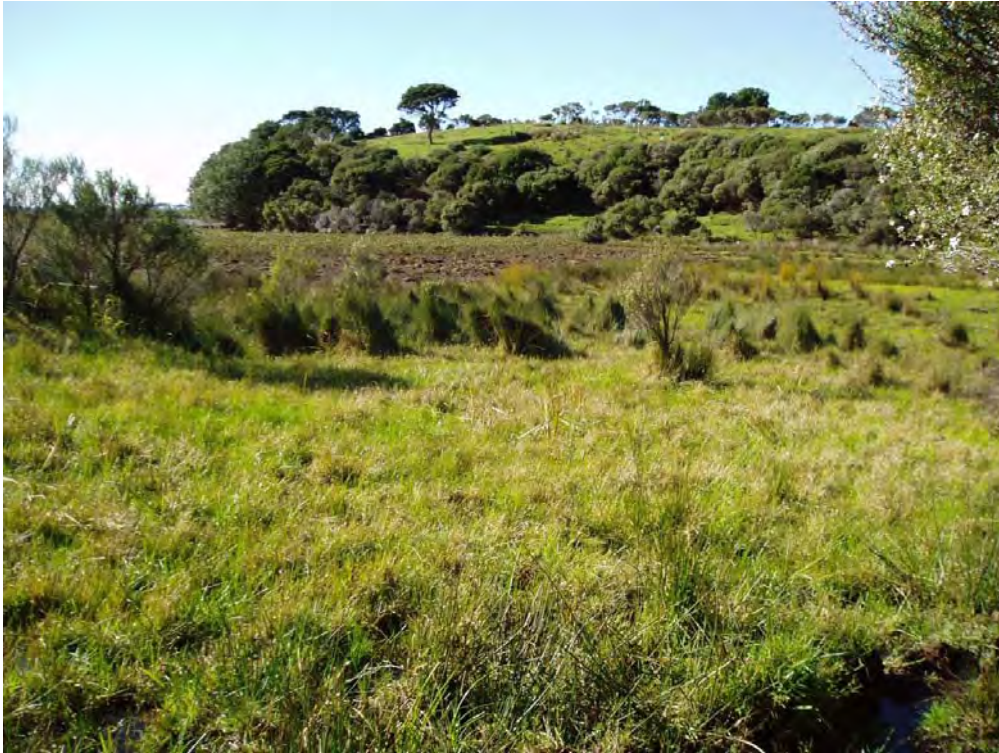
Figure 49: A view of the 'ploughed' area looking over a freshwater seepage.

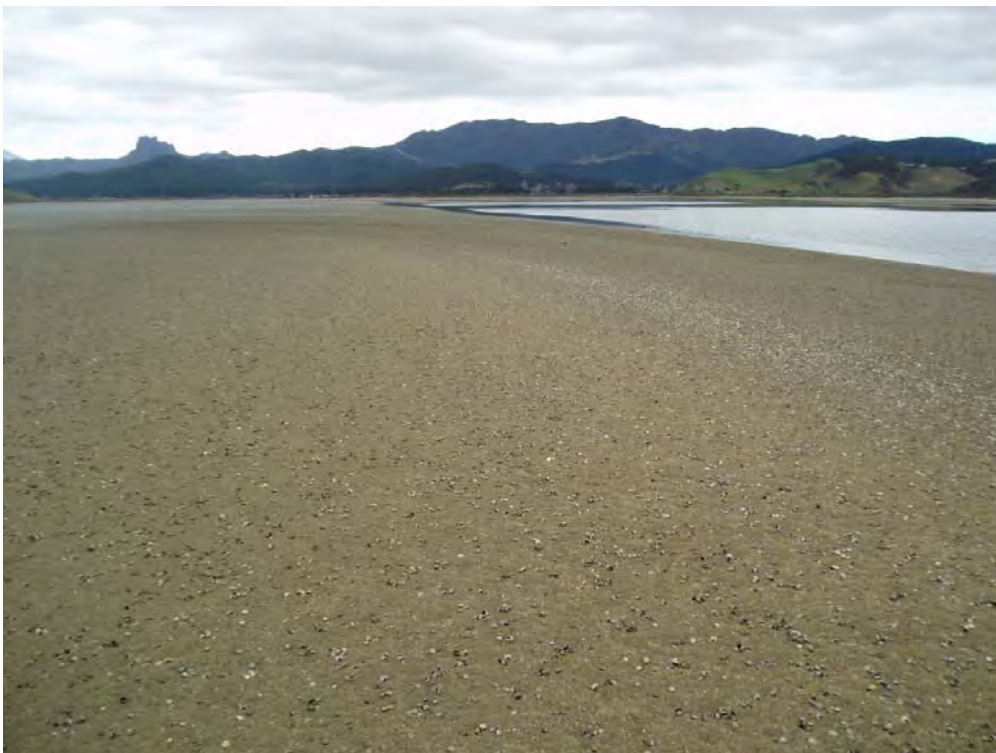
Figure 56: Extensive soft sand flats extend upstream towards the Opitonui River mouth.

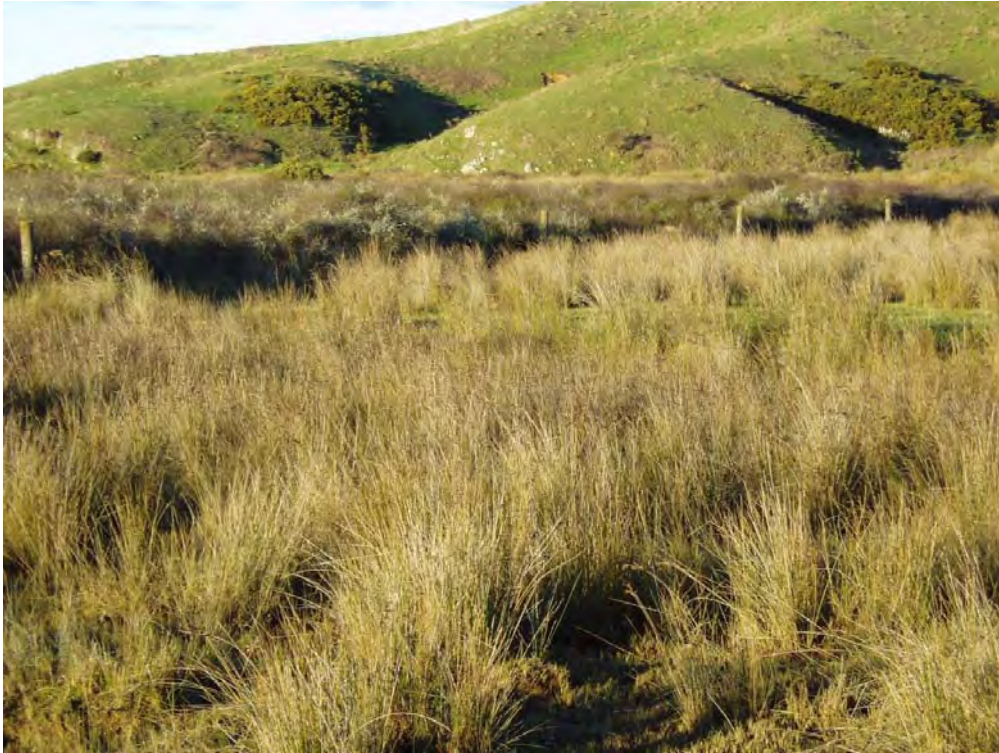
Figure 57: Stock have access to the wetland in the forefront (dominated by sea rush and saltwater paspalum) but not the saltmarsh ribbonwood in the background.

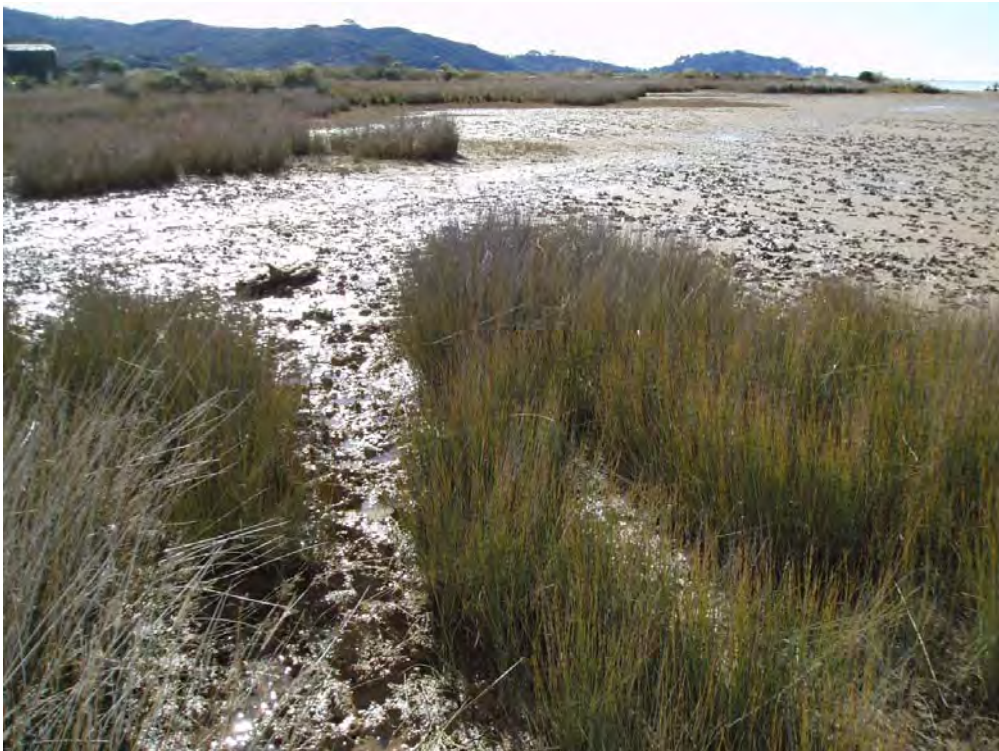
Figure 58: Cattle pugging, grazing (primarily of mangroves) and dung are visible here.

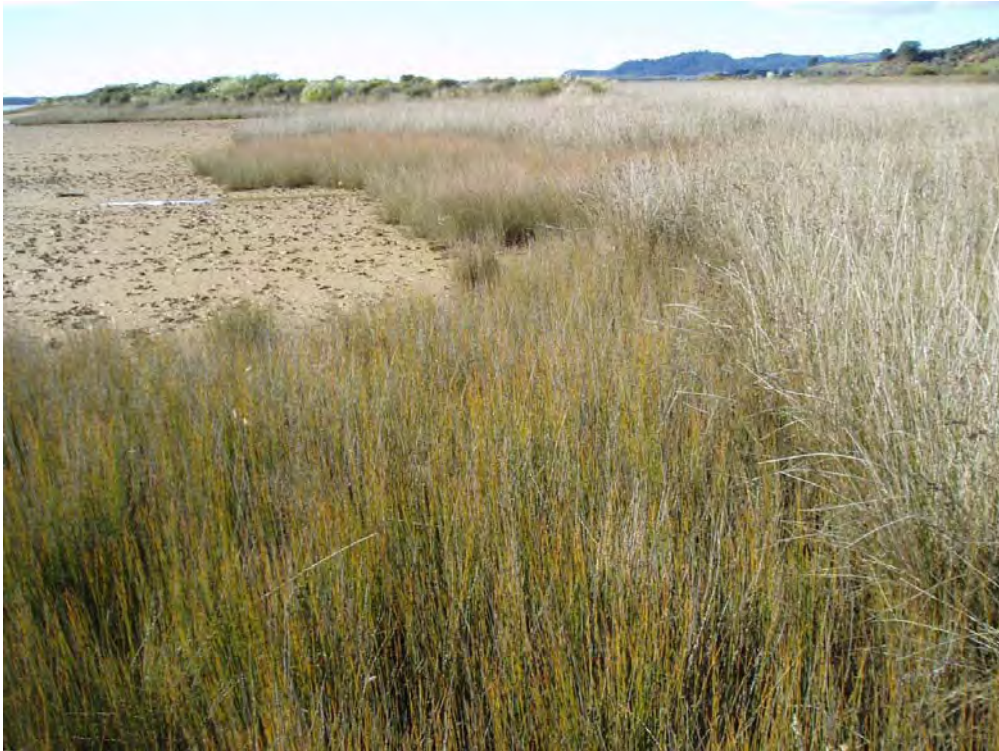
Figure 59: A fringe of oioi in front of sea rush. Note the cattle tracks over the open flats.

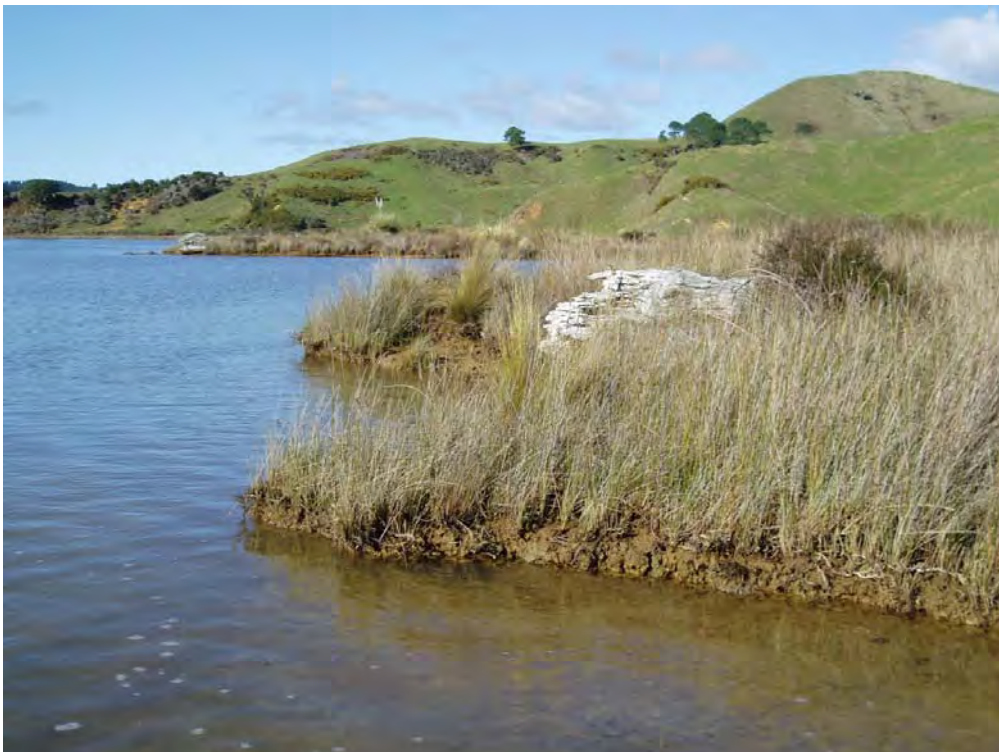
Figure 60: A view of the eroding exposed edges of the Opi-tonui/Waingaro/Waitekuri rivers wetland complex.

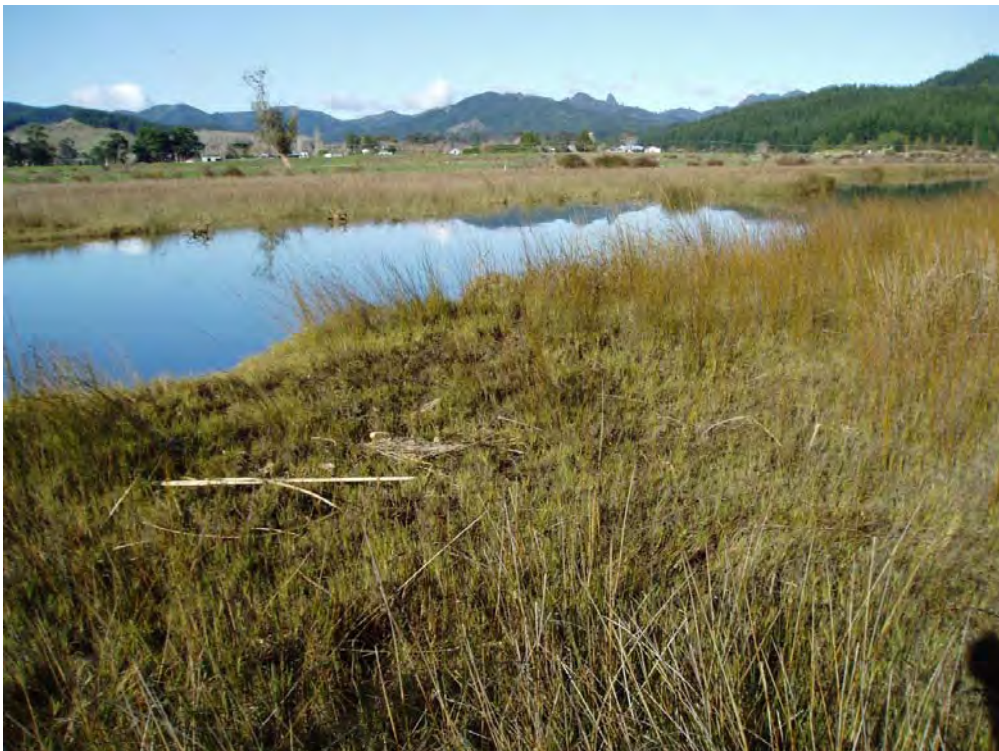
Figure 62: Saltwater paspalum is common along the lower unfenced TLB of the Waingaro River amongst oioi and sea rush. A patch of saltwater paspalum is also visible on the lower opposite bank.

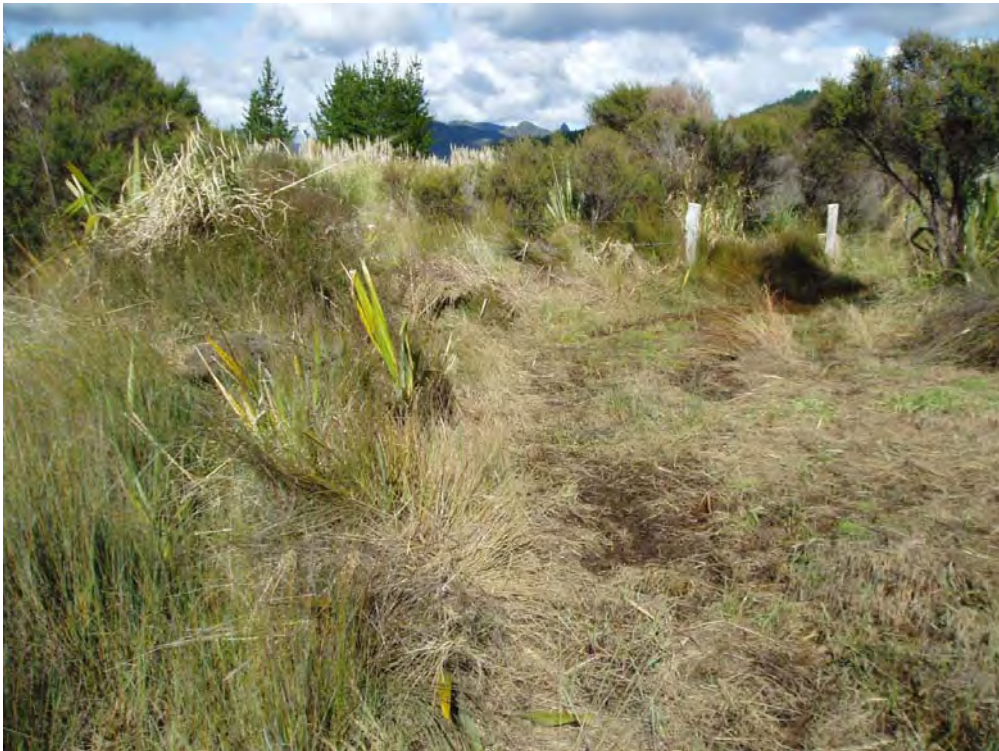
Figure 64: This cleared path down through a remnant flax and manuka freshwater wetland allows stock access to the upper harbour wetland.

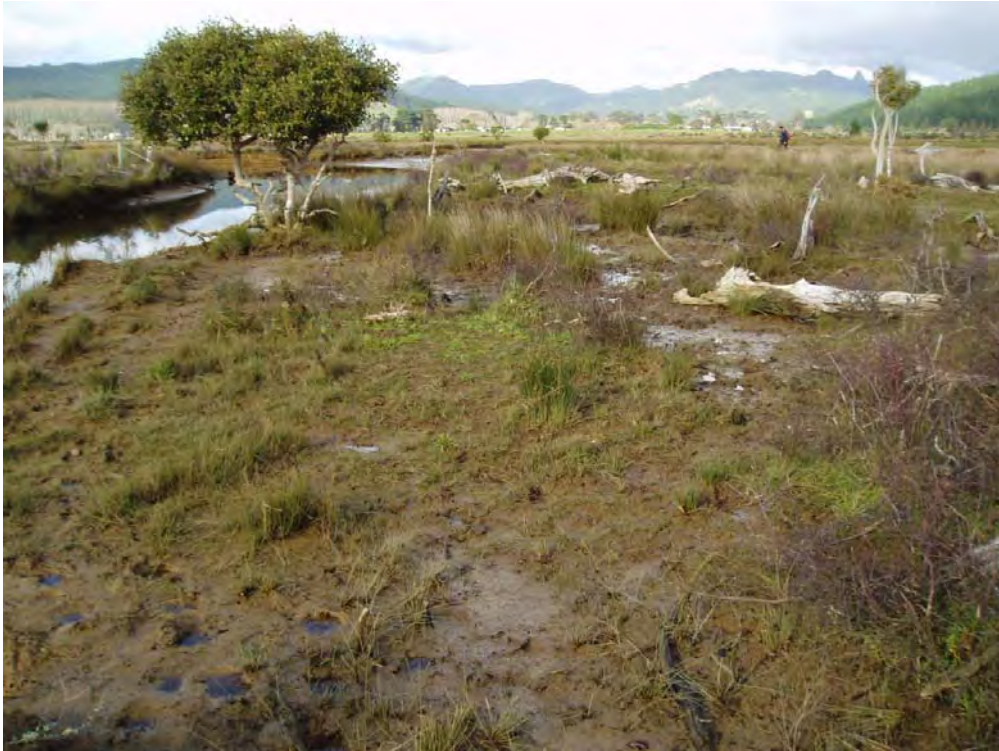
Figure 65: Looking down the lower Waitekuri River to its junction with the harbour. Grazed and pugged sea meadow, sea rush and saltmarsh ribbonwood dominates the TRB here. Only mangroves above stock reach survive.

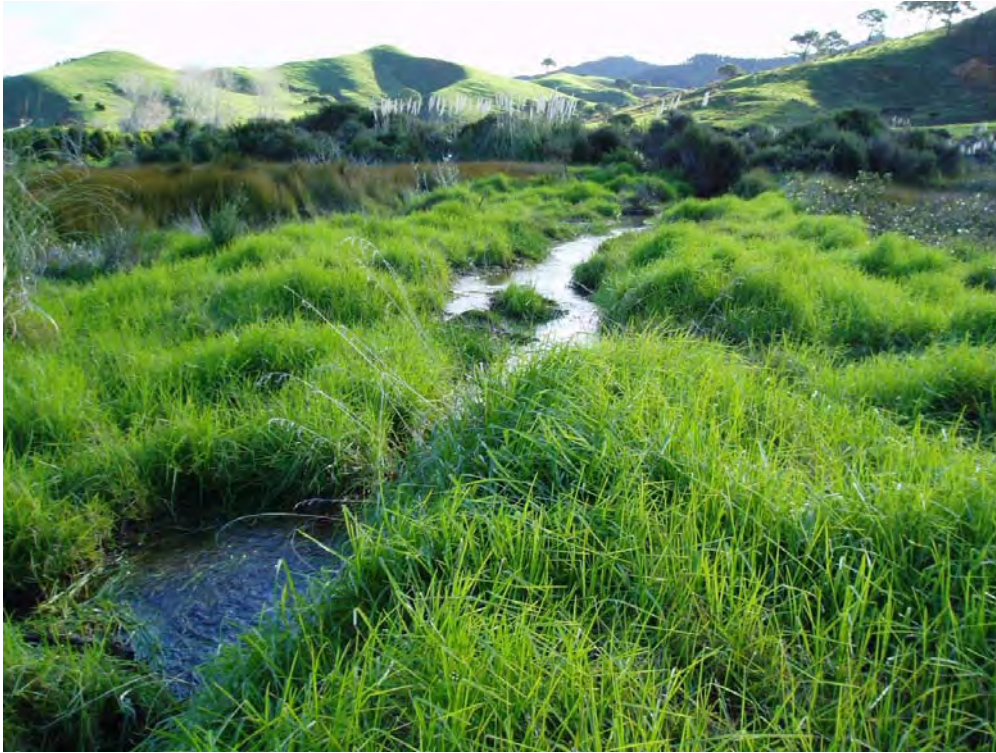
Figure 69: The mouth of the Horongaherehere Stream smothered by eroded sediment and kikuyu.

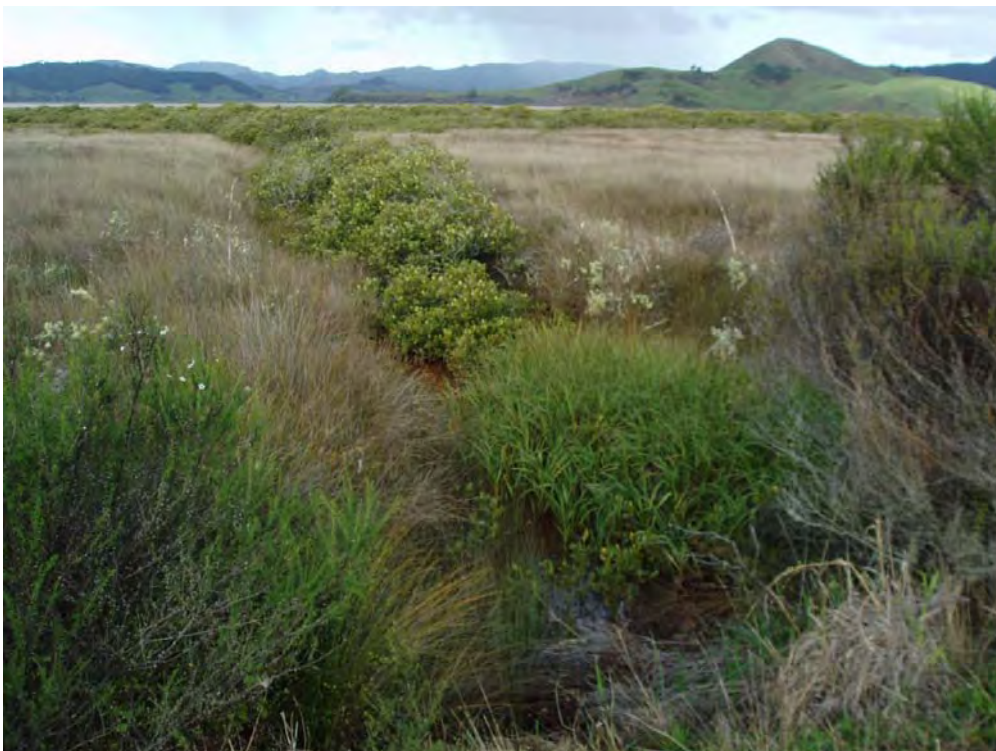
Figure 74: A healthy patch of spartina in a drain beside Whangapoua Road.

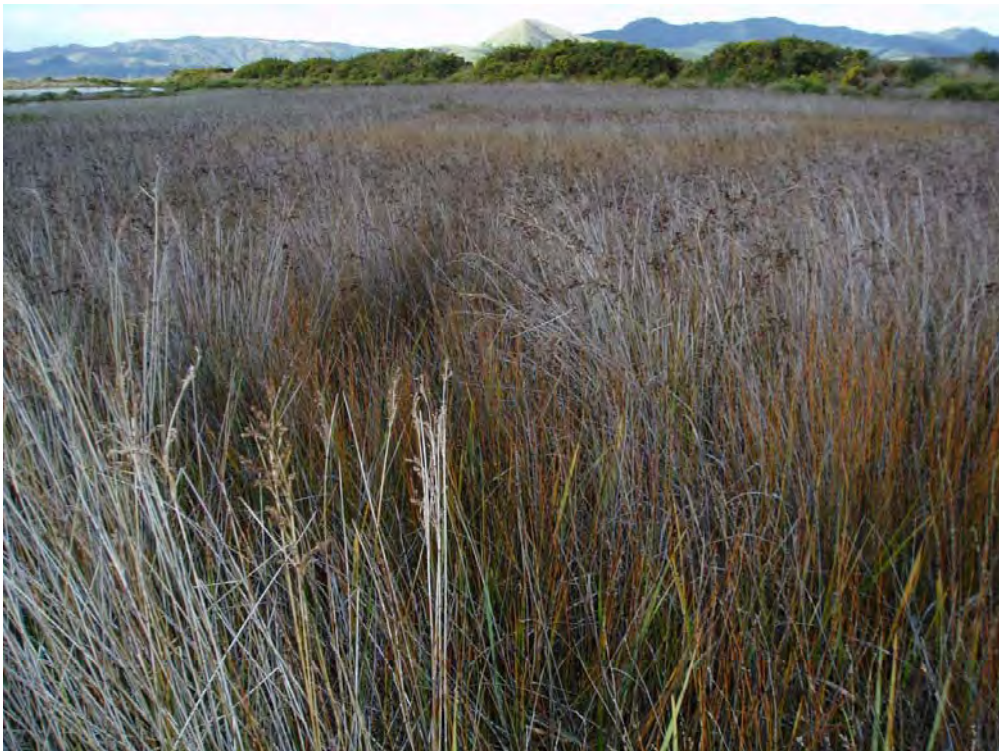
An embayment which is cut off from the main harbour by the causeway has a complete sequence of estuarine to freshwater vegetation (mangroves - rush/sedgeland – coastal freshwater wetland – coastal forest). The mangroves are actively spreading following the removal of stock and also presumably assisted by a build up of sediment and lack of frosts. A historic stopbank has been breached in a number of places which has allowed the tide to extend further inland with the resulting death of manuka along the outer edge of the coastal freshwater wetland (Figure 79). This highly significant coastal wetland is dominated by manuka, *Baumea juncea* and swamp coprosma (*Coprosma tenuicaulis*). Fernbird are common within this coastal wetland and banded rail were heard and footprints seen in the estuarine wetland. There is spartina mixed with oioi and searush (Figure 80).

Figure 80: A mix of oioi and spartina in the foreground surrounded by sea rush. The breached stopbank and causeway are in the background.

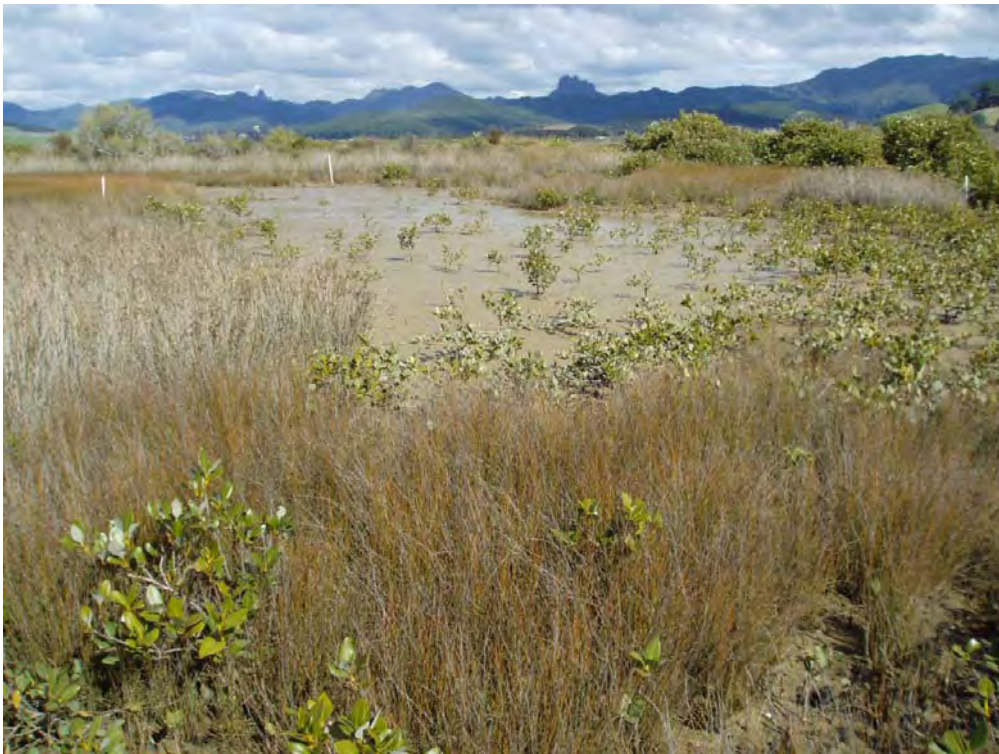
Saltwater paspalum is common along the outer exposed edges of the larger islands (Figure 91 and Figure 92). One island also has buffalo grass which has spread out into the saltmarsh ribbonwood and sea rush (Figure 96). Figure 86 shows an area of sprayed spartina that has monitoring pegs around it. A few live spartina plants are found nearby within the mangrove pneumatophores of a shallow channel.

Figure 86: Looking south over a controlled spartina patch (note survey markers).

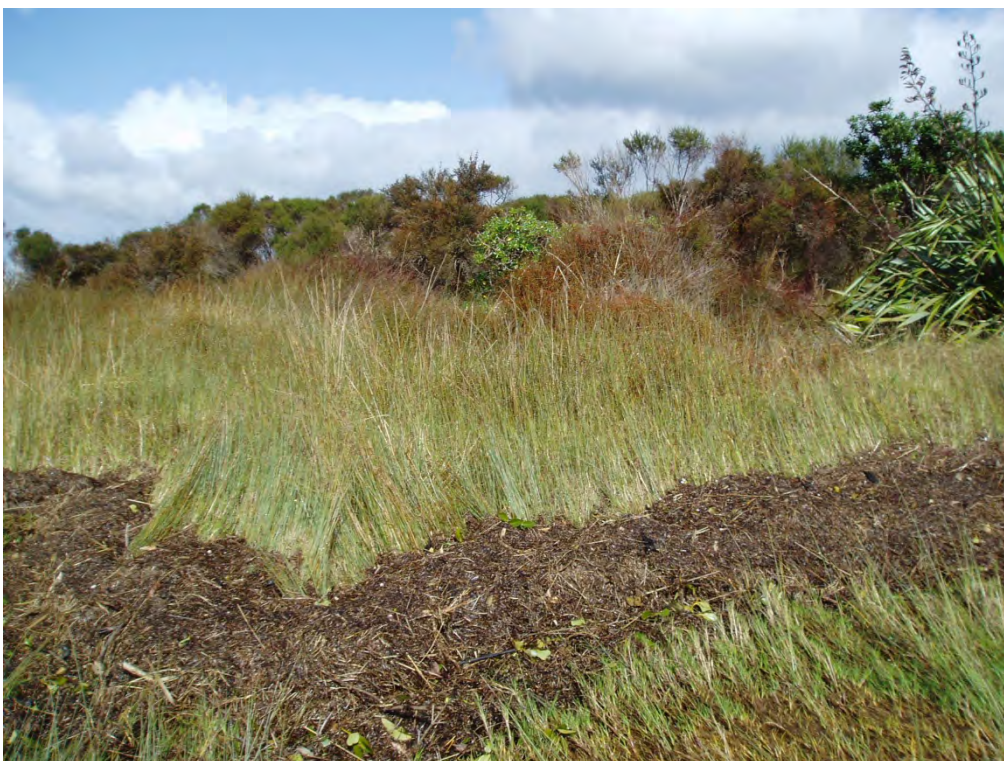
Figure 92: Seagrass washed up over saltwater paspalum into the *Baumea juncea* edge. Saltmarsh ribbonwood, pohuehue, ngaio, pohutukawa, flax, manuka, *Coprosma propinqua* and giant umbrella sedge occur on top of the chenier.

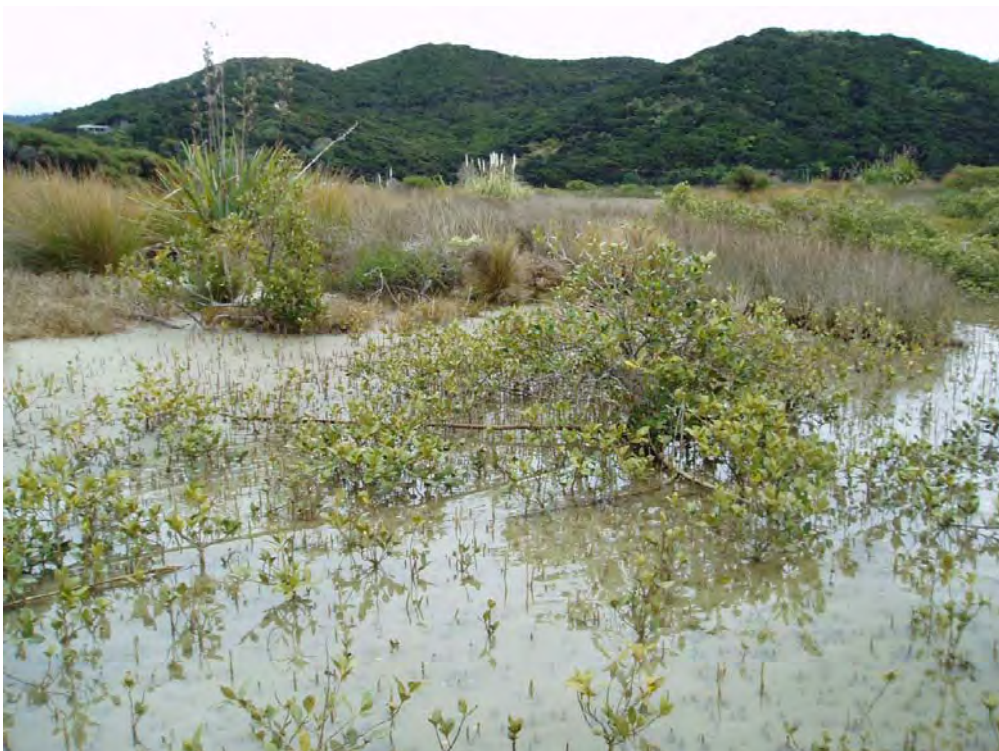
As mentioned earlier, where chenier ridges are still active there is often an eroding frontal edge (Figure 94 and Figure 90). The chenier ridges are predominantly vegetated with a wide fringe of saltmarsh ribbonwood around coastal daisy, *Coprosma propinqua*, knobby rush, pampas, manuka and flax on the highest ground (Figure 87, Figure 88, Figure 89, Figure 91, Figure 92 and Figure 95). Ngaio was also present on some islands. Banded rail footprints were commonly seen and fernbird heard.

Figure 94: Mangroves, saltmarsh ribbonwood and coast spear grass along this active chenier edge which is showing signs of erosion, even with a band of scattered mangroves seaward.

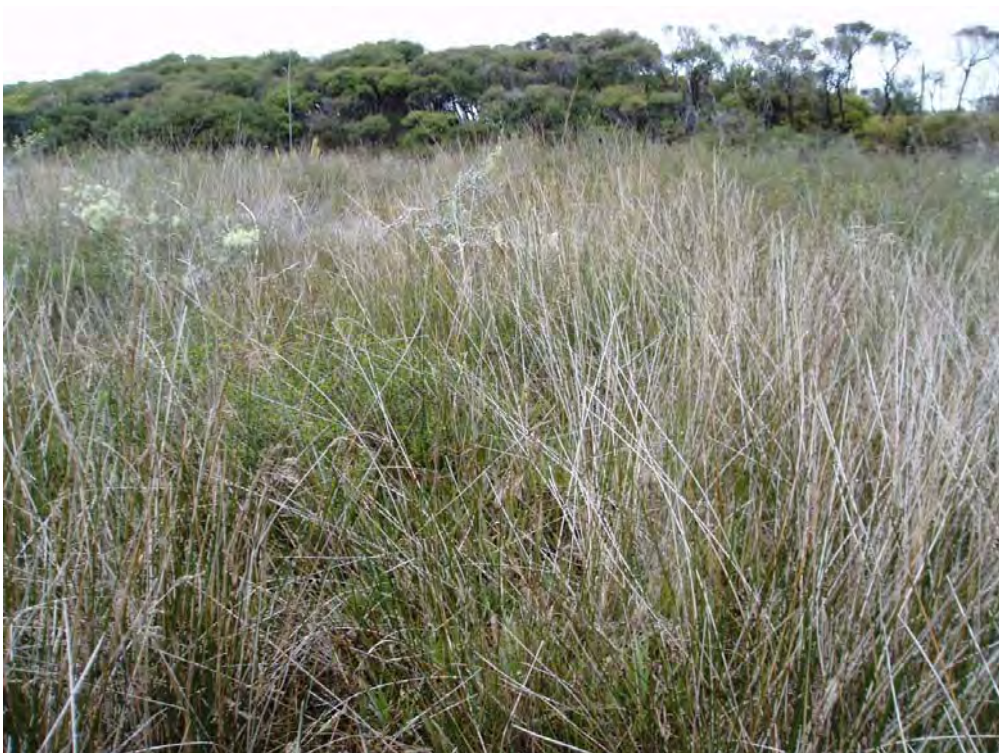
Figure 96: Buffalo grass creeping through sea rush and saltmarsh ribbonwood.

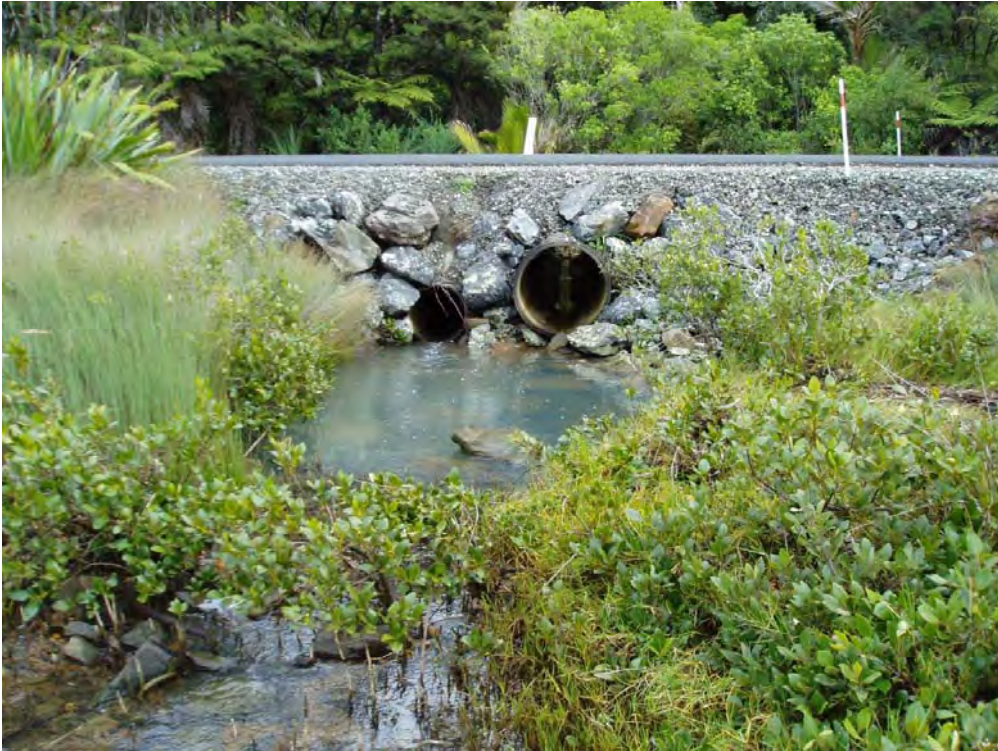
Figure 101 shows a recently installed road culvert along Whangapoua Road that is perched higher than the old culvert. Correct culvert placement is vital for fish movement up and down stream. This culvert would be better bedded down into the bed base to allow easy fish passage outside of spring high tides. A banded rail was heard in the rushes here. An old oyster farm and associated structures have provided shelter for a wide band of mangroves to establish along the coastline here. Figure 102 shows a view looking south over the harbour flats with Whangapoua Road to the right. The bed of Neptune's necklace to the left is free-floating but a permanent feature. The seagrass beds can be seen behind the Neptune's necklace in the distance forming an extensive band across the mid-harbour. Saltwater paspalum occurs in scattered areas along the road side fringe, usually mixed with oioi and sea rush and generally where there has been

Figure 101: A recently installed road culvert along Whangapoua Road that is perched higher than the old culvert.

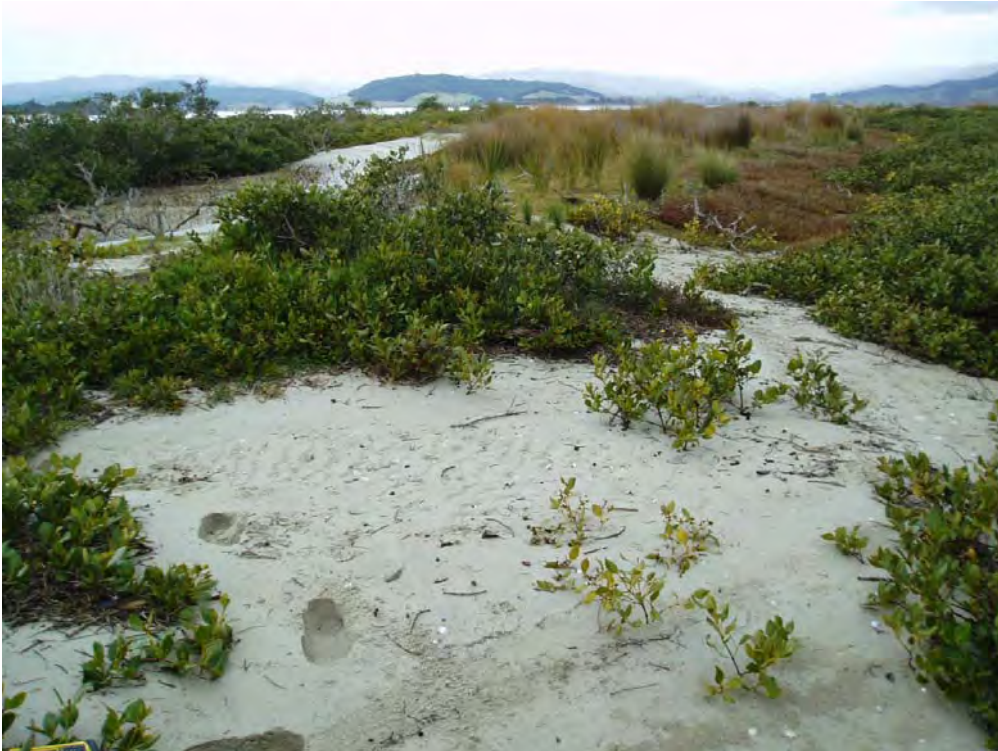
The frontal edge of the main chenier of the northern island is actively moving through the mangroves in places (Figure 107 and Figure 108). The yellowing leaves on some of the mangroves indicates they are stressed and some mangroves seaward (to left of the picture) are dead, indicating the chenier is moving landward towards the west. Mangroves that survive the passing of the chenier ridge are then exposed to wave erosion as they appear out in front of the chenier (Figure 109).

Figure 107: The active northern end of the outer chenier ridge with mangroves being swamped. Glasswort and coast spear grass fringe the landward edge of the ridge, with knobby rush and saltwater paspalum covering the higher ground.

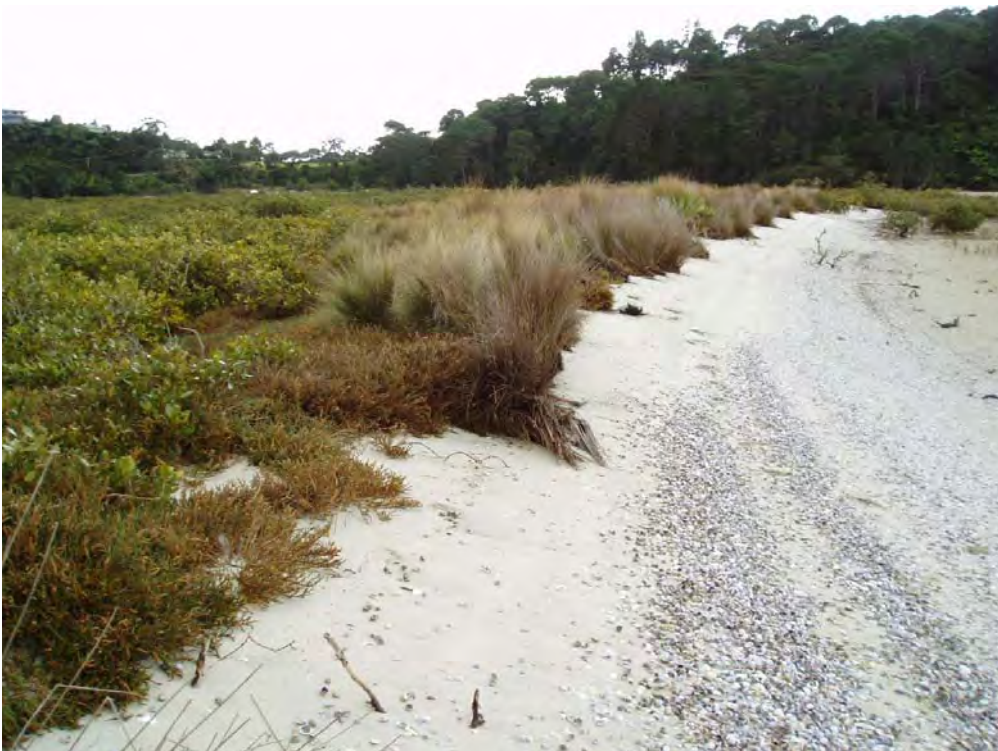
Figure 108: The more exposed middle section of the main chenier ridge is eroding. There are some scattered mangroves seaward (see following figure).

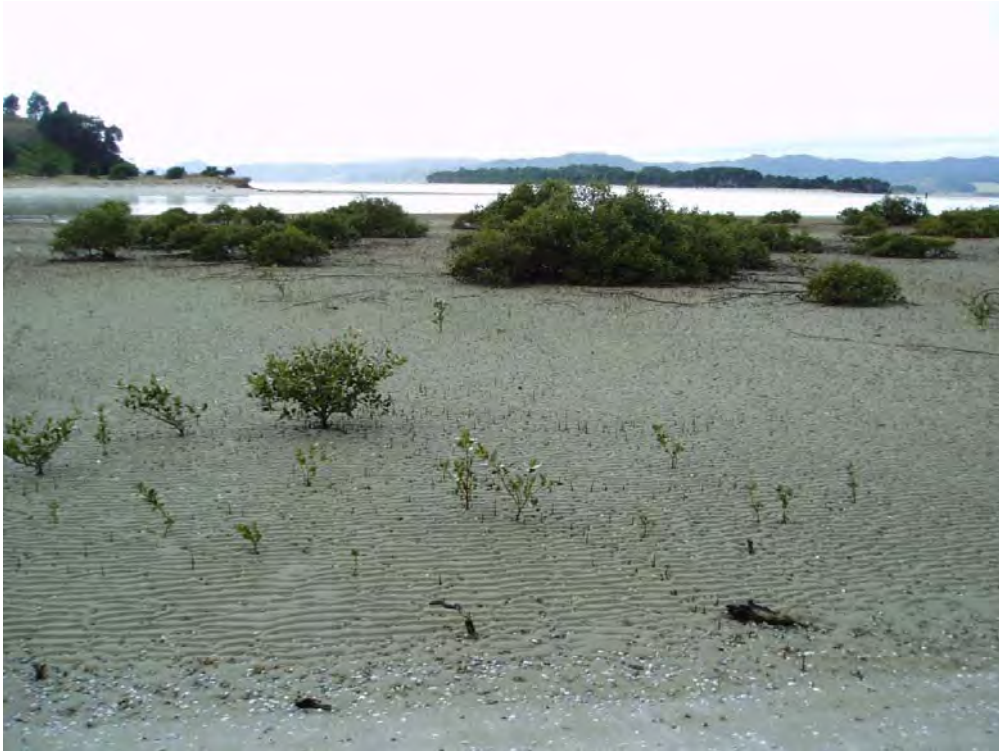
Figure 109: Mangroves seaward of the outer chenier ridge shown in Figure 108 have their pneumatophore system eroded and exposed by wave action.
