# Waikato River Bank Erosion Survey (Taupo Gates to Ngaruawahia) - Assessment Report

## Project G2011/128

**Prepared for Mighty River Power (Client)**

**By Beca Carter Hollings & Ferner Ltd (Beca)**

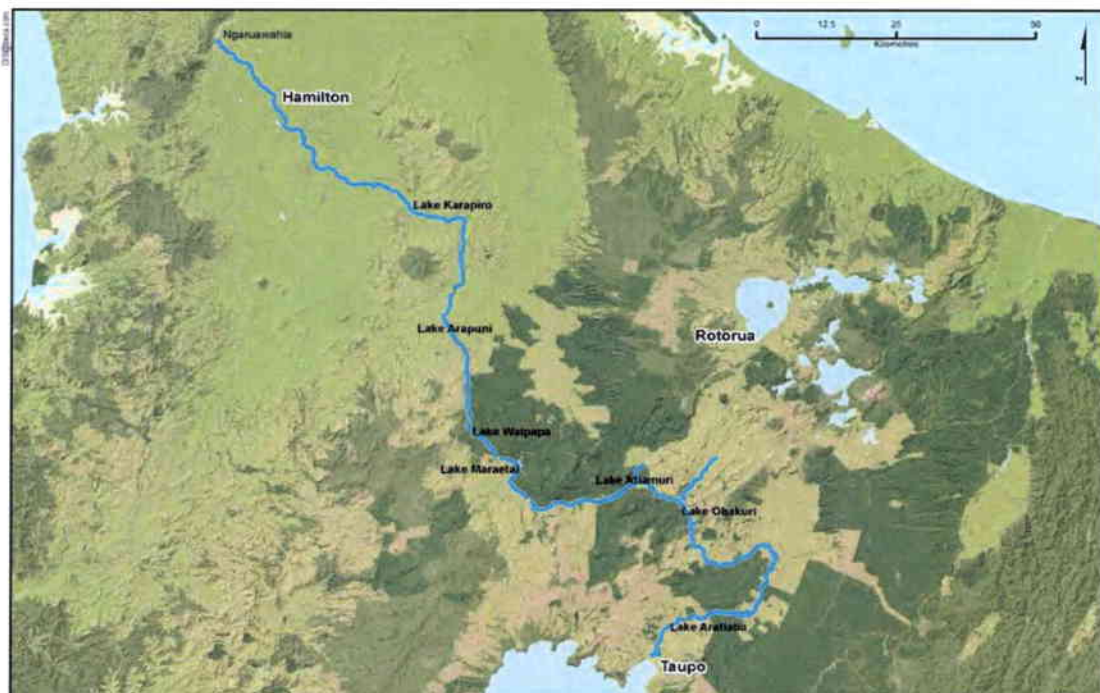
Figure E-1: The survey length (blue line)

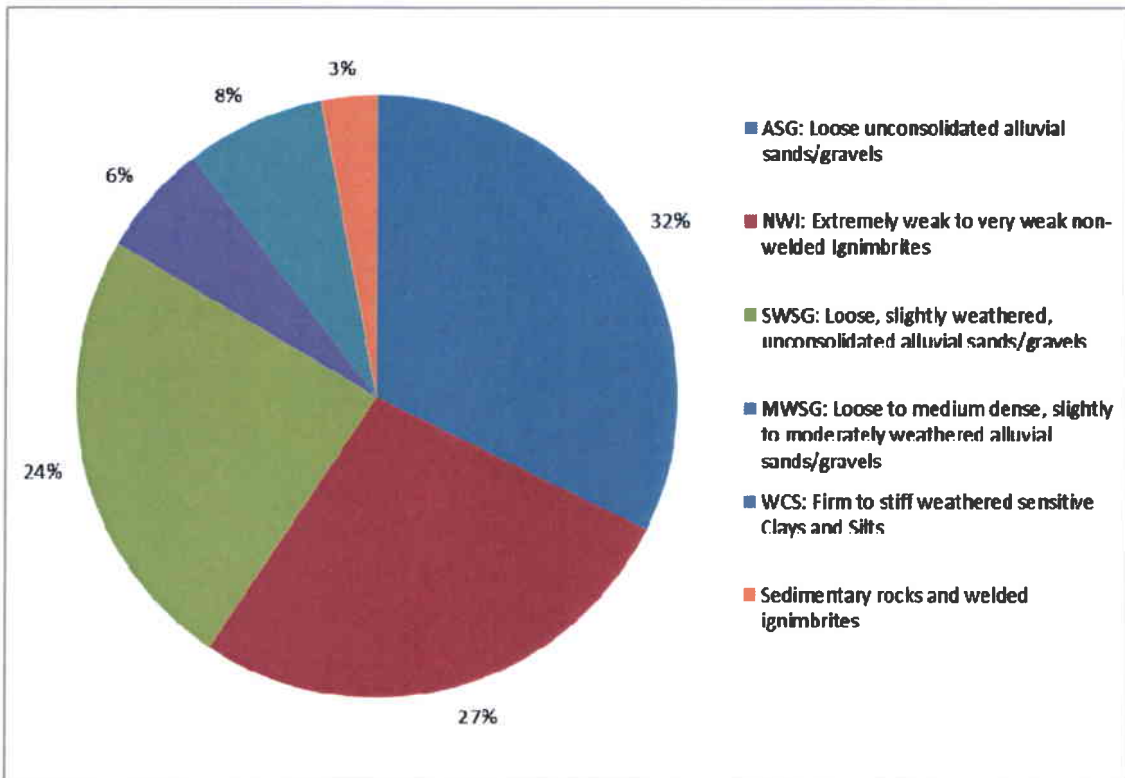
Figure E-4: Material composition of active and recent erosion sites

The study confirms the conclusions of the baseline surveys that there is a strong relationship between the amount of erosion, bank material type, and geological conditions. The majority (over 60 %) of the active and recent erosion sites are within the reworked loose alluvial deposits from the Taupo and Oruanui and older eruptions, whilst a quarter (27 %) have occurred within the non-welded ignimbrites (volcanic flow deposits) derived from these eruptions, see Figure E-4. The remaining sites (some 10 %) have developed in soils weathered from ignimbrites (7 %) and rock (3 %).

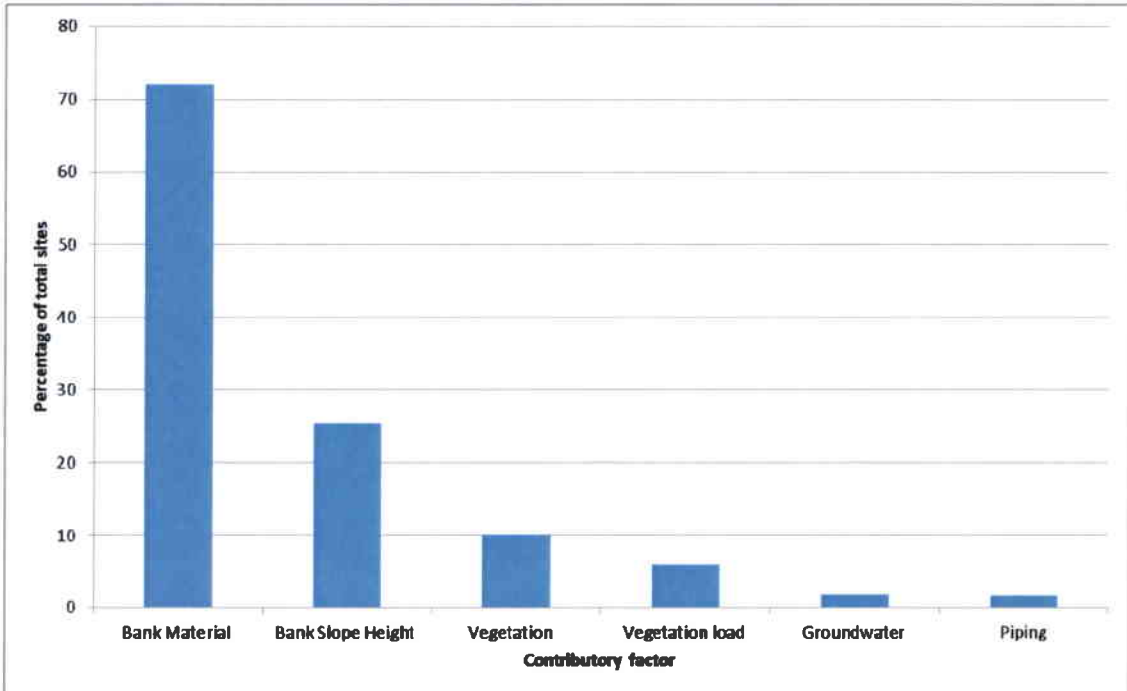
Figure E-6: Percentage of contributing factors for active and recent erosion sites in 2012

The most common **contributing** factor at the erosion sites surveyed was the bank materials, reported at 70 % of the sites (Figure E-6). Bank height contributed to erosion at about 25 % of sites observed, in particular along the lake and central river sections (from the river section Karapiro to 11.8 km downstream to the river section between Aratiatia Dam and Lake Ohakuri); and vegetation removal or loading contributed to erosion at 16 % of the recorded sites. Groundwater seepage and piping (entrainment of particles from groundwater flow) in the banks were identified as a contributing factor at less than 1 % of the sites each. However, the minor contribution to erosion reported from groundwater seepage may reflect the dry weather during the survey; it is possible that some sites identified as being contributed to by bank material may actually have also been contributed to by groundwater seepage (for example through a weaker material overlying a stronger material).

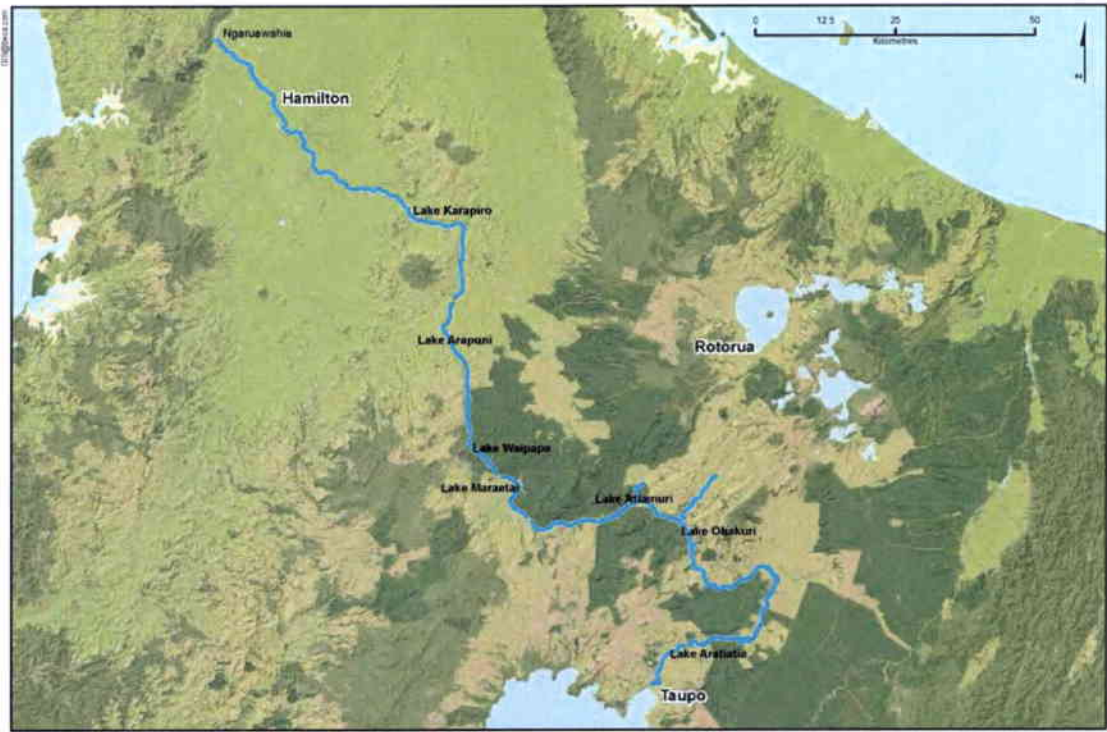
Figure 1.1: Overview of the Waikato Hydro System

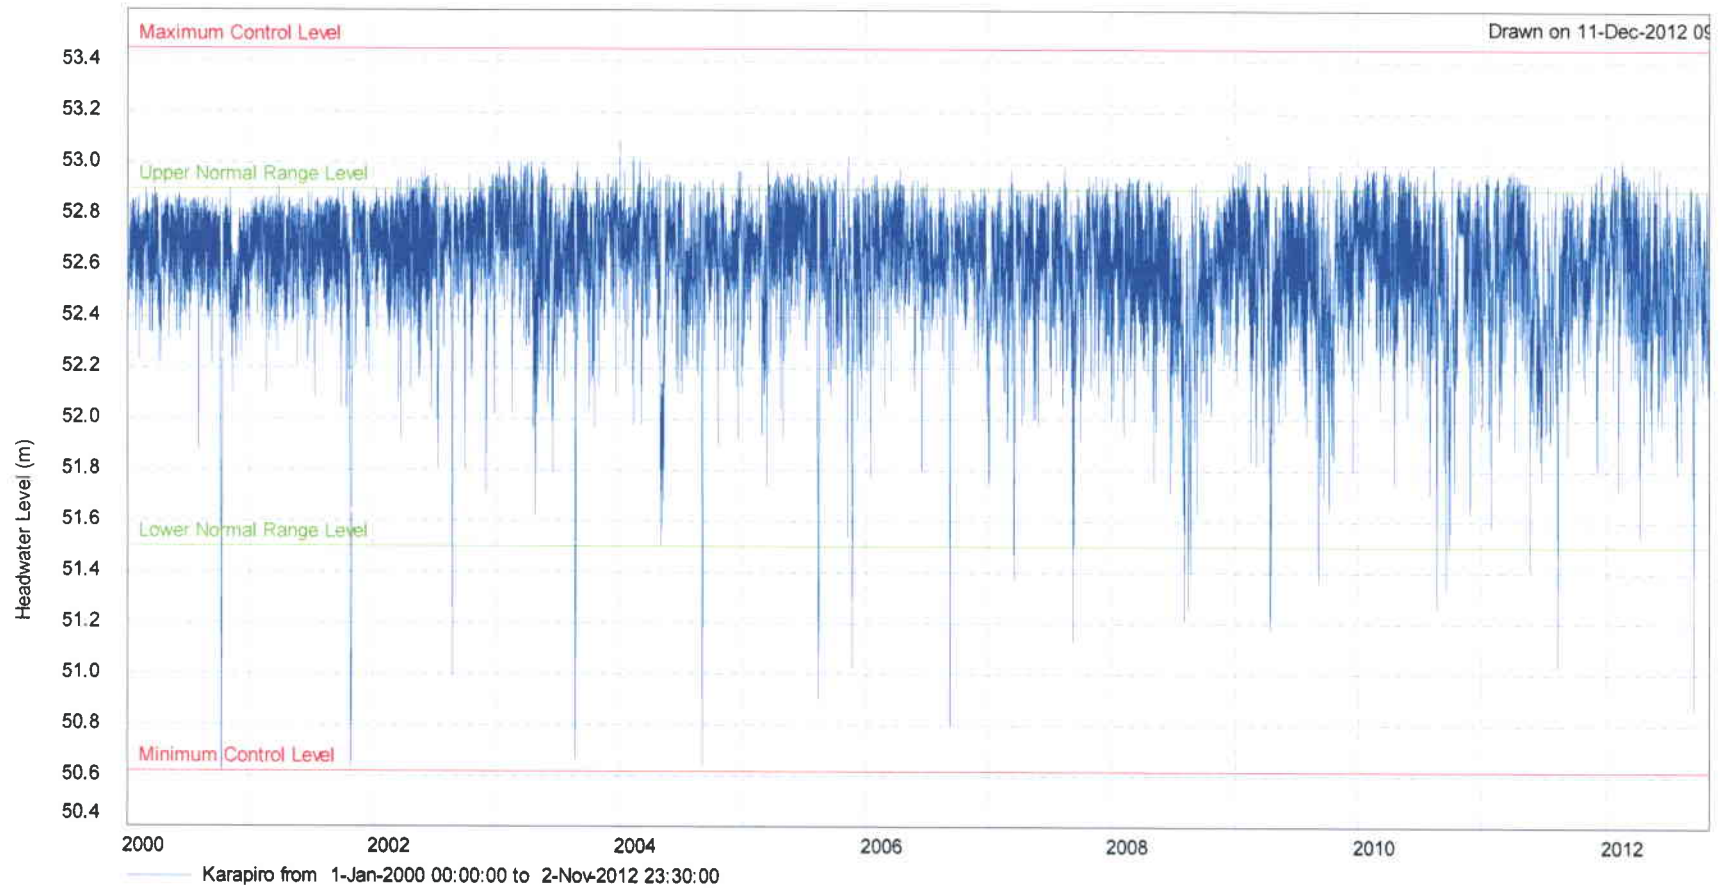
Figure 3.8: Lake Karapiro headwater levels

Figure 3.1 to Figure 3.8 in this section present the water levels of Waikato Hydro System reservoirs (showing half-hour average levels), and Figure 3.9 and Figure 3.10 show flow from Karapiro and on the Lower Waikato River (also half-hour averages). Data is presented from 2000 to 2012, to allow a

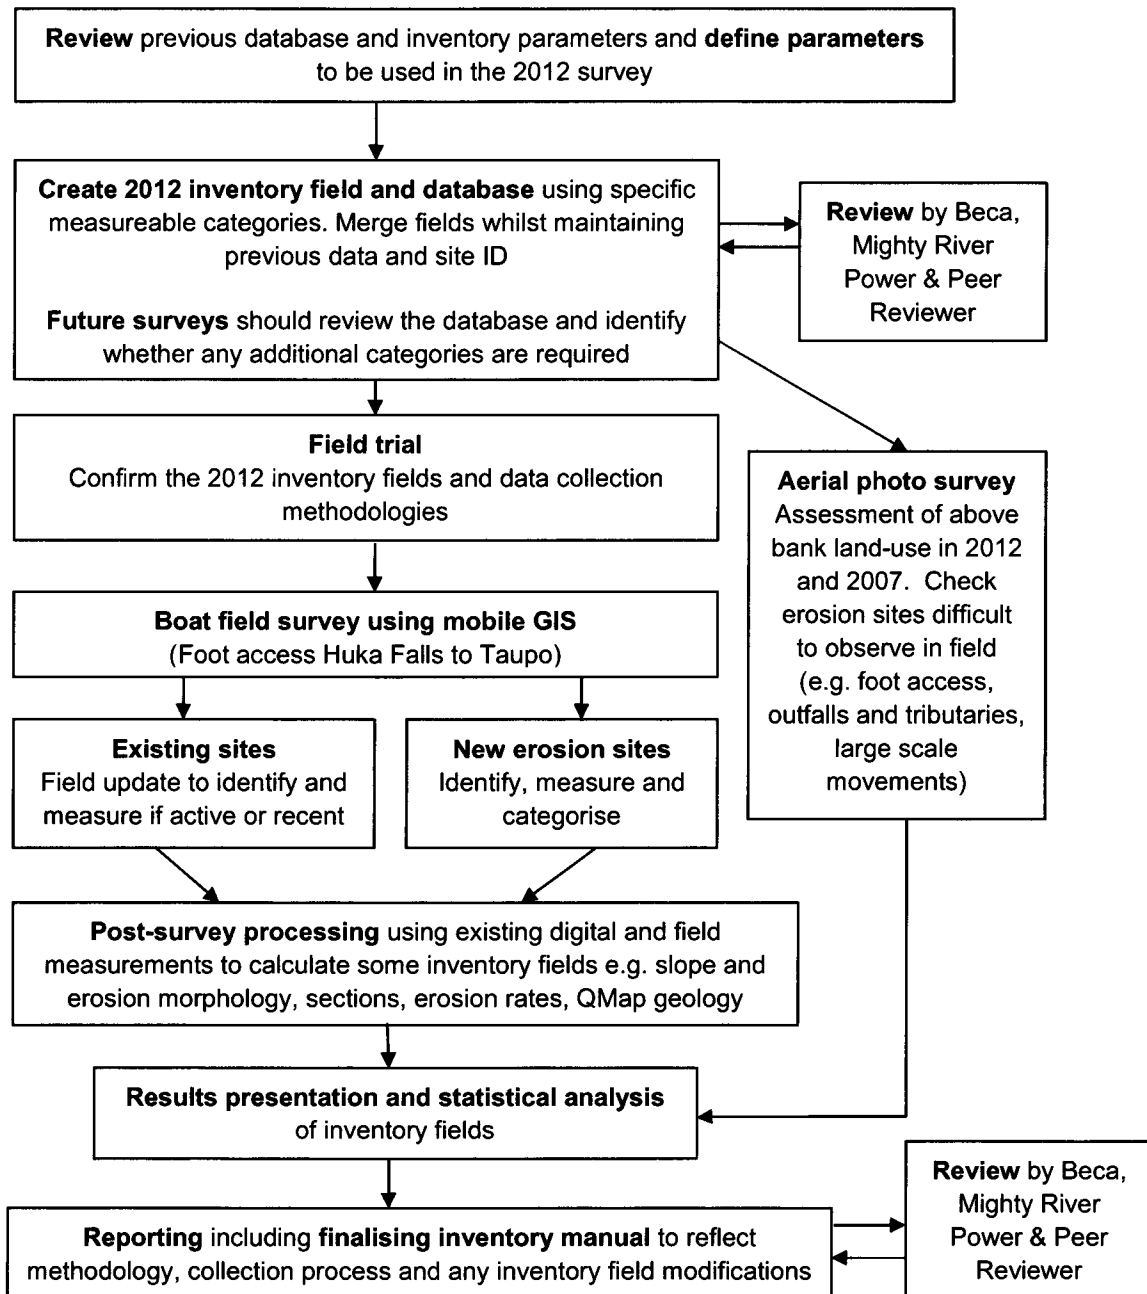
Figure 4.1: Flow diagram showing the overall project methodology

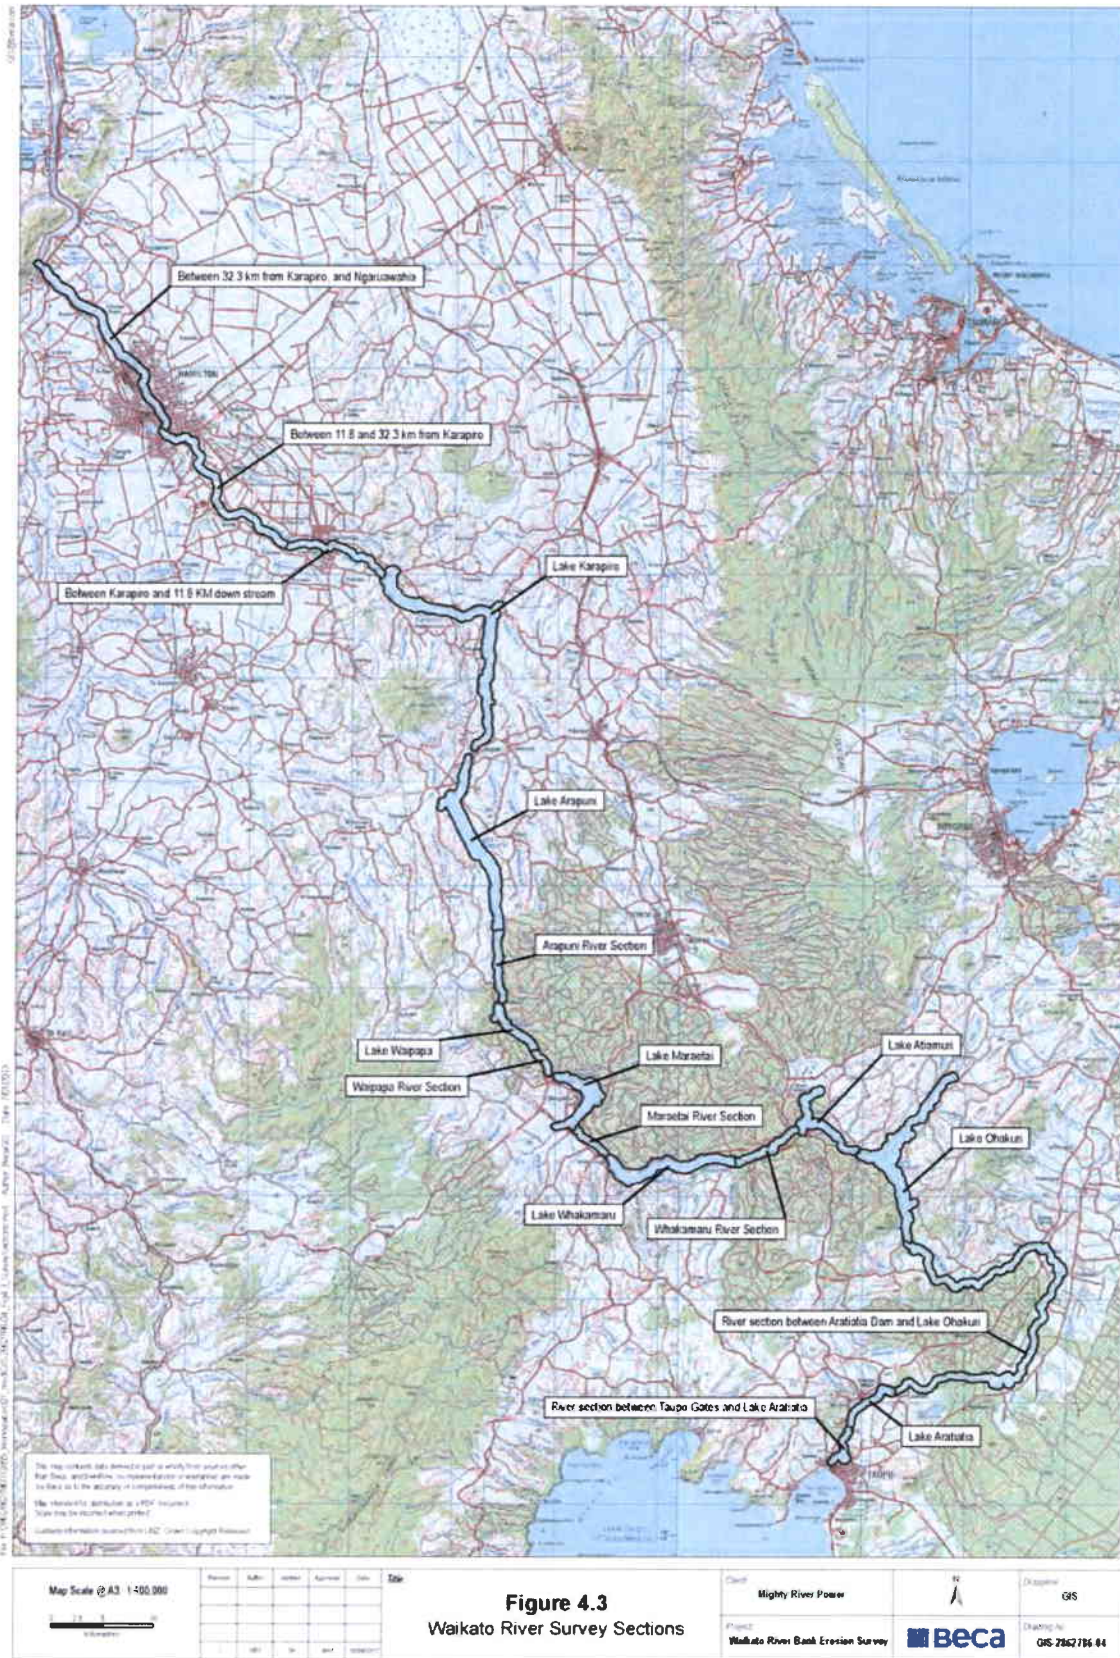
Figure 4.3: Waikato River survey sections

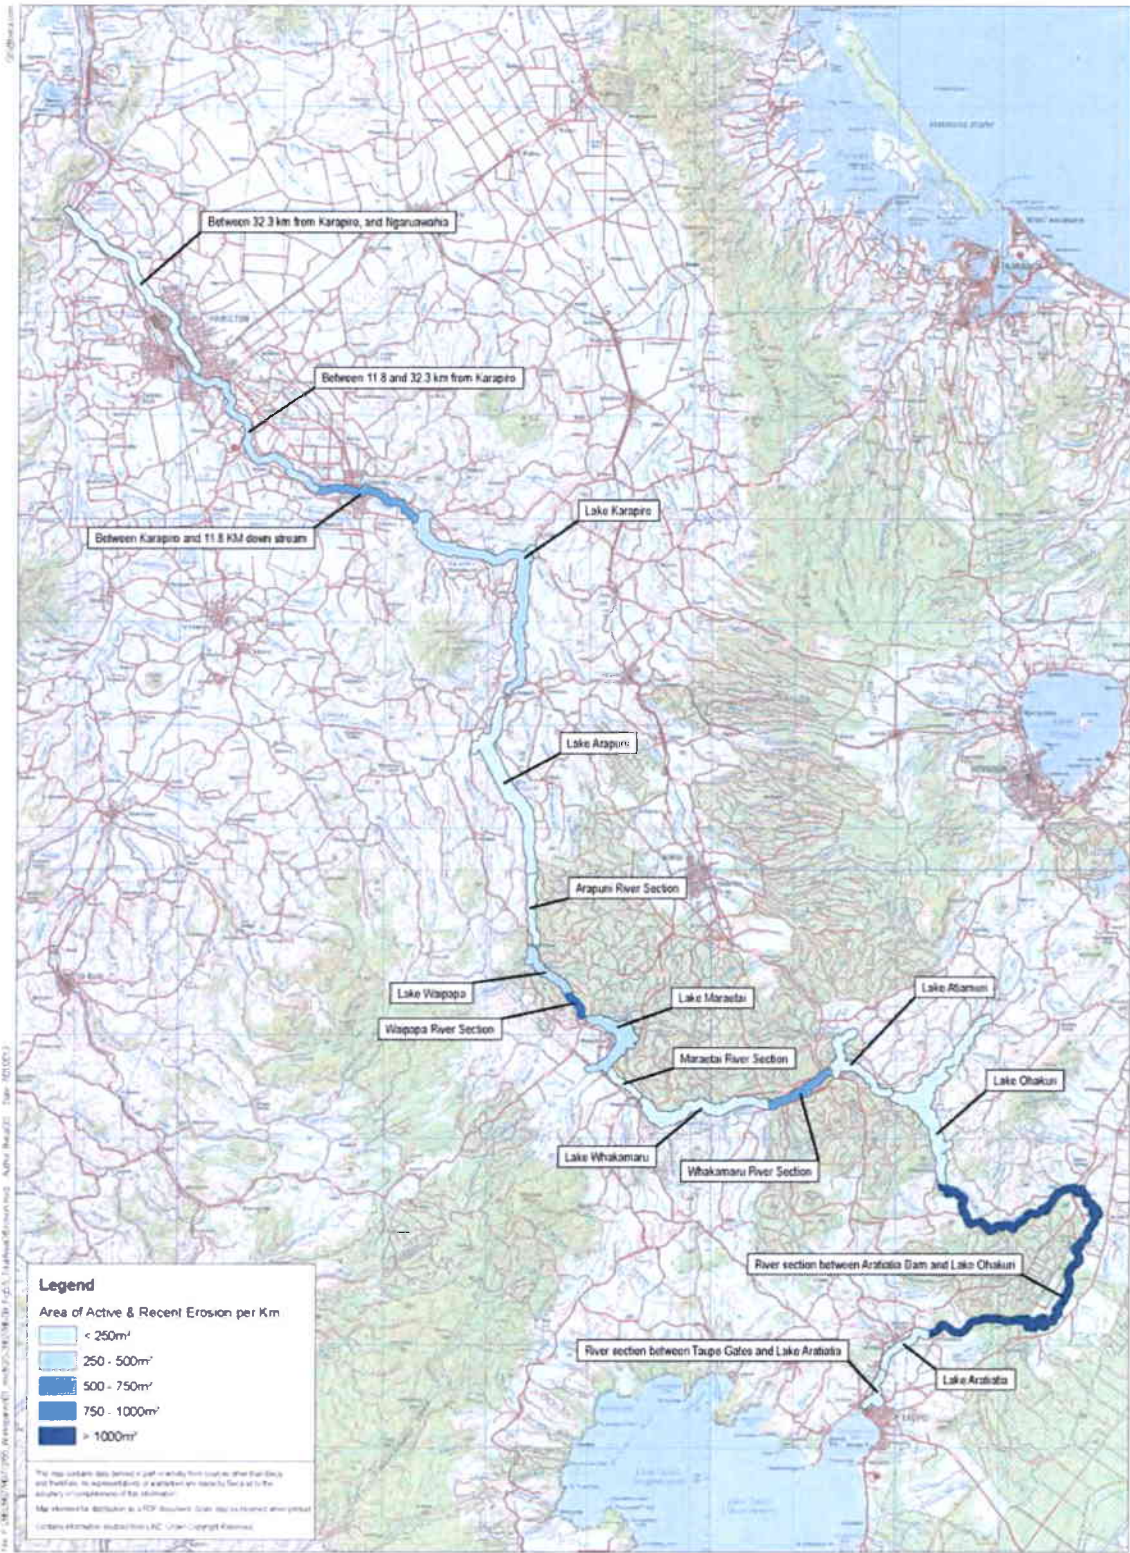
**Figure 5.5: Total area of erosion, by survey section**

The size of erosion sites was assessed by calculating the surface area of each erosion feature from measurements made during the field survey. Figure 5.5, Figure 5.6 and Table 5.1 compare the total area of bank erosion (in m<sup>2</sup>), by study area. Note that the erosion area was not able to be measured at 23 sites. The figures indicate that the majority of the measured erosion area is located in a small number of sections, particularly:

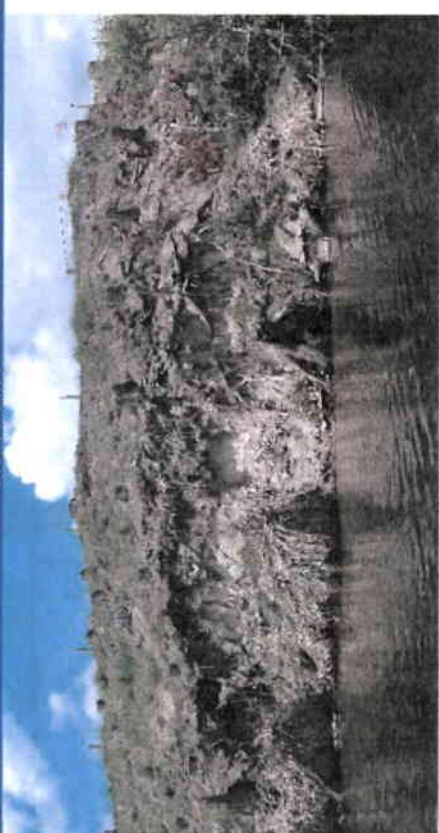
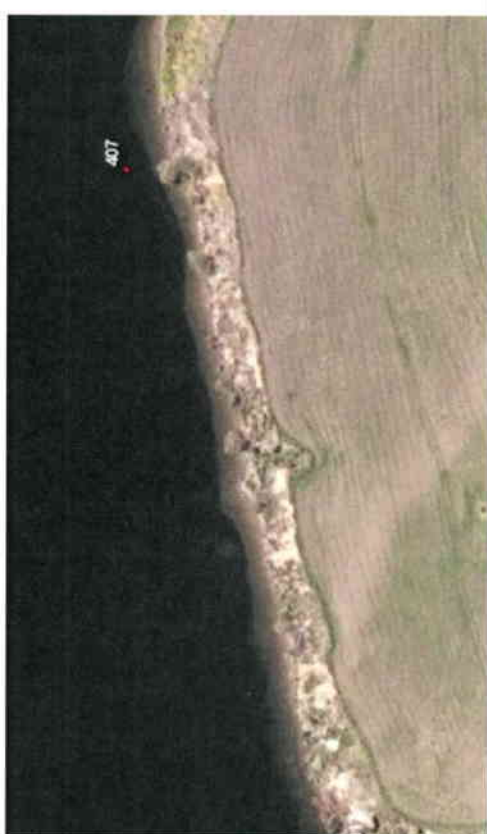
2007 PHOTOS

ID	HISTORIC SITE NAME	SECTION NAME	2012 HEIGHT (M)	2007 HEIGHT (M)	2012 LENGTH (M)	2007 LENGTH (M)	2012 AREA (M2)	2007 AREA (M2)	2012 LANDUSE	2007 LANDUSE	2012 PRIMARY CAUSAL FACTOR	2007 PRIMARY CAUSAL FACTOR	2012 CAUSAL FACTORS, OTHER
1036	641	Lake Ohakuri to Lake Aratiatia	33.2	15	303		10060	3000	Seasonal cropping	Natural	RIVER PROCESS	River processes	Water Level Variation

These photos indicate that the bank height was under-estimated during the 2007 survey. The 2007 area should therefore be at least 6000 m<sup>2</sup>.

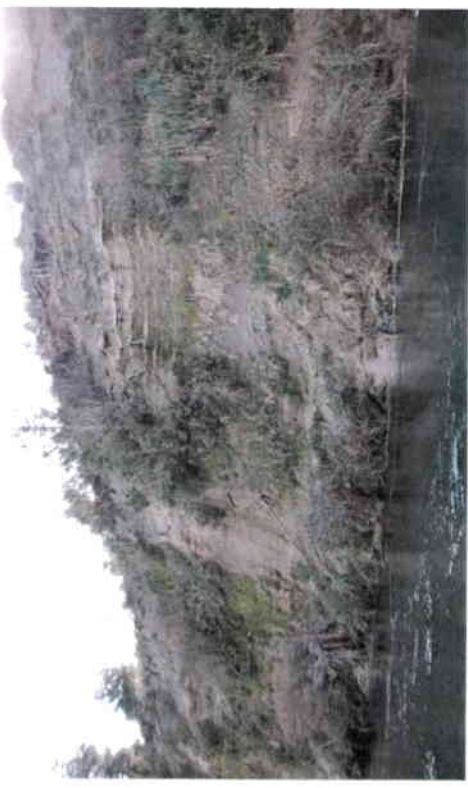
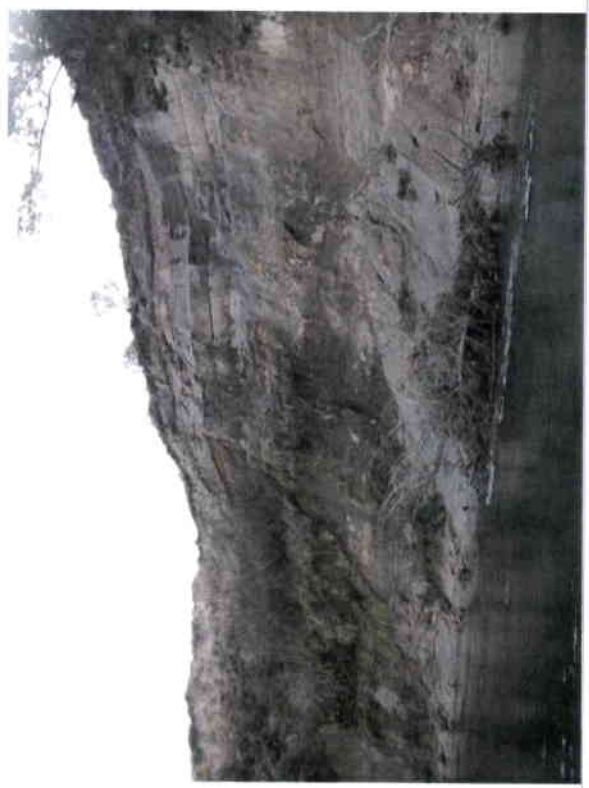
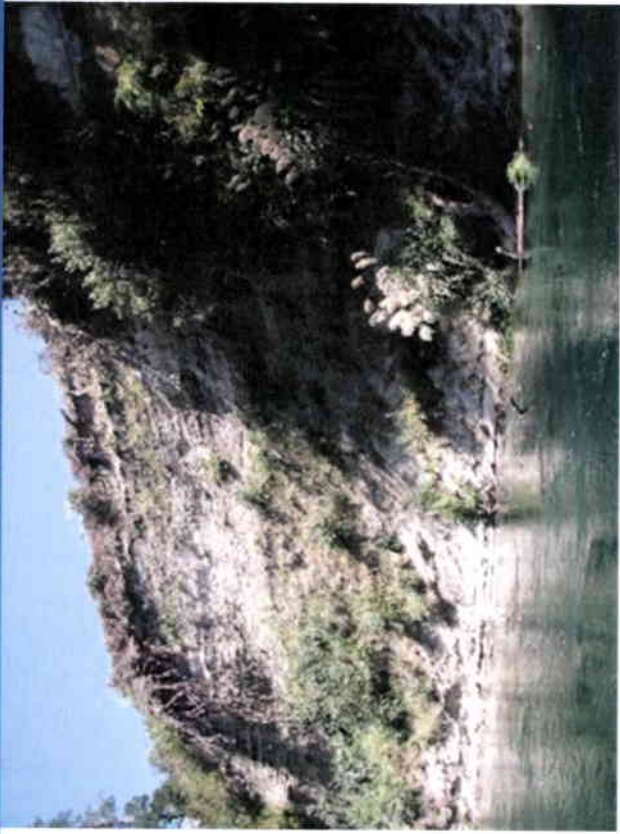
ID	HISTORIC SITE NAME	SECTION NAME	2012 HEIGHT (M)	2007 HEIGHT (M)	2012 LENGTH (M)	2007 LENGTH (M)	2012 AREA (M2)	2007 AREA (M2)	2012 LANDUSE	2007 LANDUSE	2012 PRIMARY CAUSAL FACTOR	2007 PRIMARY CAUSAL FACTOR	2012 CAUSAL FACTORS: OTHER
1076	681	Lake Ohakuri to Lake Aratiatia	29.45	15	156		4602	450	Forestry	Forestry	RIVER PROCESS	Land use

These photos indicate that the bank height was under-estimated during the 2007 survey. The 2007 area should therefore be at least 1000 m<sup>2</sup>, and possibly more if the length of the erosion feature was also under-estimated.

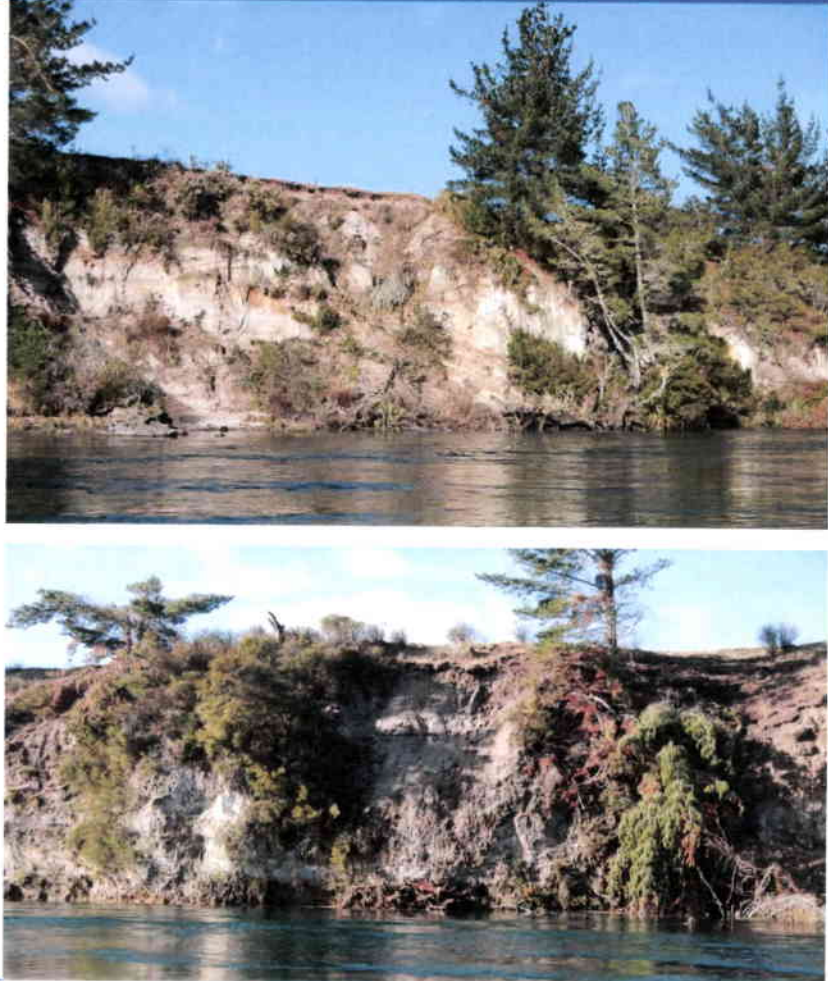
ID	2012 PHOTOS	2007 PHOTOS
1076

ID	HISTORIC SITE NAME	SECTION NAME	2012 HEIGHT (M)	2007 HEIGHT (M)	2012 LENGTH (M)	2007 LENGTH (M)	2012 AREA (M2)	2007 AREA (M2)	2012 LANDUSE	2007 LANDUSE	2012 PRIMARY CAUSAL FACTOR	2007 PRIMARY CAUSAL FACTOR	2012 CAUSAL FACTORS: OTHER
1077	682	Lake Ohakuri to Lake Aratiatia	30.49	8	145		4417	480	Forestry	Forestry	RIVER PROCESS	River processes

These images also indicate that the 2007 height was greatly under-estimated. The 2007 area should therefore have been at least 1,800 m<sup>2</sup> and possibly more if the length of the feature was also under-estimated.

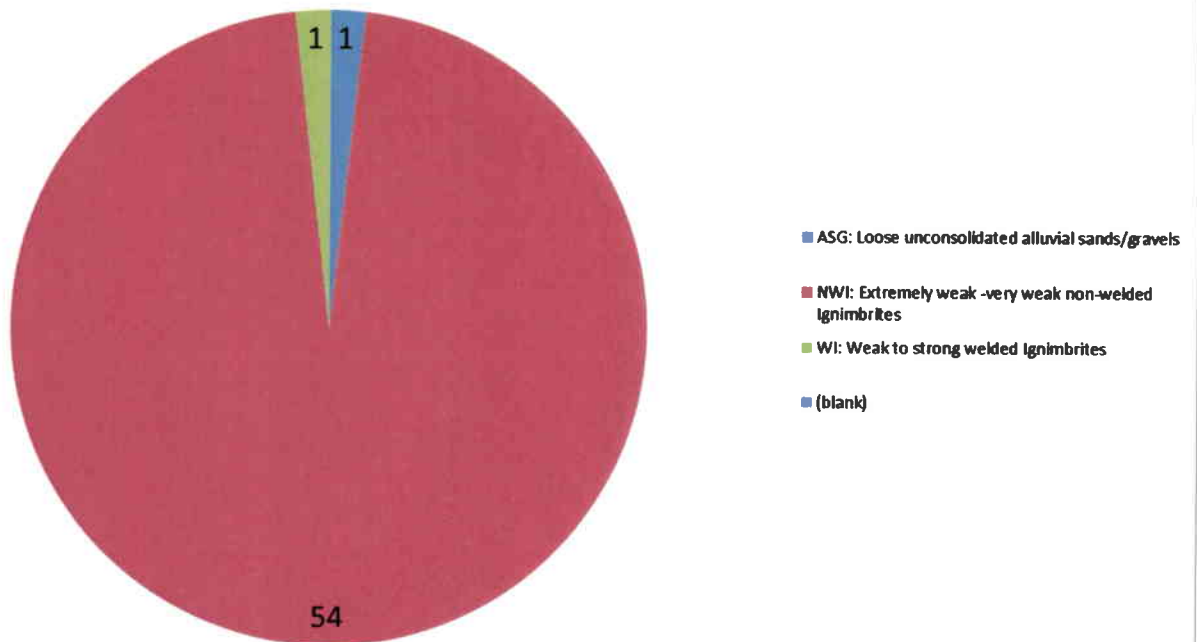
**Number of sites by primary engineering geological description  
Section 9**

Note: Geological units are taken from maps, engineering geology from field observations. Where the engineering geology could not be observed, this is not identified.

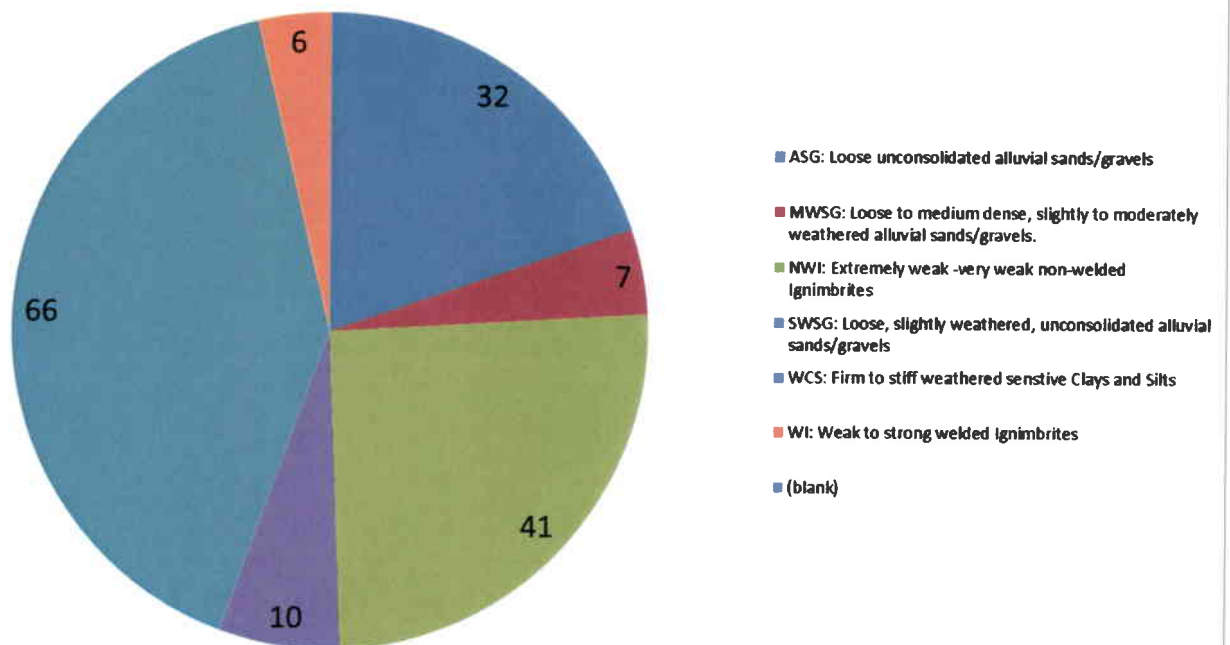
**Number of sites by primary engineering geological description  
Section 14**

Note: Geological units are taken from maps, engineering geology from field observations. Where the engineering geology could not be observed, this is not identified.
